October 17, 2019

Re: Fairgrounds Middle School
Building Survey Findings
RPF File 199461

Between September 26, 2019 and October 8, 2019, RPF Environmental, Inc. (RPF) conducted a survey at Fairgrounds Middle School located at 27 Cleveland Street in Nashua, New Hampshire. The survey was performed in the building, as designated by you, for accessible hazardous building material as indicated herein. Below is a summary of findings, discussion of the results and preliminary recommendations for proper management of the identified hazardous building material. Attached to this report are the survey data tables, laboratory results, survey methodologies and limitations.

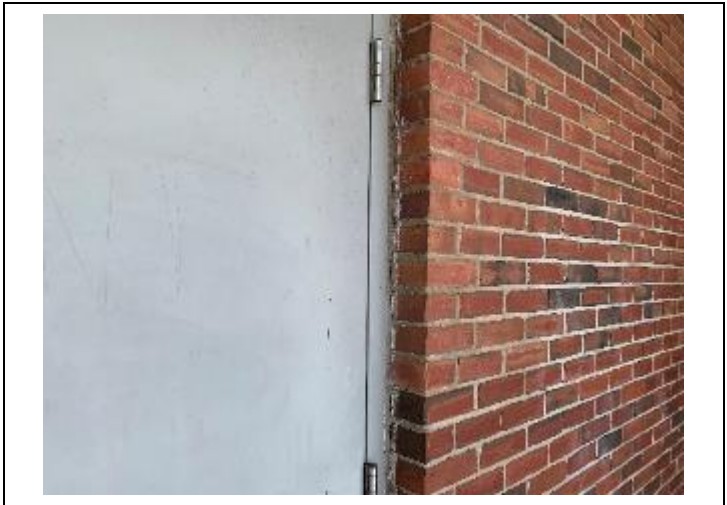
2. ACBM remnant door caulk. Assumed to be around all doors on original brick structure.

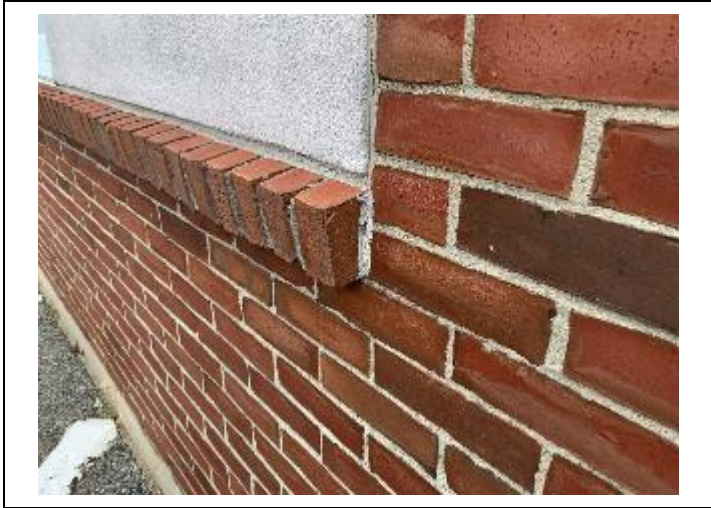
3. Exterior window caulk. No asbestos detected.

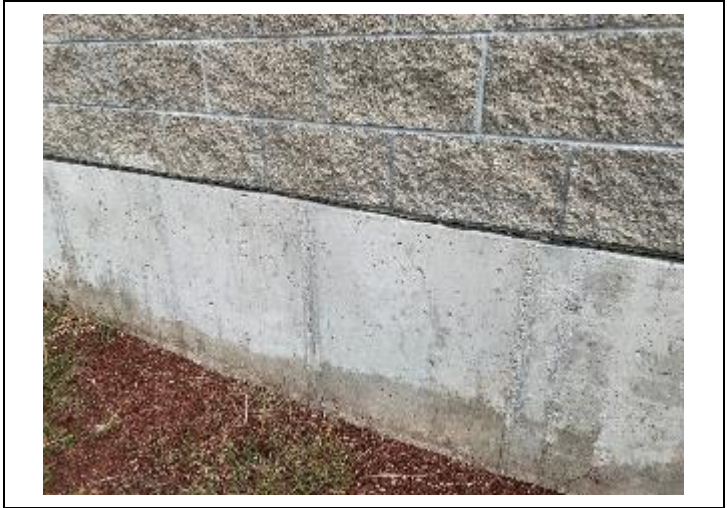
4. Black sealant on addition flashing on the base of the exterior wall. No asbestos detected.

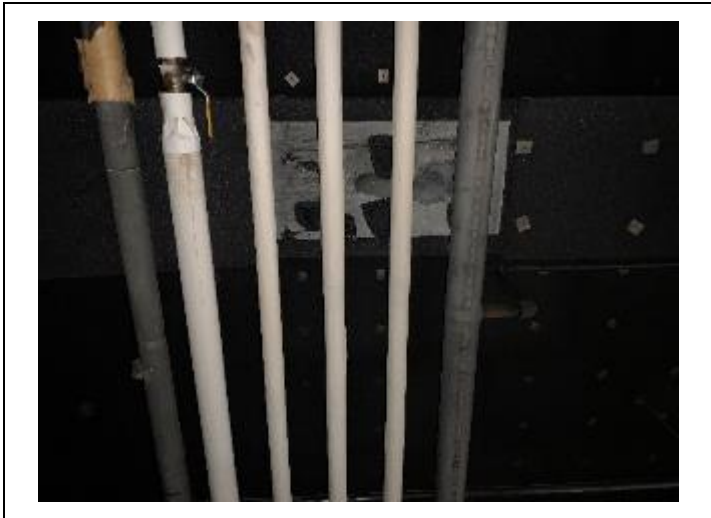
5. ACBM black glue daub behind black foam insulation on boiler room ceiling.

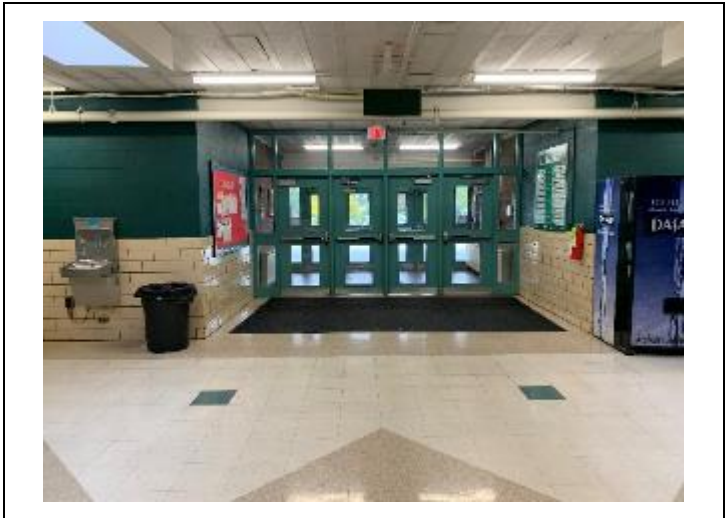
In the course of this survey, RPF collected eighteen (18) samples of black flooring mastic throughout the school below the existing 12" floor tile. Of these, 3 were found to contain greater than 1% asbestos. Given the homogenous appearance of the existing floor tile and black flooring mastic throughout the school, not counting the pod classrooms at the ends of each of the 6th, 7th and 8th grade wings, RPF recommends that all of the black flooring mastic throughout the building be assumed to be asbestos containing. This is also consistent with the 1996 abatement report discussion that the ACM mastic was not fully removed during that project. Further evaluation should be conducted during design phase, including a review of any past abatement records not previously provided, if any, and additional destructive sampling in an effort to delineate and confirm locations of residual mastic as feasible.

6. Entrance with 12" floor tile with ACBM black flooring mastic.

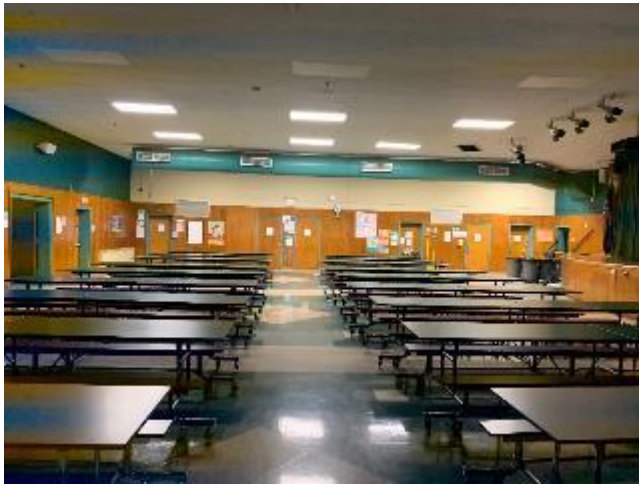
7. Cafeteria with 12" floor tile and ACBM black flooring mastic.

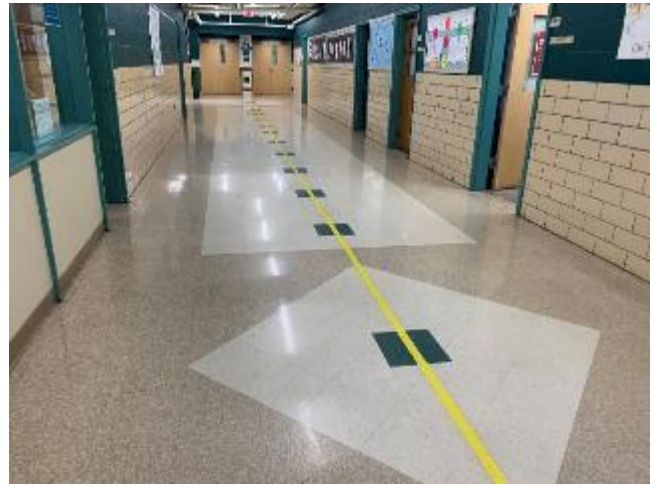
8. Main Hallway with 12" floor tile and ACBM black flooring mastic.

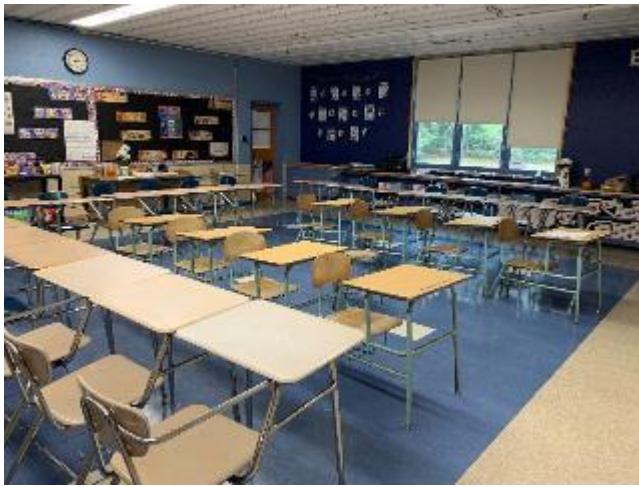
9. Classroom with ACBM flooring mastic and ACBM chalkboard with assumed ACBM glue daubs.

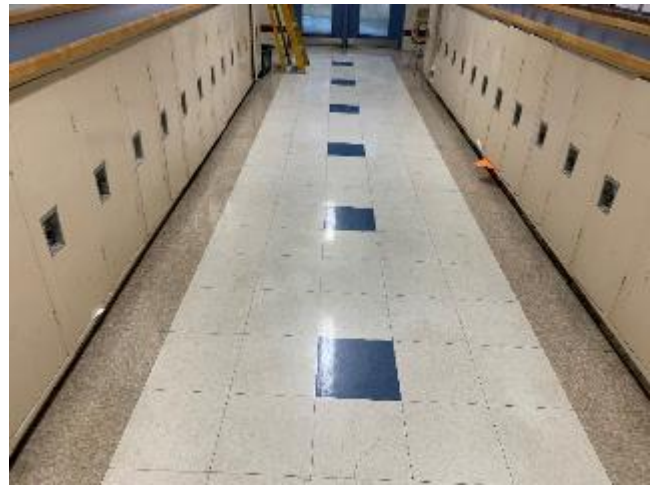
10. Hallway with 12" floor tile and ACBM black flooring mastic.

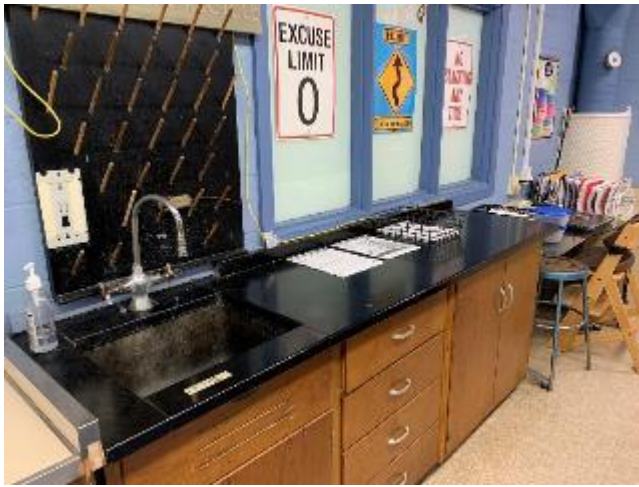
11. ACBM black bottle drying rack.

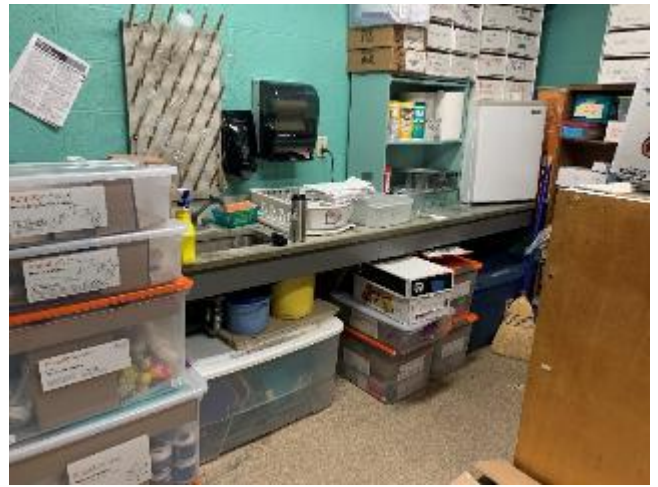
12. ACBM gray bottle drying rack and lab counter with 601/701/801 storage rooms.

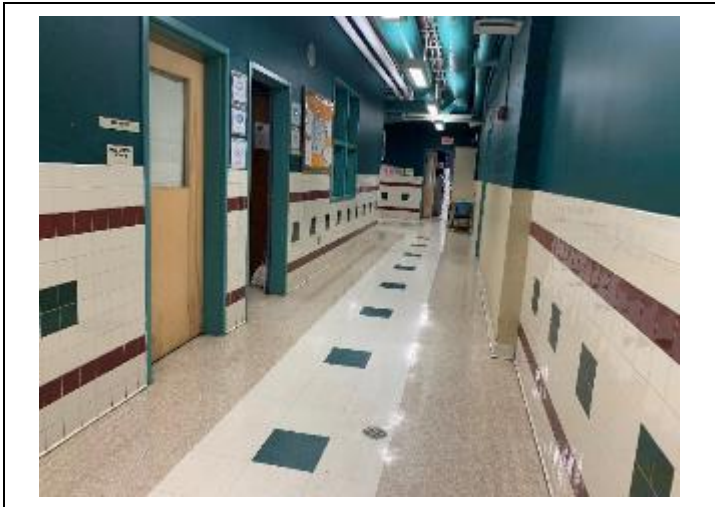
13. Hallway with wall tile adhesive and grout. No asbestos detected. ACMF flooring mastic below 12" Tile.

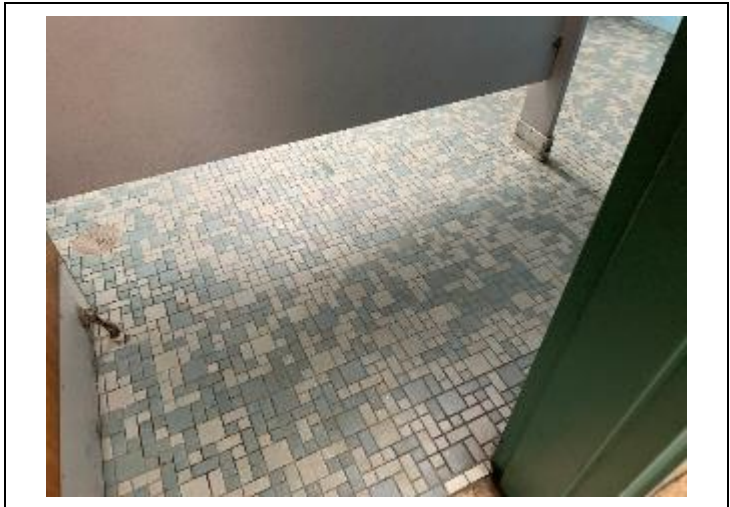
14. Bathroom tile and grout with thinset and grout. No asbestos detected.

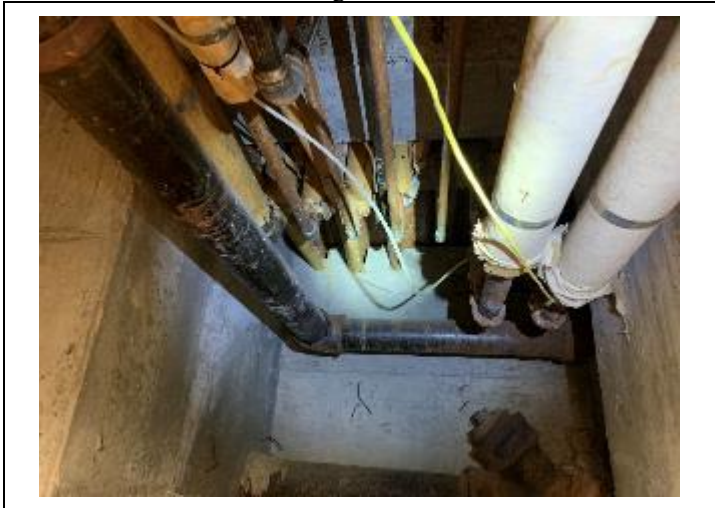
15. Visible pipe insulation within basement. Insulation and fittings observed to be fiberglass.

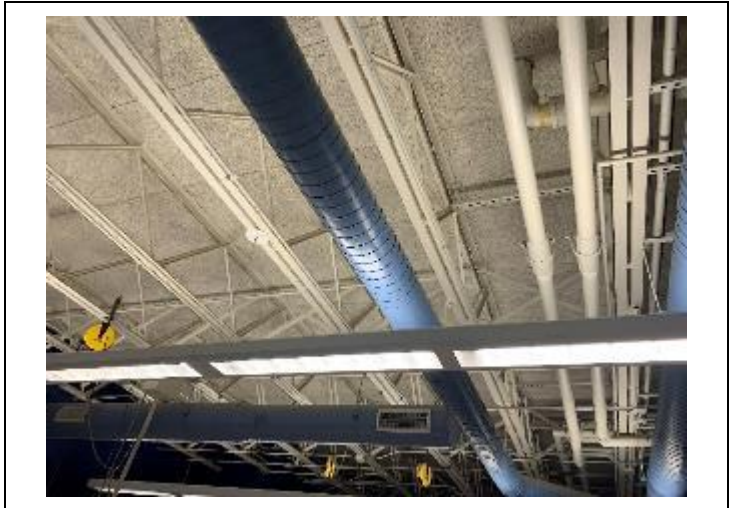
16. Tectum roof deck. No asbestos detected.

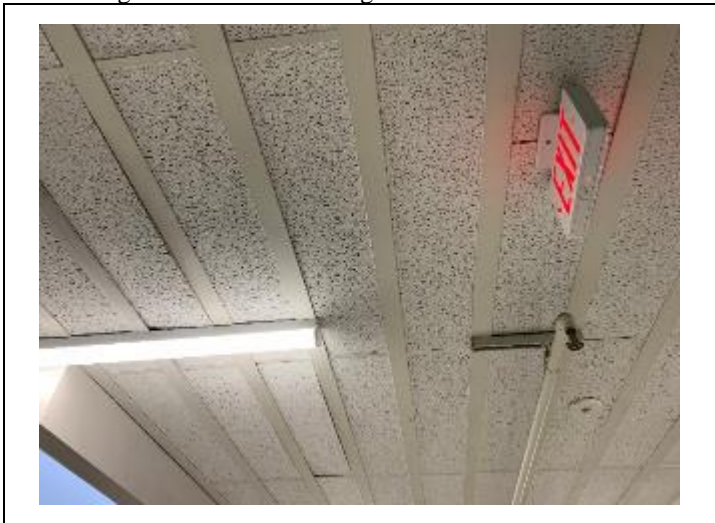
17. Suspended ceiling tiles throughout. No asbestos detected.

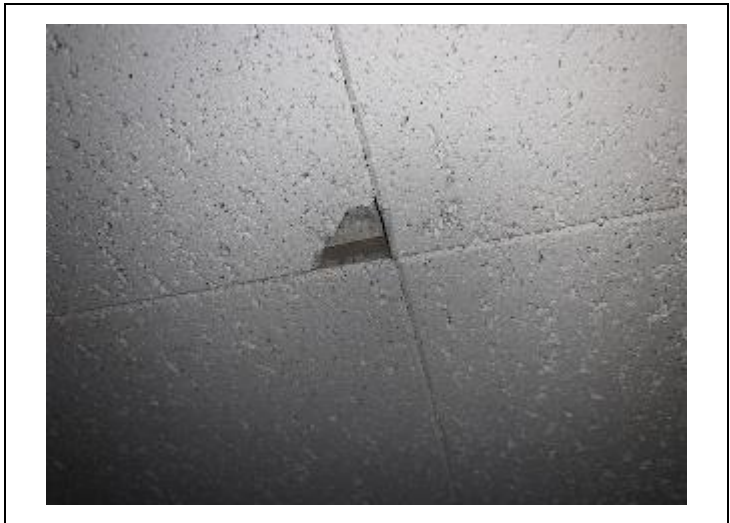
18. 12" fixed ceiling tile within room 105 storage room. No asbestos detected.
