October 11, 2019

Re: Pennichuck Middle School
Building Survey Findings
RPF File No. 199461

Summary of Findings

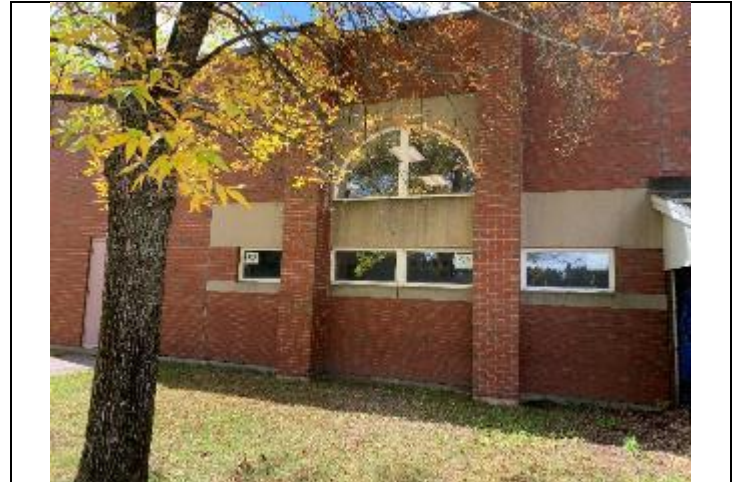
2. Exterior Windows with white caulking.

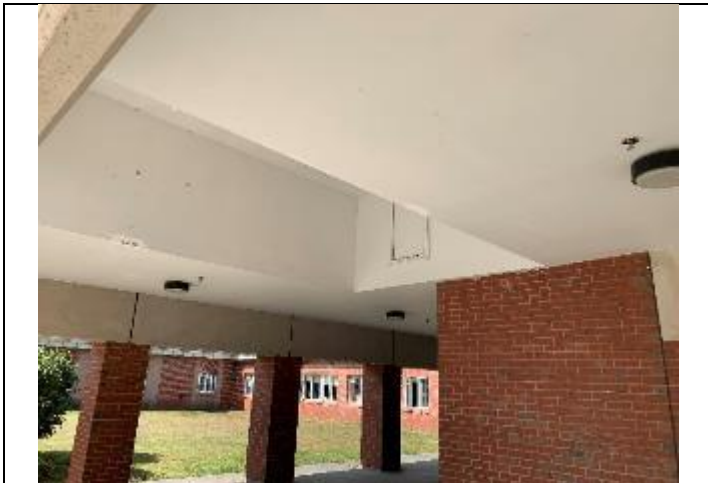
3. Entry overhang with gypsum and joint compound.

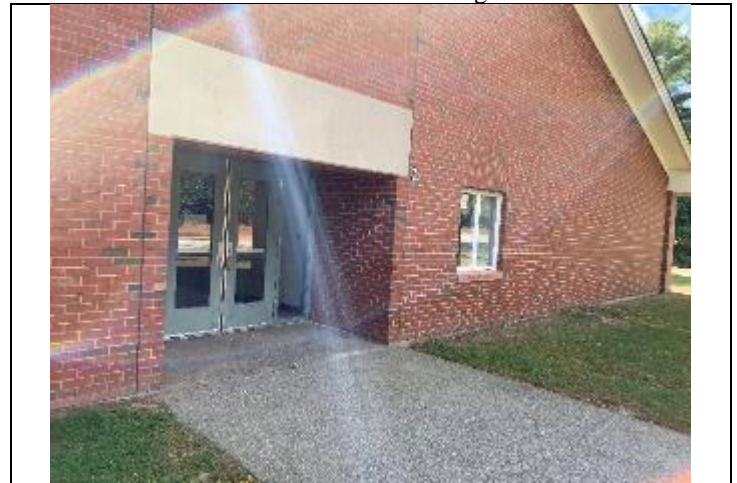
4. Small Entry overhang with gypsum and joint compound as well as door caulk.

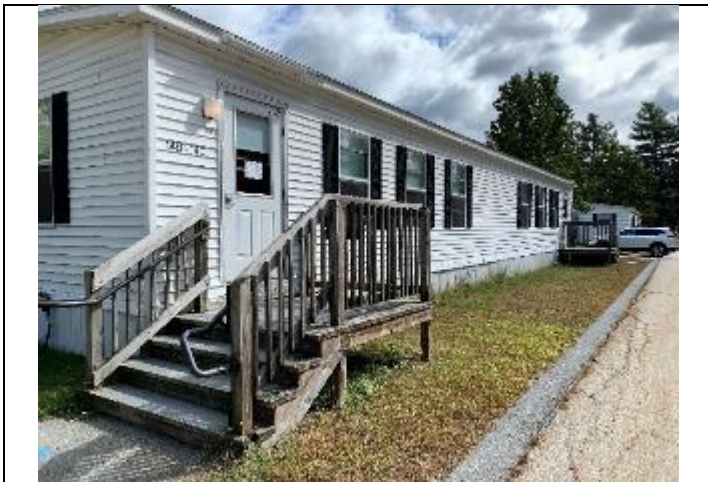
5. Detached modular classroom structures.

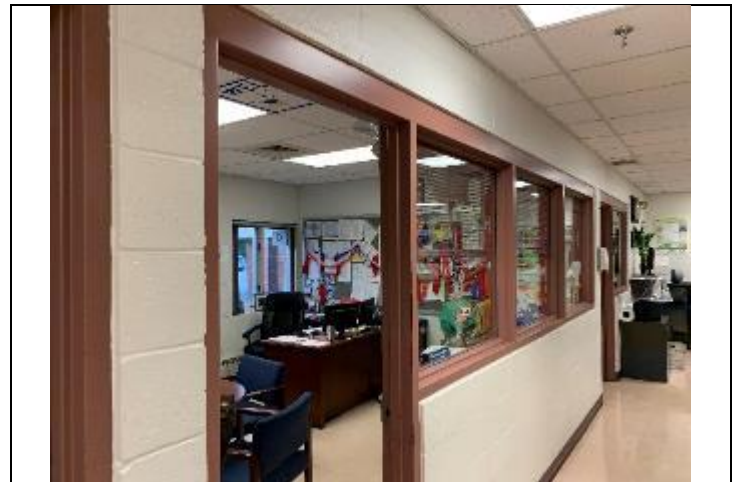
6. Main office with CMU walls, 12" floor tile and suspended ceiling tiles.

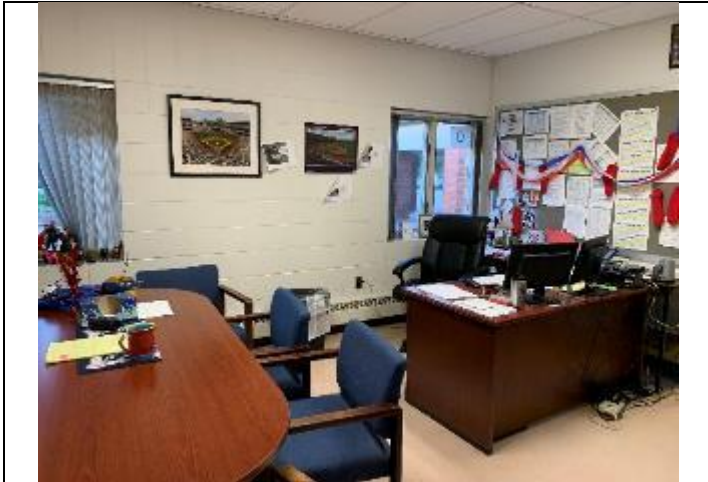
7. Main office with CMU walls, 12" floor tile and suspended ceiling tiles.

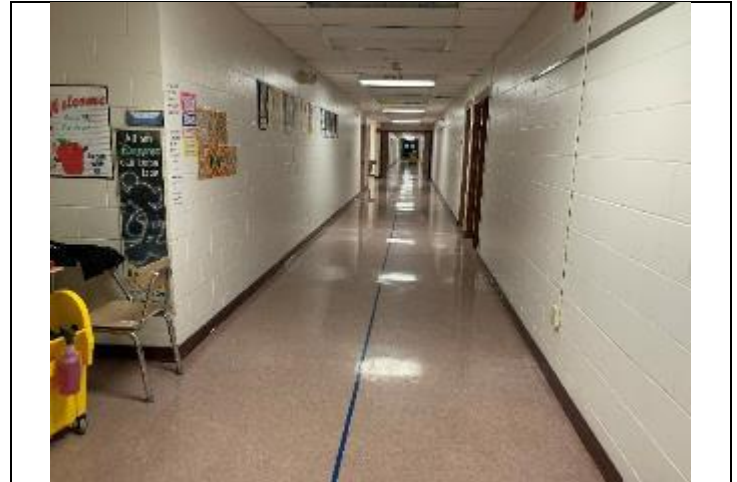
8. Hallway with CMU walls, 12" tile and suspended ceiling tile.

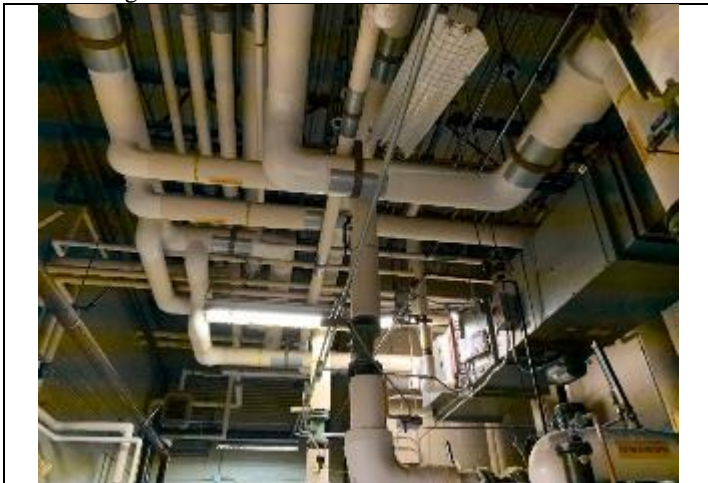
9. Boiler room with fiberglass insulation.

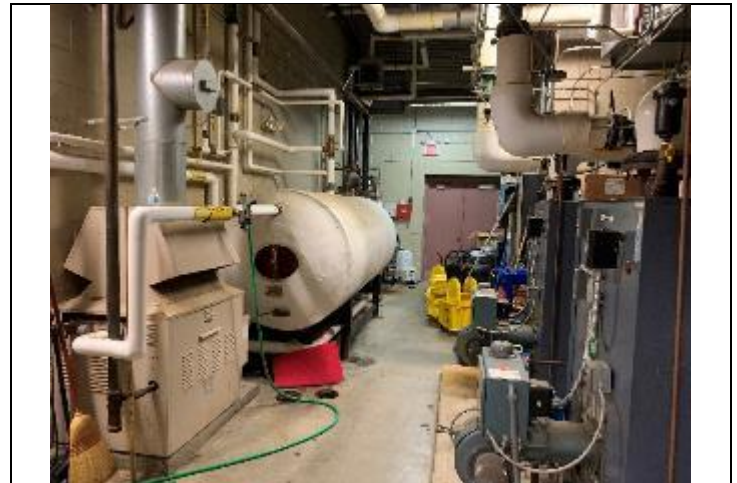
10. Boiler room water tank insulation. No asbestos detected.

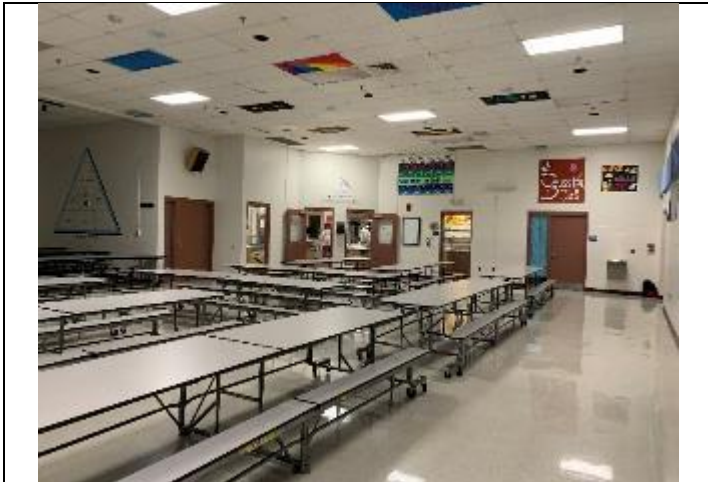
11. Cafeteria with 12" tile and suspended ceiling tiles.

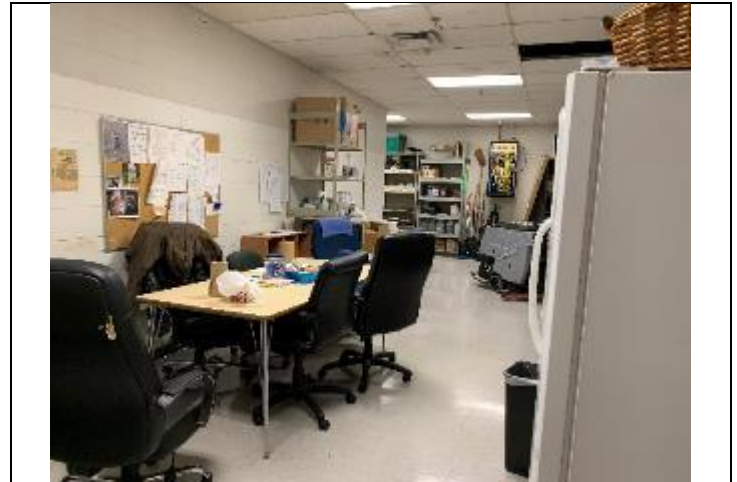
12. Custodial room with 12" tile and suspended ceiling tiles.

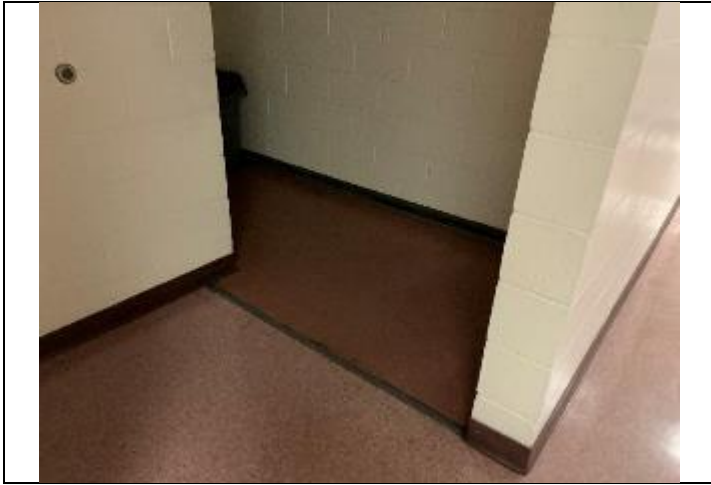
13. Poured flooring within hallway bathrooms.

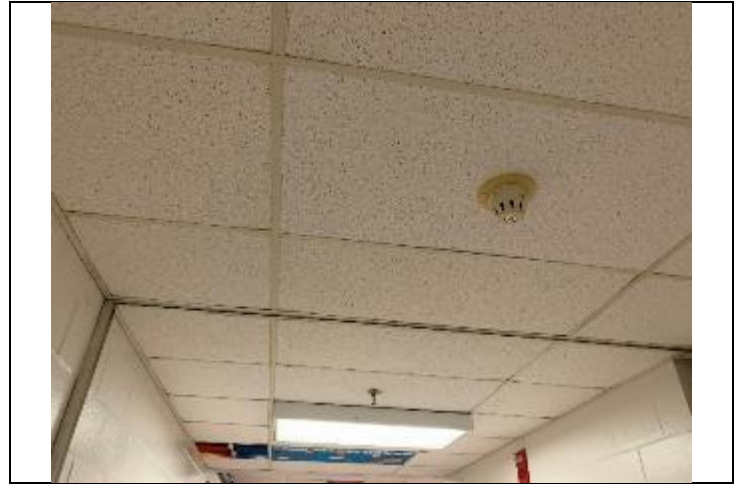
14. Suspended ceiling tile was present throughout with LED lighting.

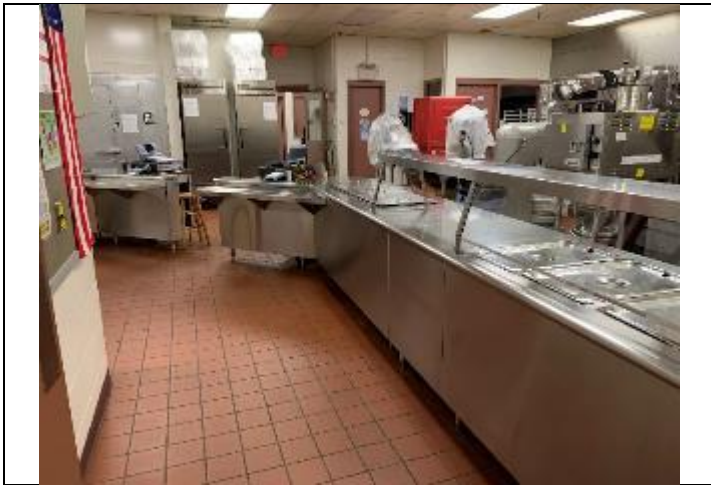
15. Quarry Tile within kitchen area.

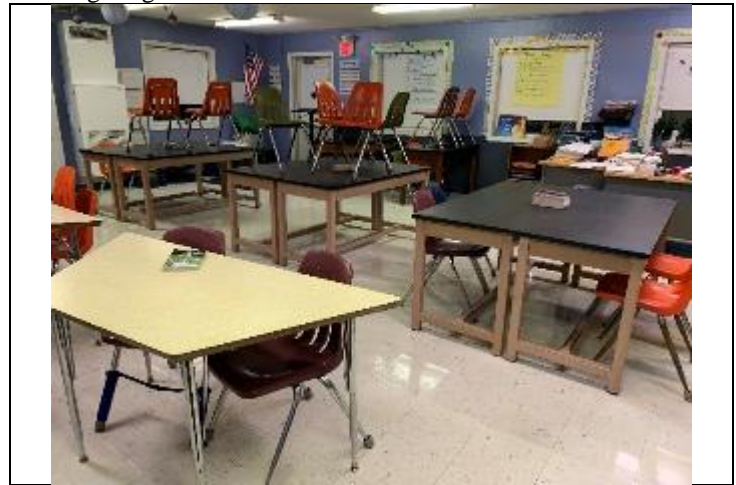
16. Classroom with lab desks and counters.

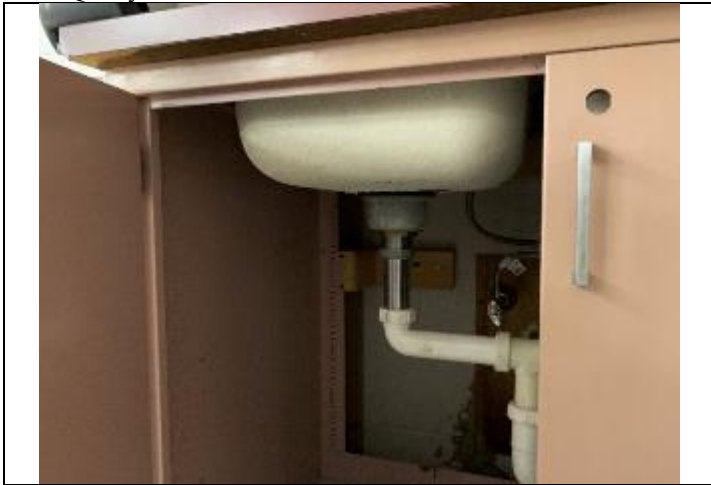
17. Sink Basin undercoat. No asbestos detected.

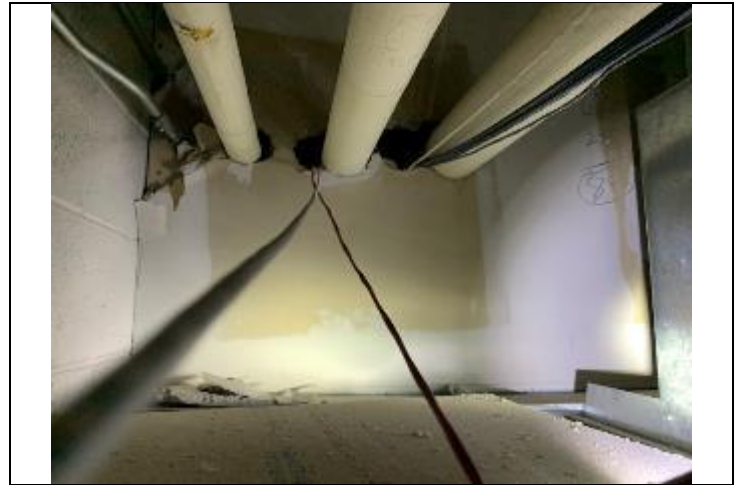
18. Gypsum and Joint compound present above hallway ceilings.
