SECTION 2

FACILITY ANALYSIS

FACILITY ANALYSIS OVERVIEW

ELM STREET MIDDLE SCHOOL

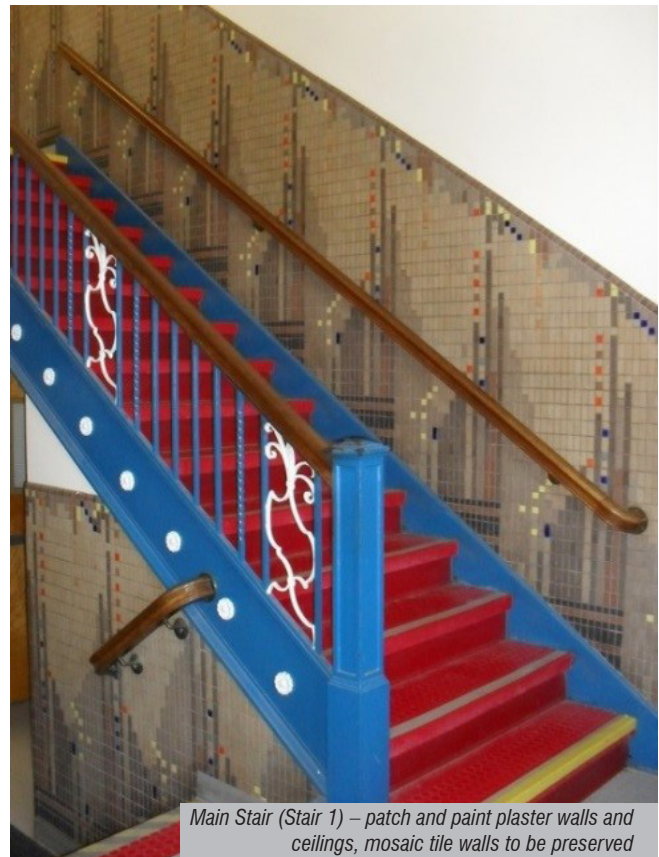
Main Stair (Stair 1) – patch and paint plaster walls and ceilings, mosaic tile walls to be preserved

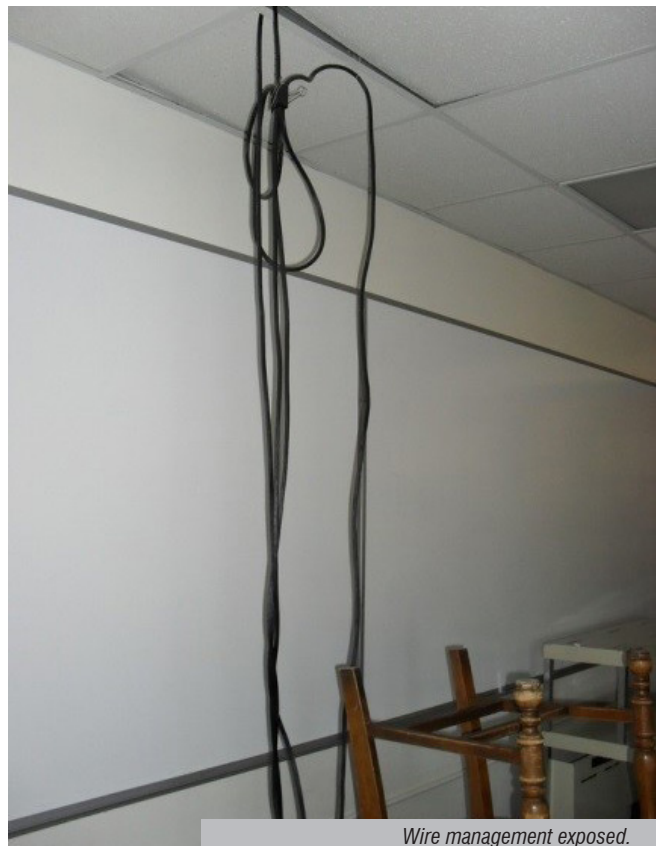
Wire management exposed.

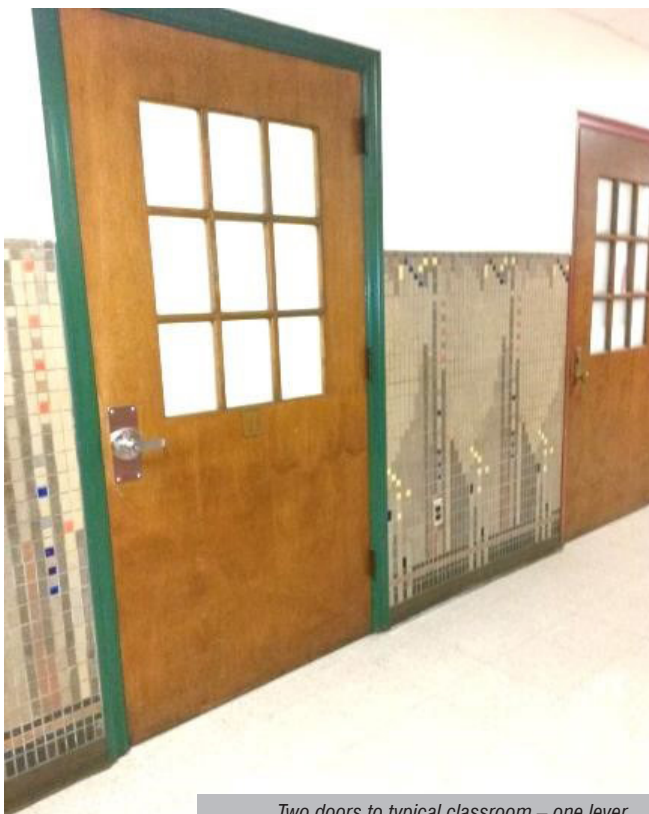
Two doors to typical classroom – one lever handle and the other original knob

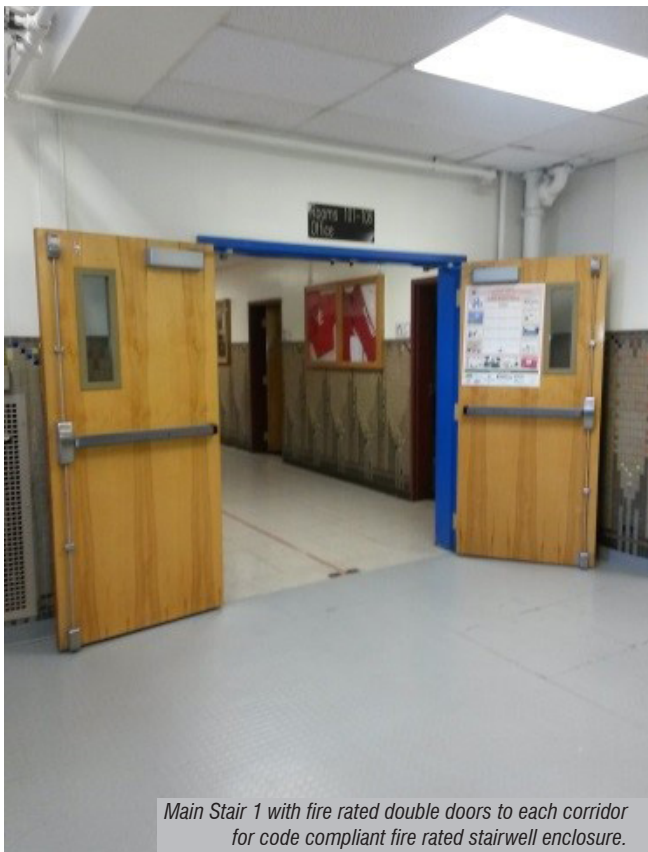
Main Stair 1 with fire rated double doors to each corridor for code compliant fire rated stairwell enclosure.

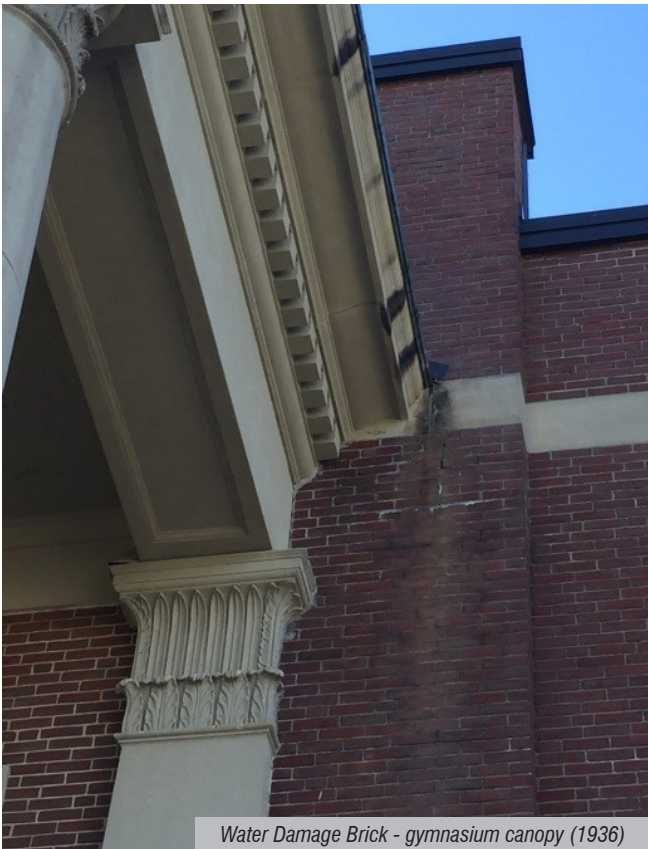
Water Damage Brick - gymnasium canopy (1936)

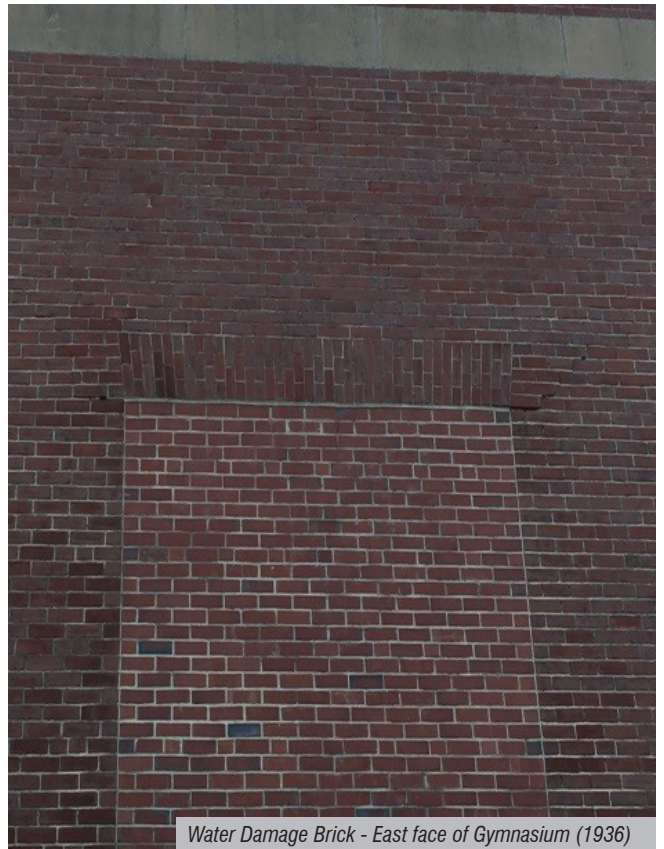
Water Damage Brick - East face of Gymnasium (1936)

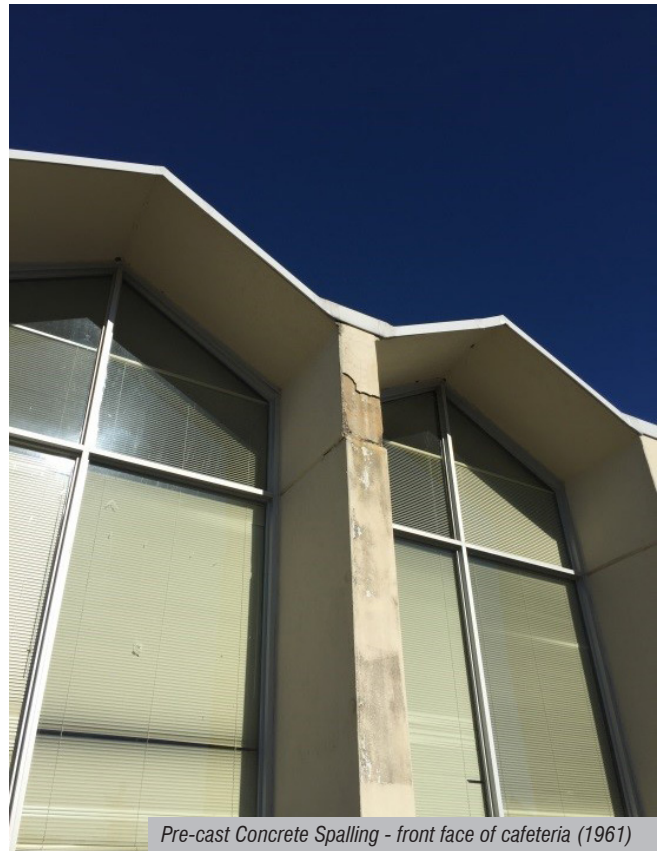
Pre-cast Concrete Spalling - front face of cafeteria (1961)

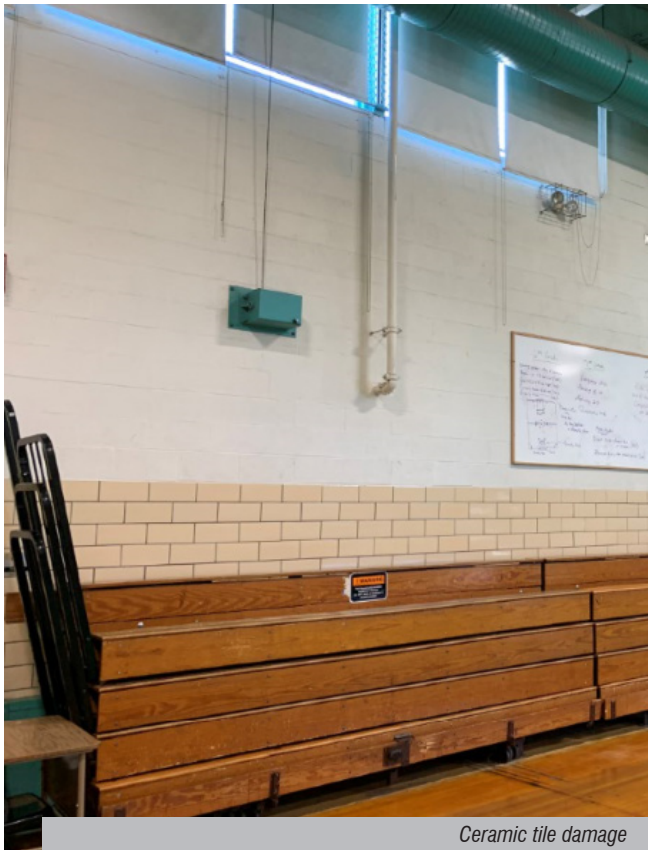
Ceramic tile damage

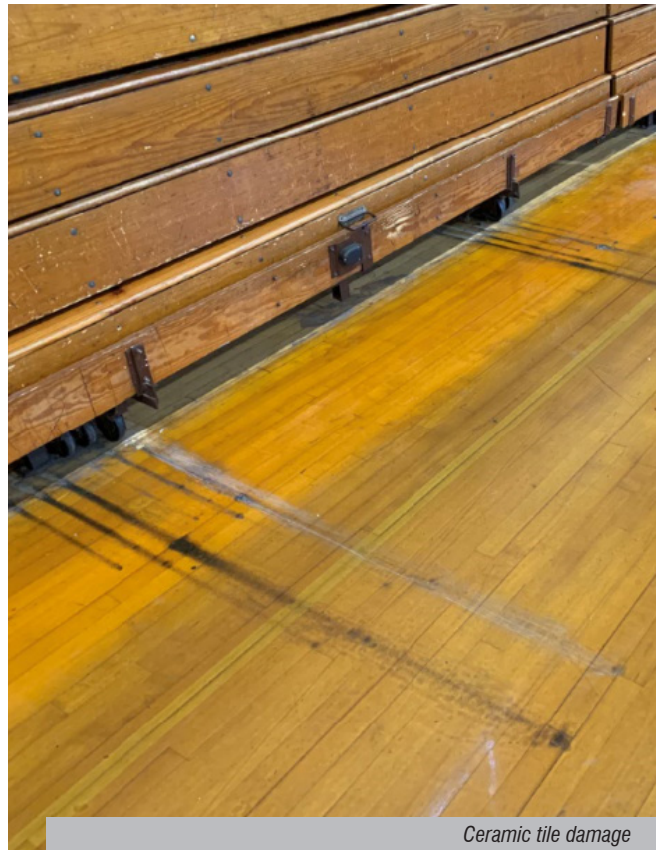
Ceramic tile damage

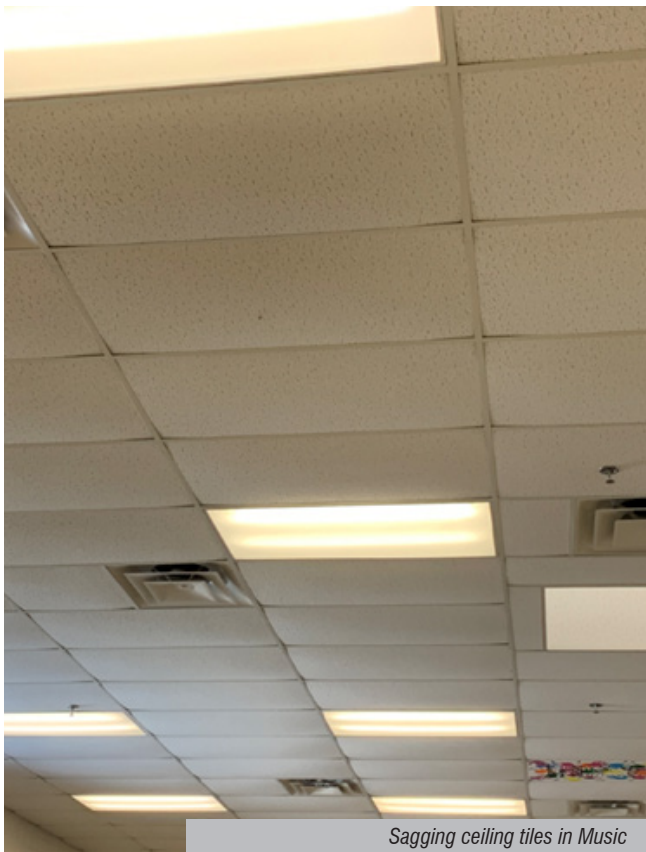
Sagging ceiling tiles in Music

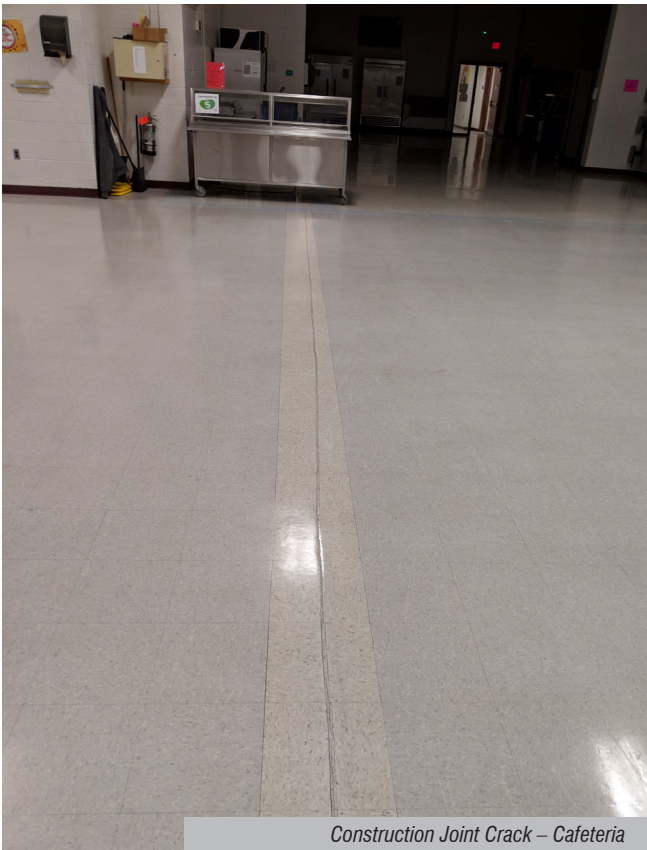
Construction Joint Crack – Cafeteria

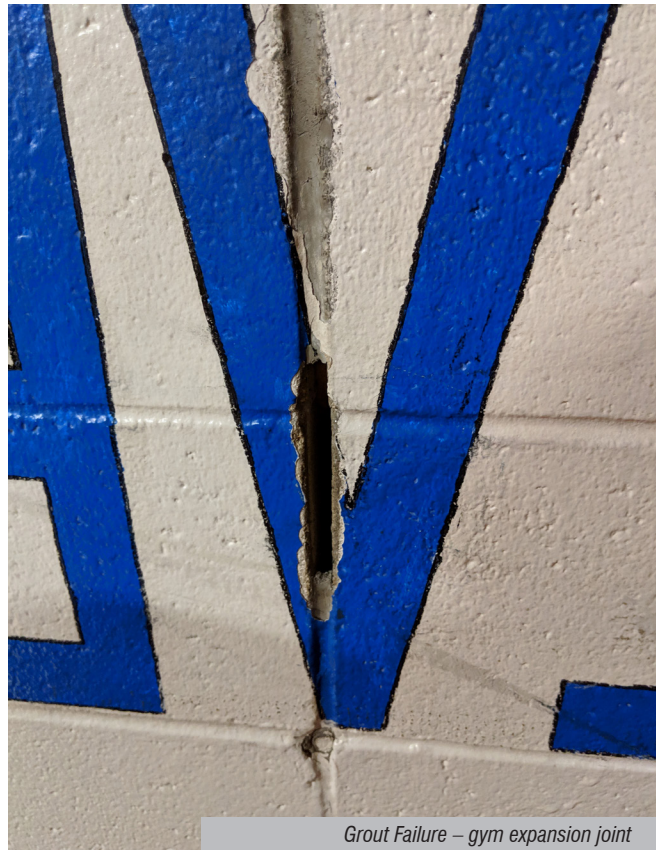
Grout Failure – gym expansion joint

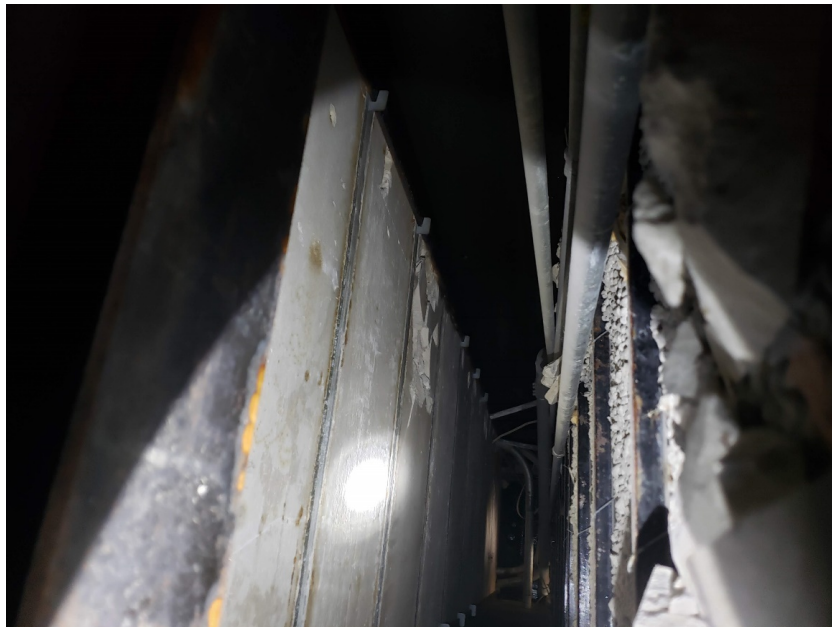
Figure 16 Room 7 Ceiling w/ Spall

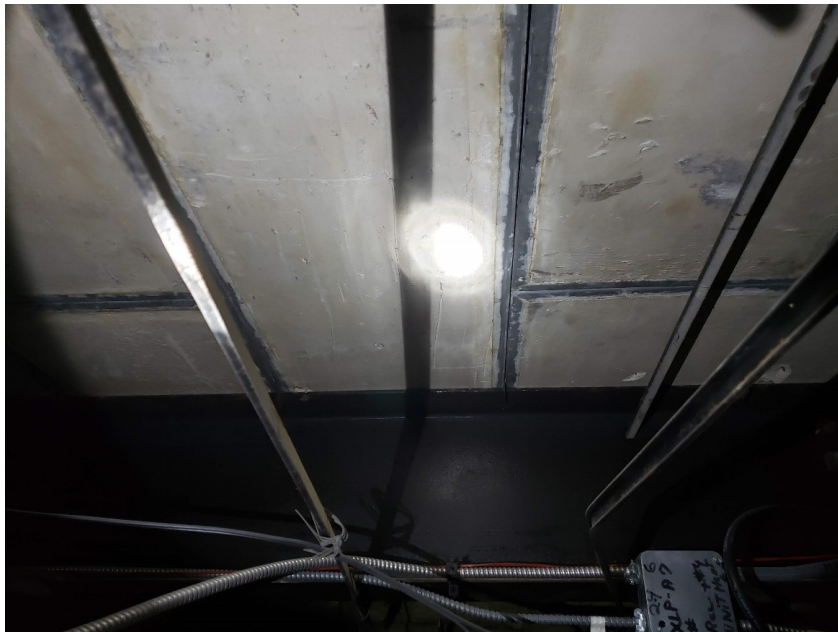
Figure 24 Room 3 Ceiling w/ Minor Spalling
