SECTION 2

FACILITY ANALYSIS

FACILITY ANALYSIS OVERVIEW

ELM STREET MIDDLE SCHOOL

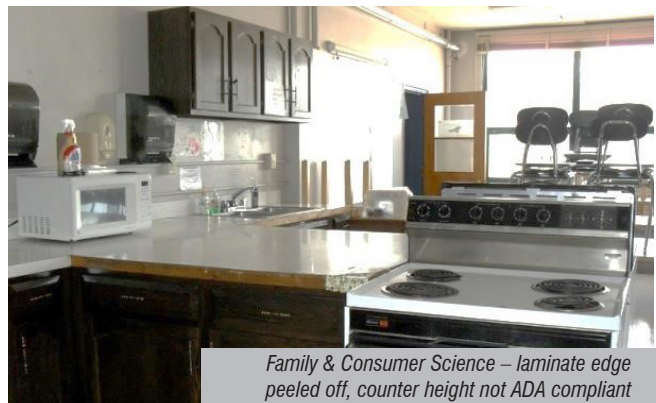
Family & Consumer Science – laminate edge peeled off, counter height not ADA compliant

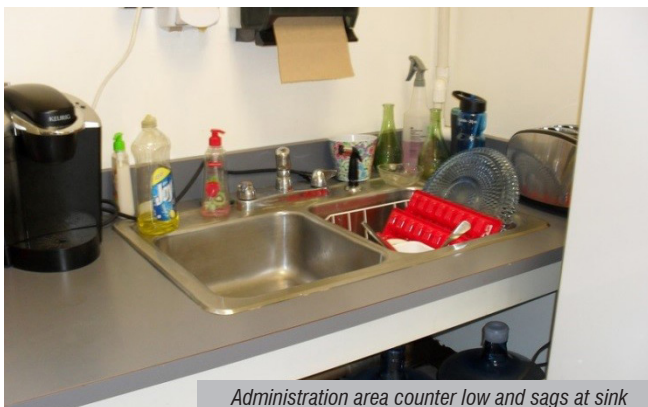
Administration area counter low and sags at sink

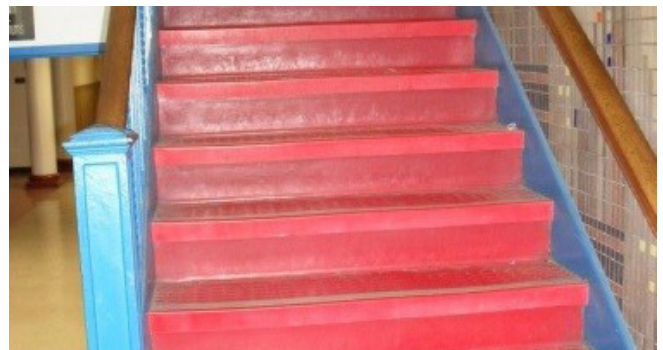
Stairs in original 1936 building do not meet code requirements for dimensions of guardrails, handrails, balusters handrail extensions, etc.

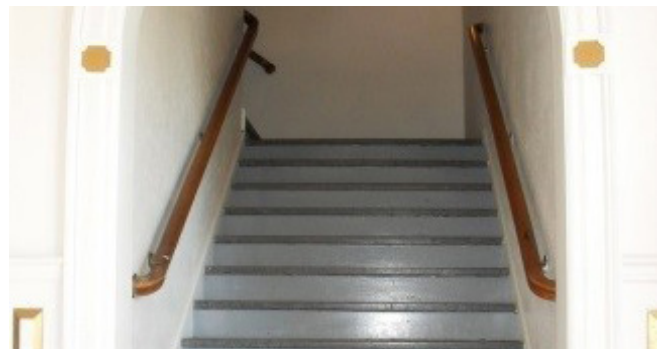
Auditorium Stairs: Access to balcony handrails does not meet code.

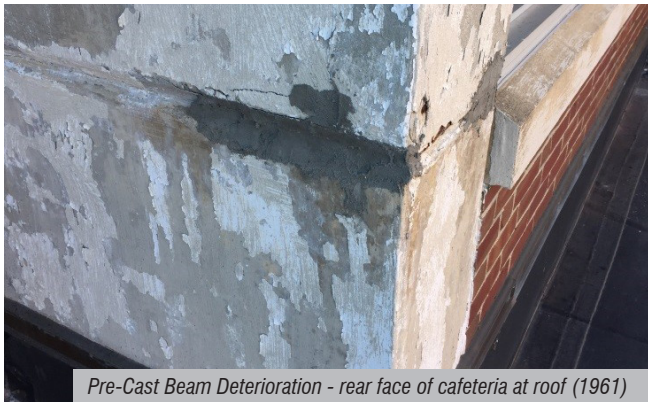
Pre-Cast Beam Deterioration - rear face of cafeteria at roof (1961)

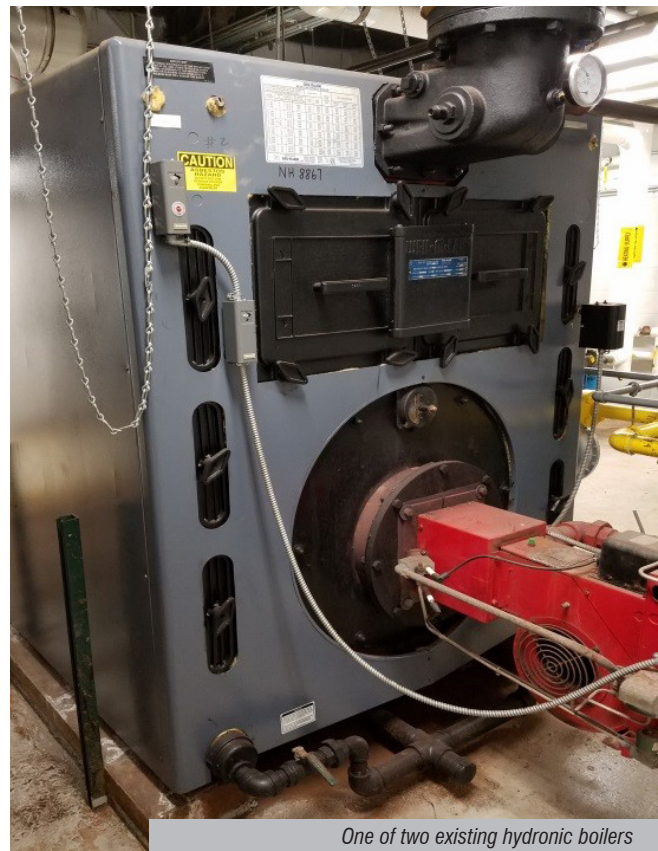
The secondary heating system was installed in the basement beneath the foyer of the new gymnasium in the 1961 addition. These two boilers supply hot water to only the gymnasium. This system is hydronic and consists of two Weil-McLain boilers, Model No. 1594. The gross output for each boiler is 4,070 MBH. The net IBR rating for hot water is 3,539 MBH. These boilers are in good condition as they are not the original boilers and have probably been replaced in the past 15-20 years and have 10-15 more years of use.

One of two existing hydronic boilers

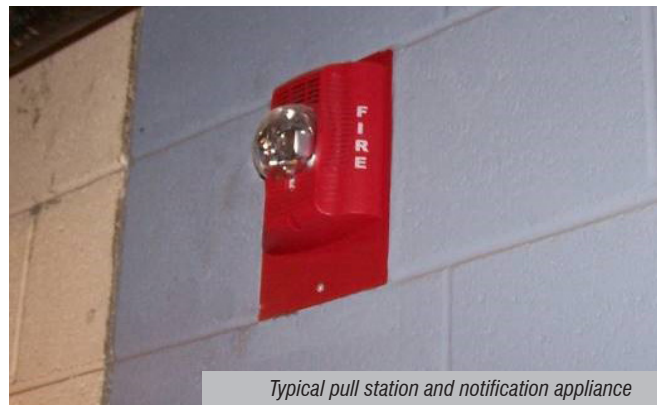
Typical pull station and notification appliance

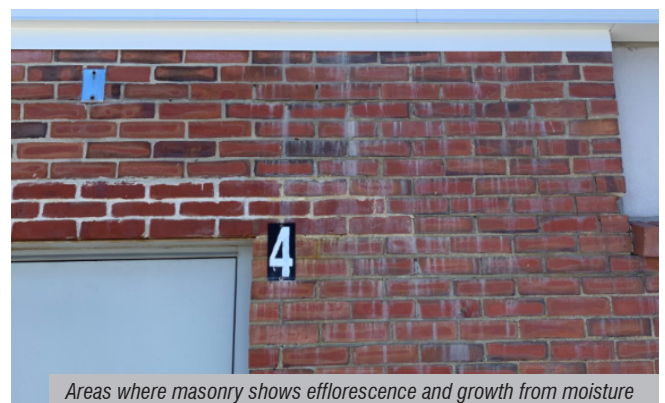
Most brick and mortar joints appear to be in good-to-fair condition overall; however, localized areas of joints in poor shape were noted and should be repaired. Brick weeps were not noted at the base of the brick around the original building, but were found in areas of the new addition CMU veneer. Although not prevalent everywhere around the building, there were some areas of efflorescence noted in a few locations on the masonry veneer. Efflorescence of masonry usually occurs when moisture occurs behind the brick and the moisture pushes the salts that are naturally in the brick and joints to the surface. A proper cleaning of these surfaces can typically alleviate any visual concerns. In instances where the building lacks an air vapor barrier or weather tends to breach the wall system, there is potential for reoccurrence. Regular inspection of sealants should be performed and resealed if the inspections warrant it. Any missing sealant at joints should be filled to prevent infiltration of weather.

Areas where masonry shows efflorescence and growth from moisture

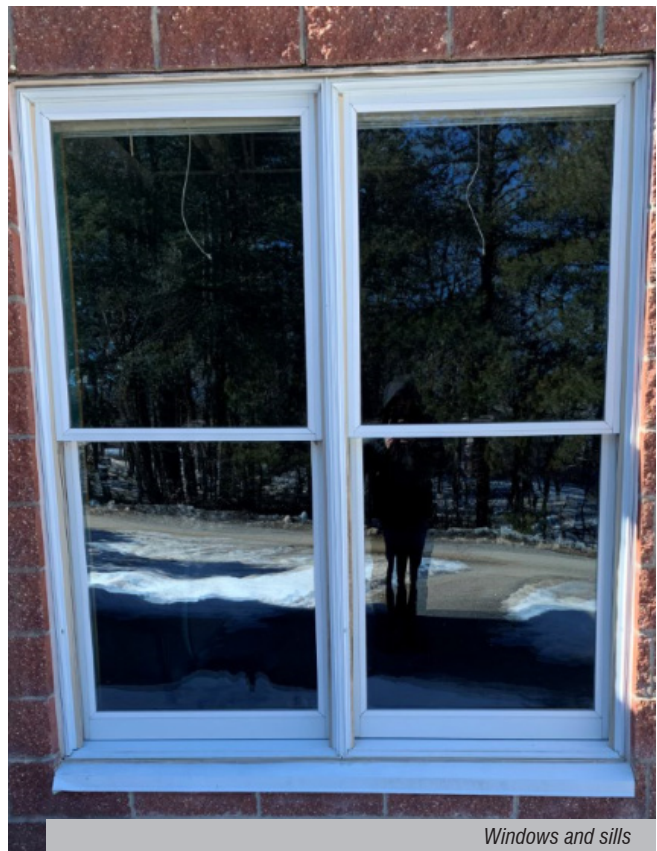
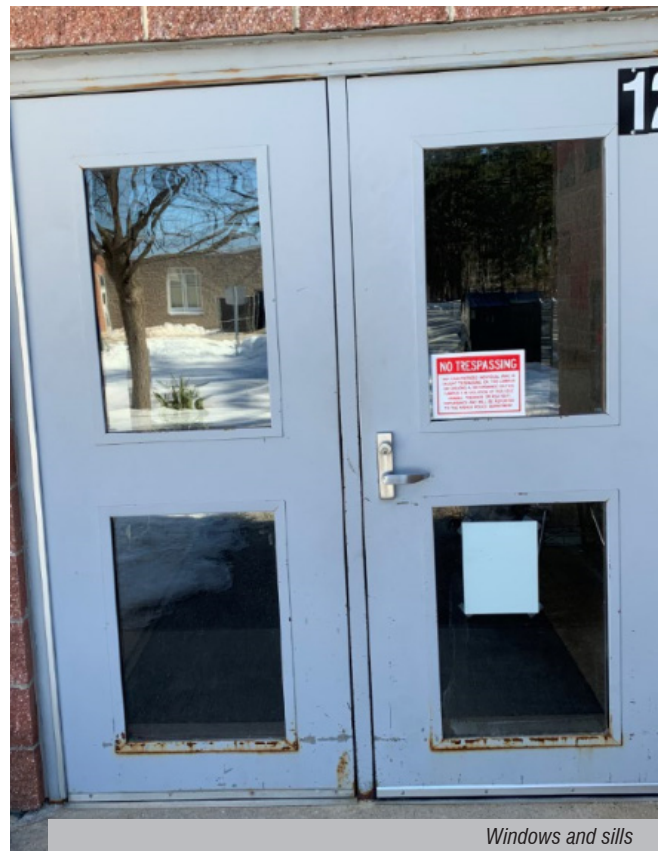
The windows appear to have been replaced during the 1996 renovation, with primarily aluminum-clad wood, double hung windows. Some windows were noted to be fixed type windows. They generally appear to be in good condition; however, some windows were found to be damaged. Damaged windows should be replaced. The glass was noted to be insulated panels and none were noted as failing at this time. A commercial window's life expectancy is based on average wear-and-tear of windows. Clad windows are expected to last around 25 years, and but can be extended with regular maintenance. In many cases the screen at the windows were missing. Replacement of any missing or damaged screens should be done to prevent pests from entering the building when windows are open.

The sills of the windows are made of prefinished metal at the 1996 additions. They are made from sloped rowlock brick at the original portions of the building. The locations with prefinished metal were noted as being in good shape. Several locations of brick window sills were noted as being in poor shape and may even allow weather into the wall cavity. At these locations, sealant may have been missing or disturbed, or in some locations the brick joints may have been disintegrating. Review of the locations should be done and repaired where needed. Resealing of windows should be done and continued maintenance should persist to ensure long life of wall components.

Windows and sills

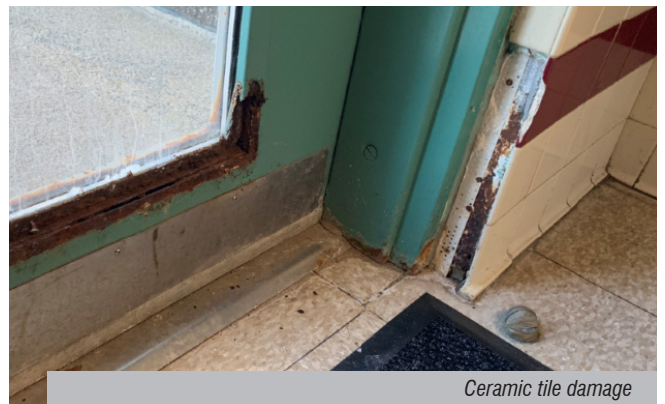
Ceramic tile wainscoting was used in the newer addition corridors and is generally in poor shape in many of the areas, with chipped and broken tiles. Replacement by patching or wholesale is recommended.

Ceramic tile damage

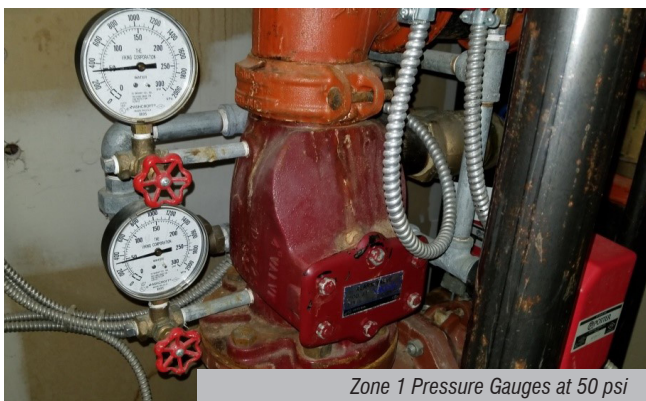
The sprinkler system was installed in the mid-1990s. Three wet pipe riser valves serve all areas of the building. The static pressure at the base of the risers on the day of the survey was 50 psi. The test cards indicate a static pressure of 60 psi. It appears the sprinkler piping and calculations were produced with 60 psi incoming static pressure or higher. The design calculation labels on the piping indicate a required pressure for each protected zone between 48 and 53 psi flowing pressure. At a static pressure of 50 psi, the system will not flow water to the design areas at the calculated rate.

Zone 1 Pressure Gauges at 50 psi

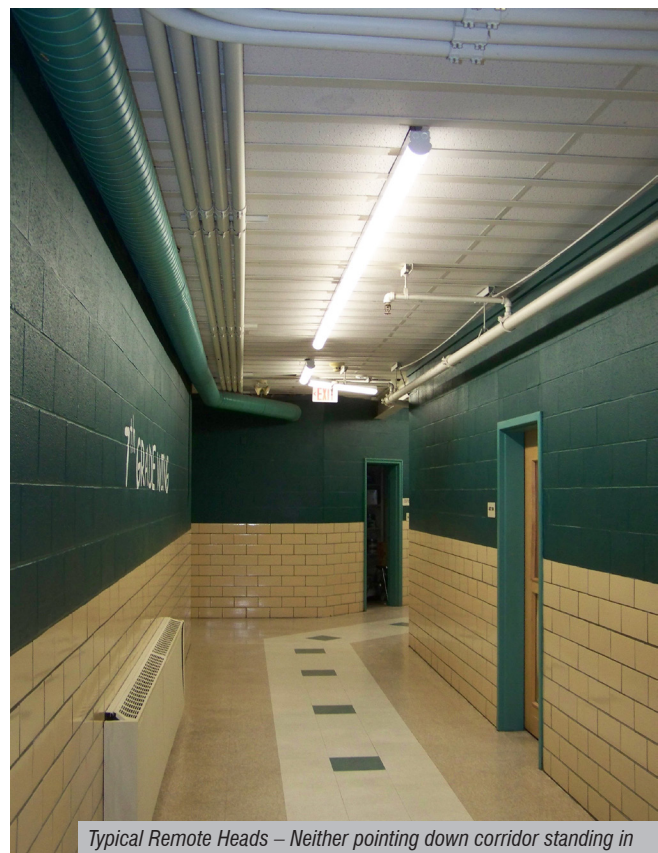
No egress lighting was observed in the “Shop” classrooms.

Typical Remote Heads – Neither pointing down corridor standing in

- / Provide additional and replace existing emergency battery units to provide the code required egress lighting levels.
- / Add exit signs as necessary so there are always two paths to egress.

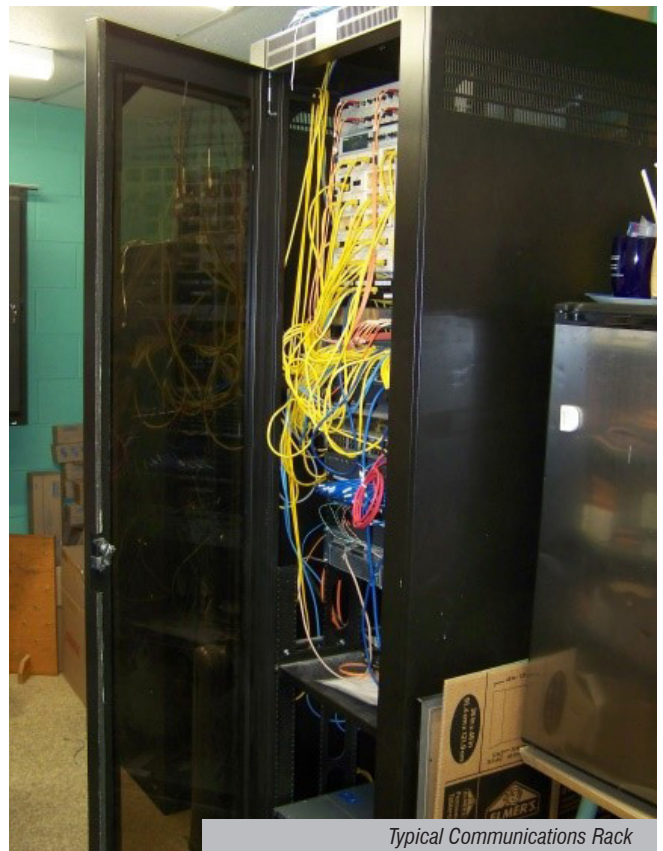
wall-mounted, had little to no space to accommodate additional patch panels or switches, and are not in rooms dedicated to IT.

Typical Communications Rack

- / To accommodate future needs, floor mounted communications racks should be provided in rooms dedicated to IT.
- / Replace and upgrade cabling, jacks, patch panels, and switches to current standards.
- / Provide additional drops as required to accommodate the requirements of today and the near future.

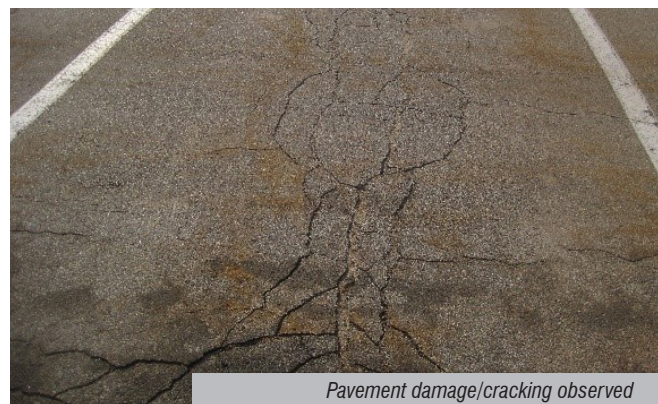
Pavement damage/cracking observed

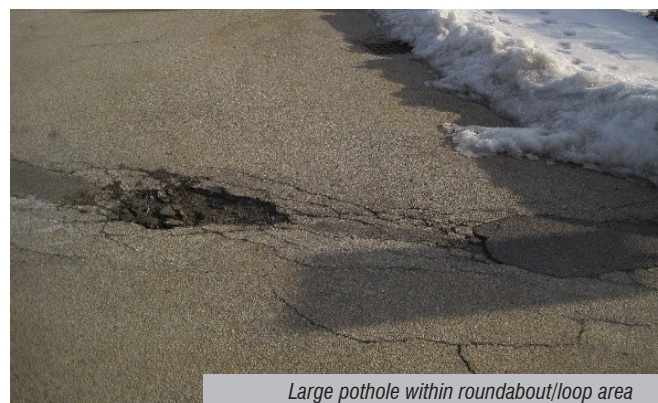
Large pothole within roundabout/loop area

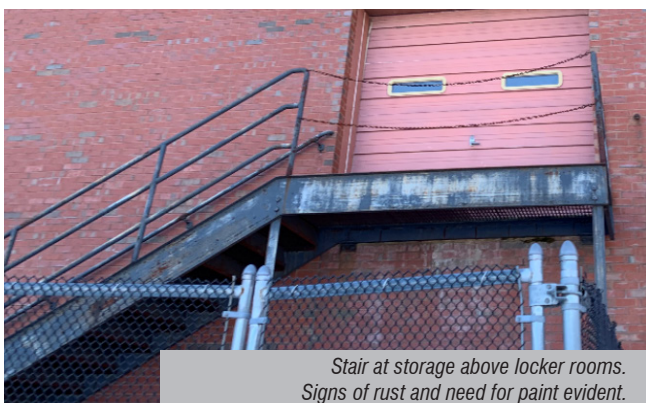
There was a metal stair located near the Gym that provides access to the storage space above the locker rooms. The stairs' steel shows obvious signs of aging. Flaking and peeling paint was observed as well as some rusting at the stringers for the

*Stair at storage above locker rooms.
Signs of rust and need for paint evident.*

steps. The stairs were inaccessible at the time of our visit, and it is recommended that further investigation of the rust be done to see if structural integrity is still in place. If no structural repairs are needed, the stairs, stringers and railings should be cleaned, prepped, and painted to preserve the metal.

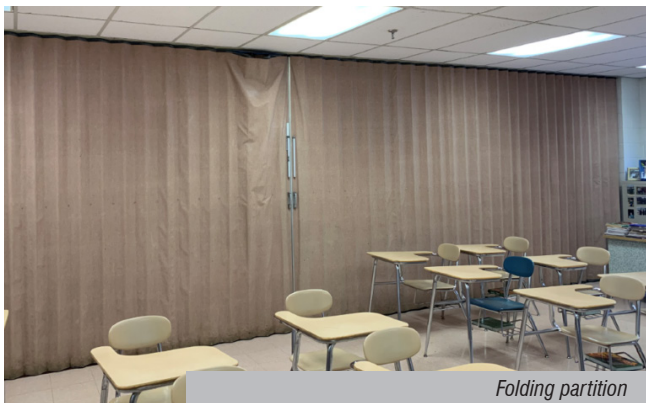
Folding partition

Multiple classrooms were noted to have fabric folding partitions. The folding partitions are in poor condition and should either be replaced or removed and filled in if they are not utilized. These folding partitions generally do not do a good job of separating sound from one classroom to the next, however, the flexibility of the space is often more important and should be reviewed as needed.

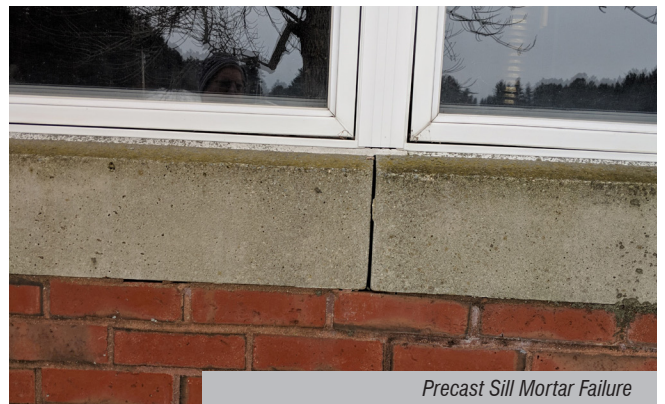
Precast Sill Mortar Failure

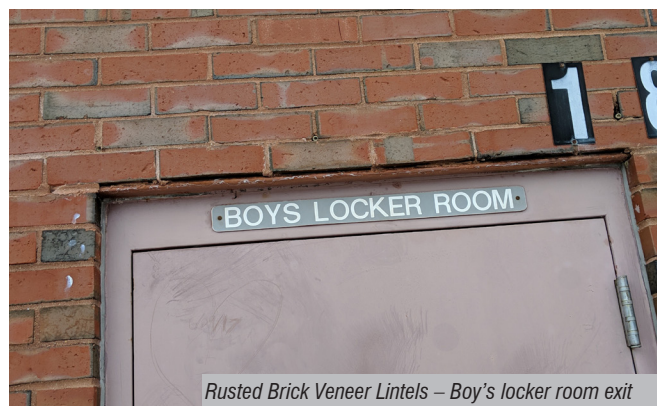
1. Areas were observed where there was damage and spalling to the mortar between the bricks and precast concrete sills.
2. Rusted Lintels were noted in certain locations around the building and are recommended to be repaired or addressed to avoid further deterioration and potential brick cracking above.

Rusted Brick Veneer Lintels – Boy's locker room exit

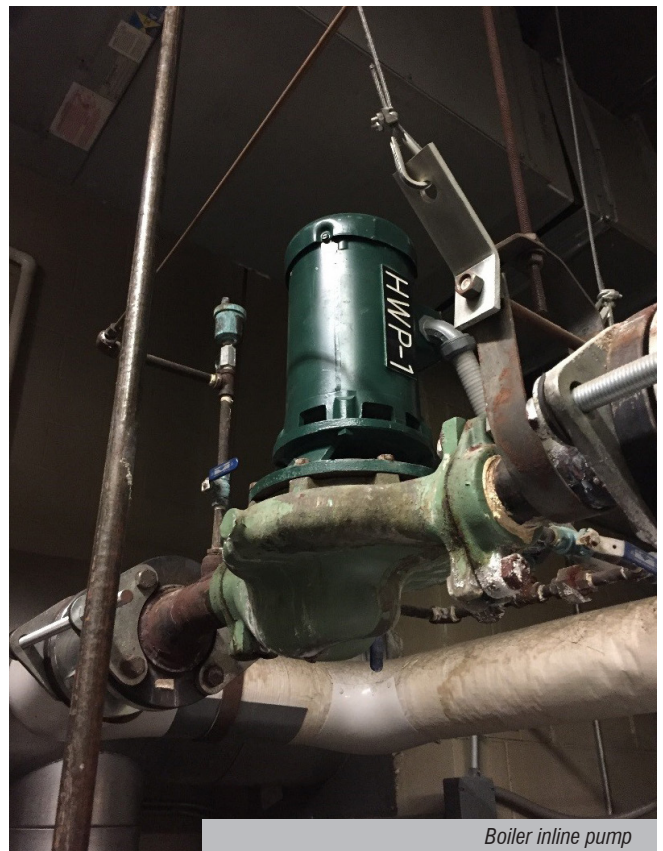
Boiler inline pump

Two base mounted pumps (HWP-3 & 4) circulate water in a lead/standby arrangement throughout the building. The pumps are stacked vertically on a custom made rack. Each boiler is served with a separate inline pump (HWP-1 & 2) which are decoupled from the base mounted pumps with closed spaced tees. The exact selection requirements for any of the pumps are unknown as nameplate data was illegible or did not provide ample information. The pumps are not original so information from existing construction documents could not be used. What nameplate data that could be used indicate that the base mount-

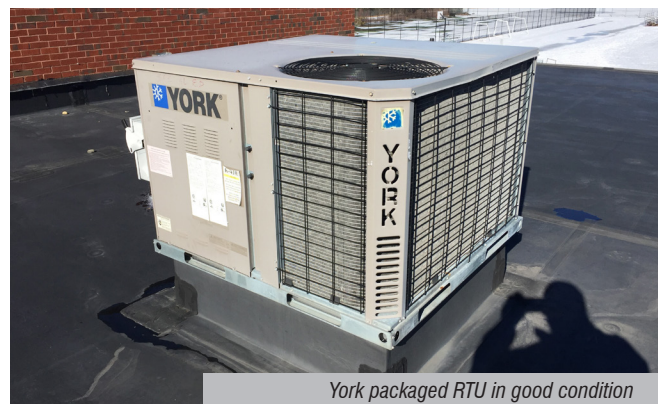
York packaged RTU in good condition

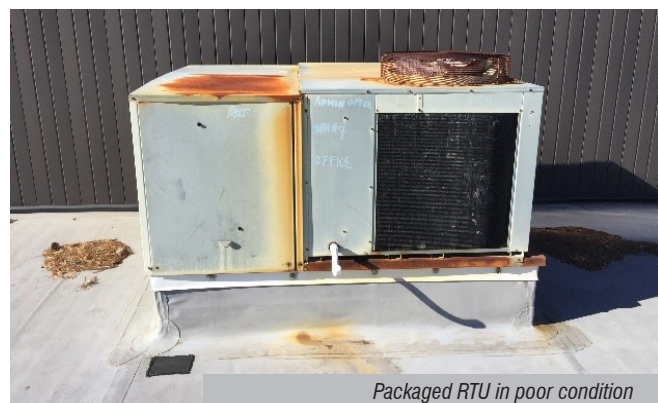
Packaged RTU in poor condition

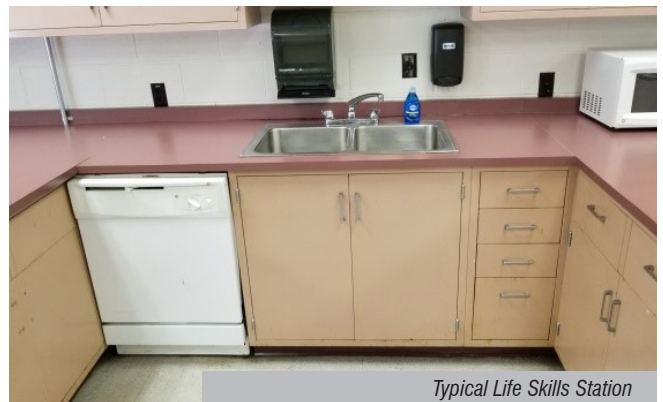
Typical Life Skills Station

The Life Skills room has stainless steel drop-in sinks with swing spout faucets. The fixtures are in good condition. There are no ADA compliant stations in the room.

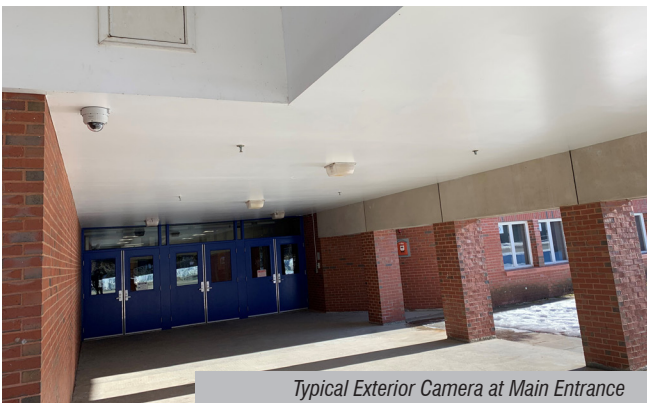
Typical Exterior Camera at Main Entrance

Based on a recent Physical Security Enhancement Master Plan report, technology has far advanced since their installation on the surveillance system. At minimum, recommend replacing existing and adding new exterior and interior cameras.

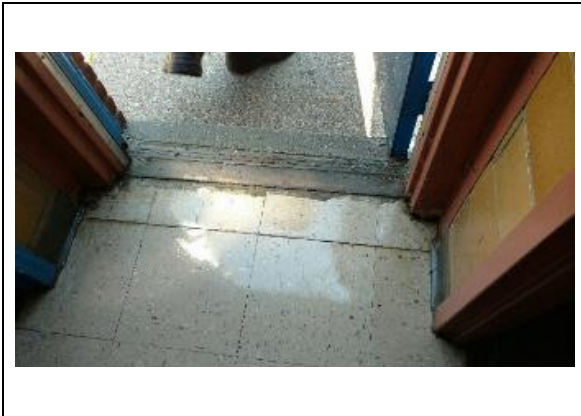
1. Ledge Street School, example of cracked floor tile along the entrance.

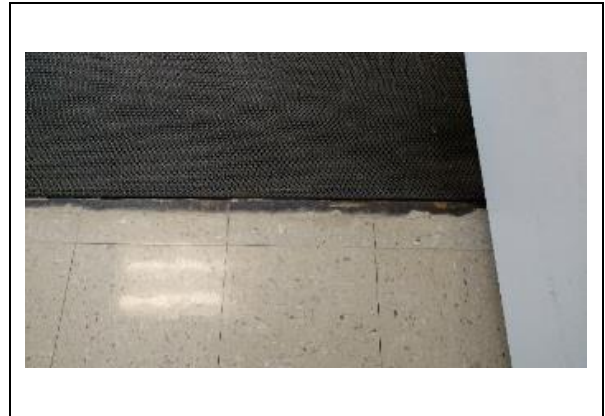
2. Ledge Street School, example of cracked floor tile along the entrance.

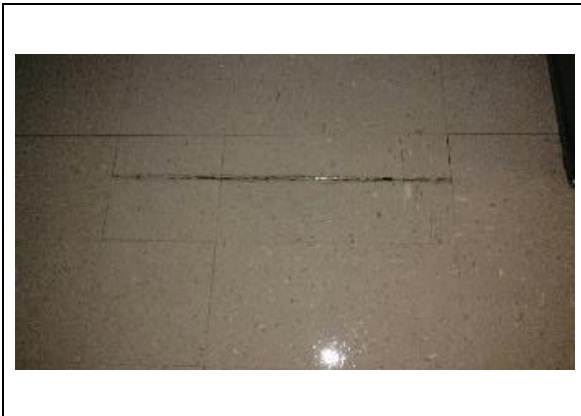
3. Charlotte Avenue, example floor tile damage.

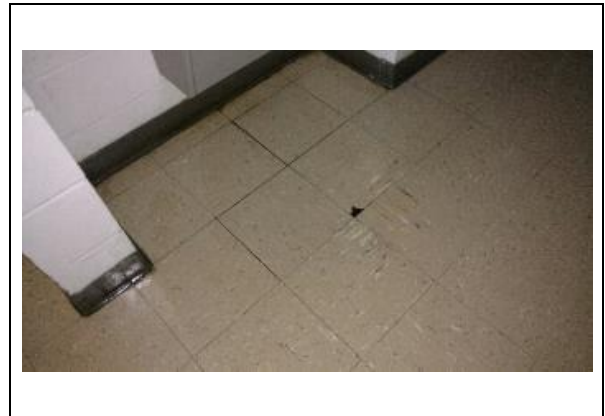
4. Charlotte Avenue, example of flooring damaged.

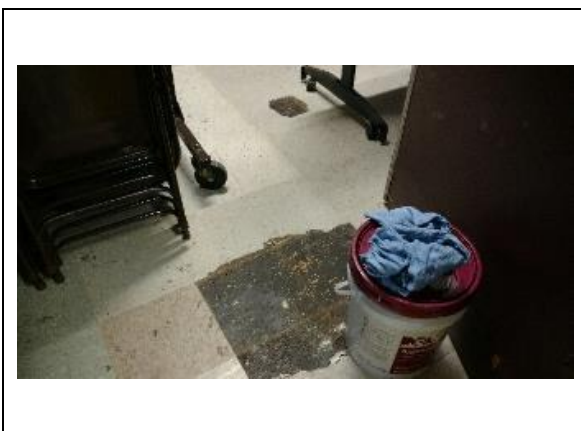
5. Mt. Pleasant, damaged flooring with ACBM mastic exposed in chair room.

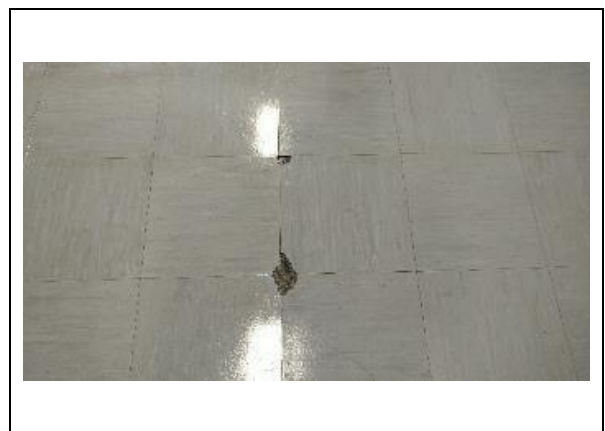
6. Mt. Pleasant, damaged and chipped flooring with mastic exposed.

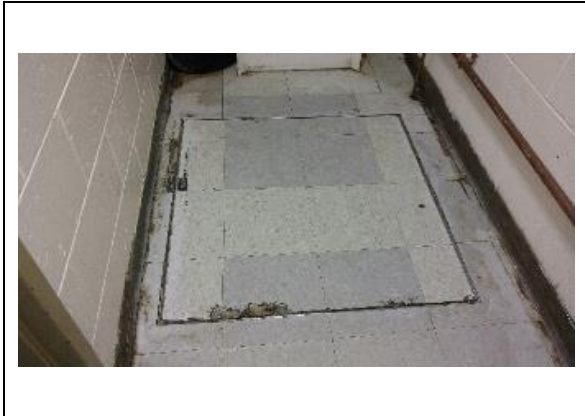
7. Broad Street School, example chipped flooring along a floor hatch with ACBM mastic.

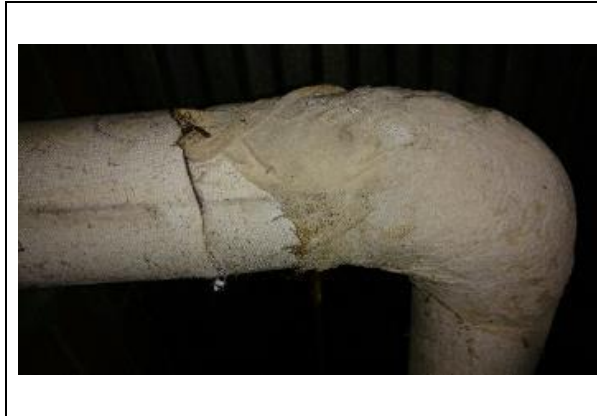
8. Elm Street, damaged pipe fitting outside Room 30 above ceiling.

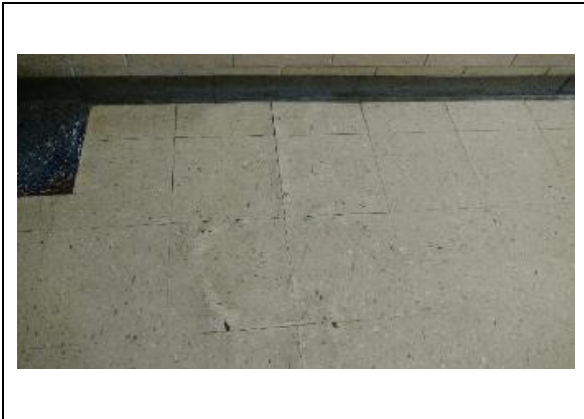
13. Flooring chipped with ACBM Mastic at Main Dunstable.

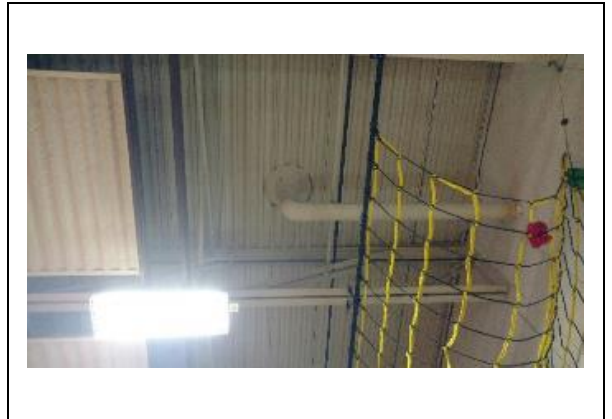
14. Assumed ACB roof drain at Main Dunstable.

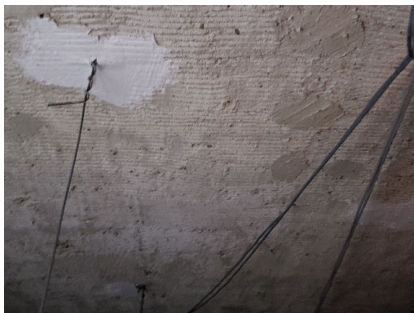
Asbestos Ceiling Plaster

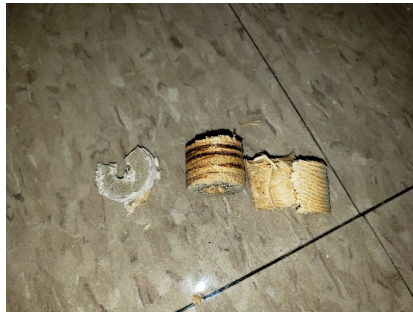
Polarized-light microscopy is not consistently reliable in detecting asbestos in floor tiles. Confirmation by Transmission Electron Microscopy is recommended for negative floor tile samples.

Floor Core non-Asbestos

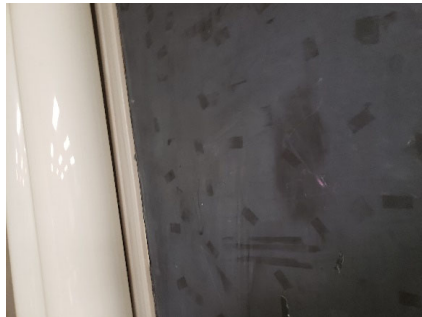
Assumed Asbestos Blackboard

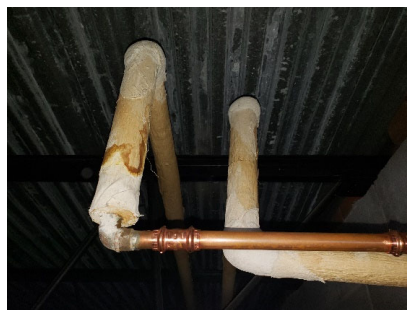
Asbestos Pipe Fittings

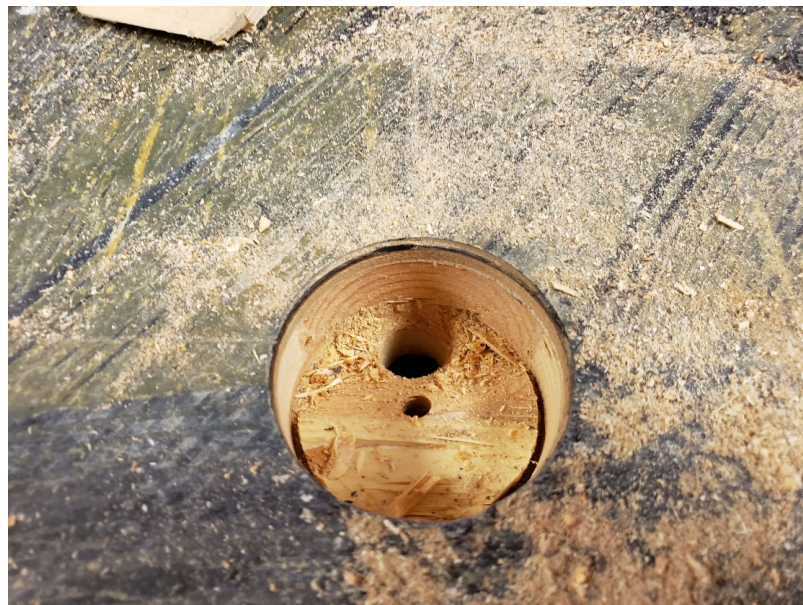
Figure 2 Wood Bore Hole

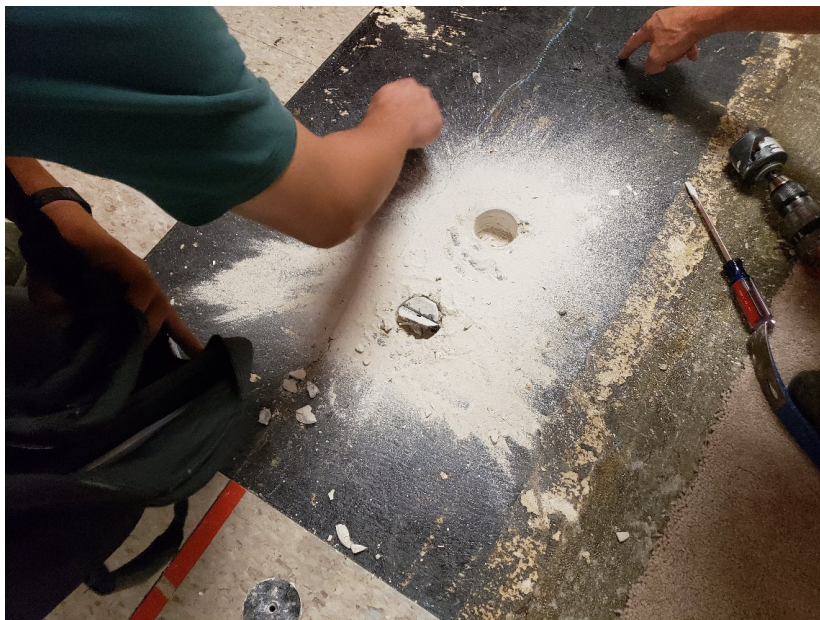
Figure 4 Gypsum Panel Bore hole

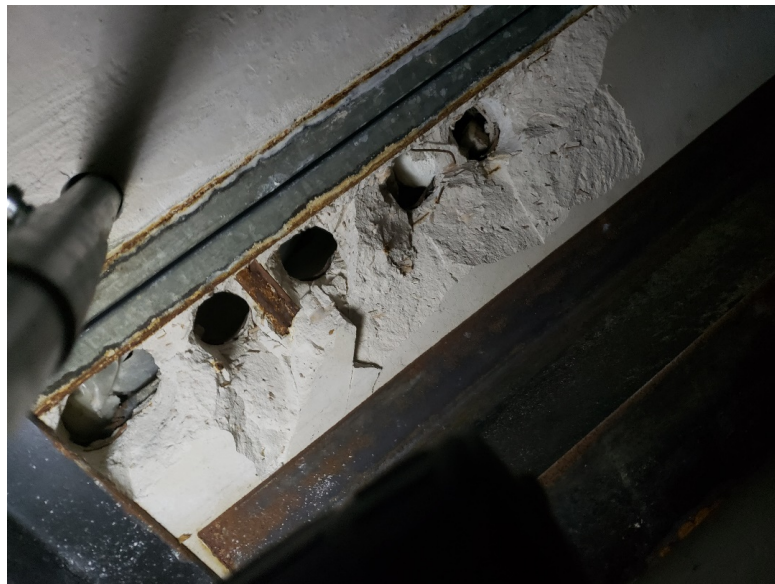
Figure 14 Room 7 Ceiling w/ Drill Holes

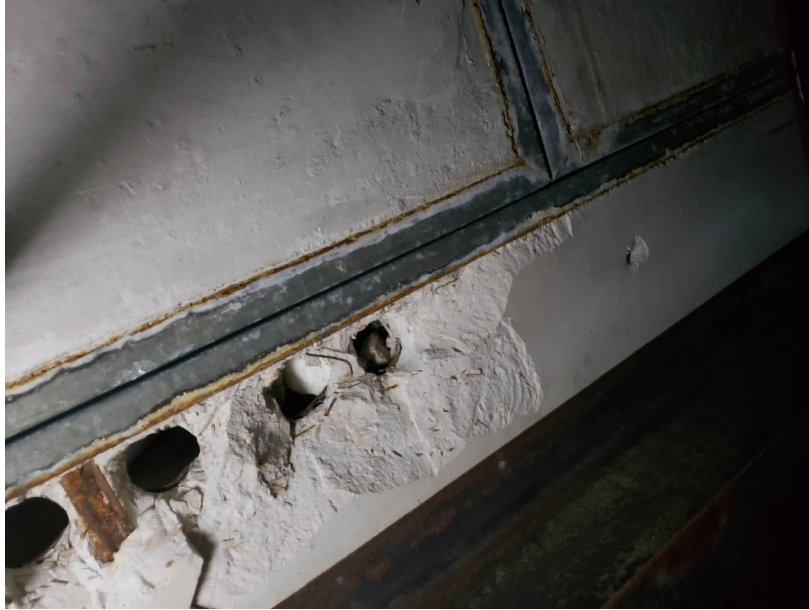
Figure 15 Room 7 Ceiling w/ Drill Holes

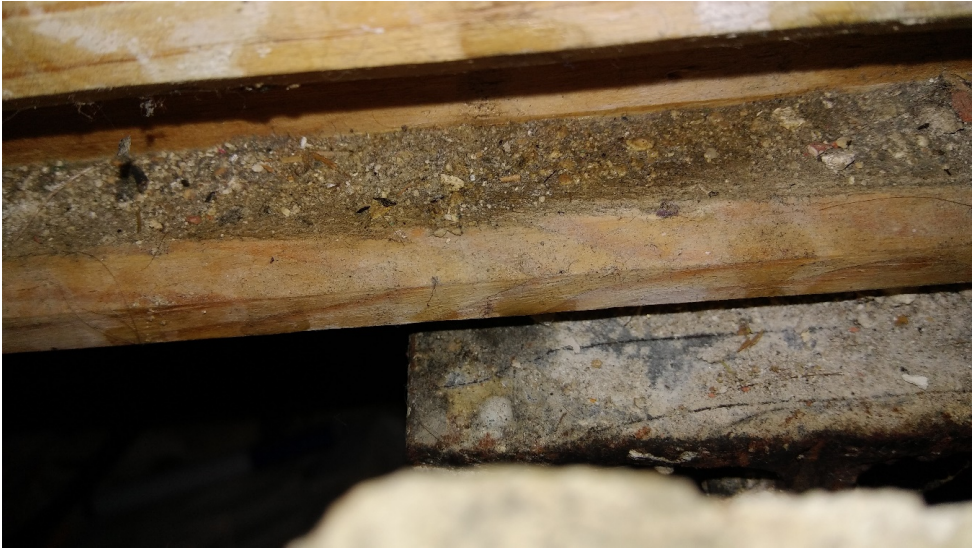
Figure 26 Tongue and Groove over I-Beam Room 305

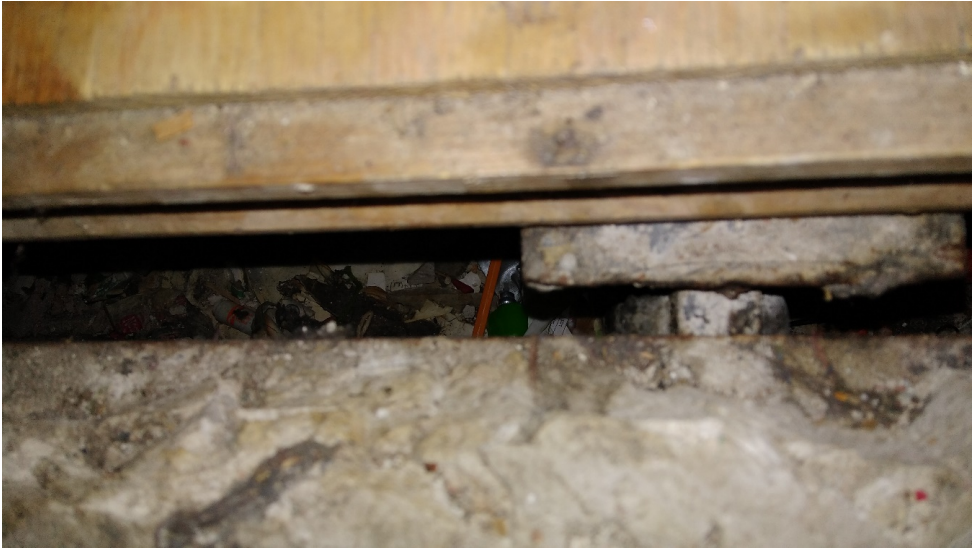
Figure 27 Tongue and Groove over I-Beam Room 305

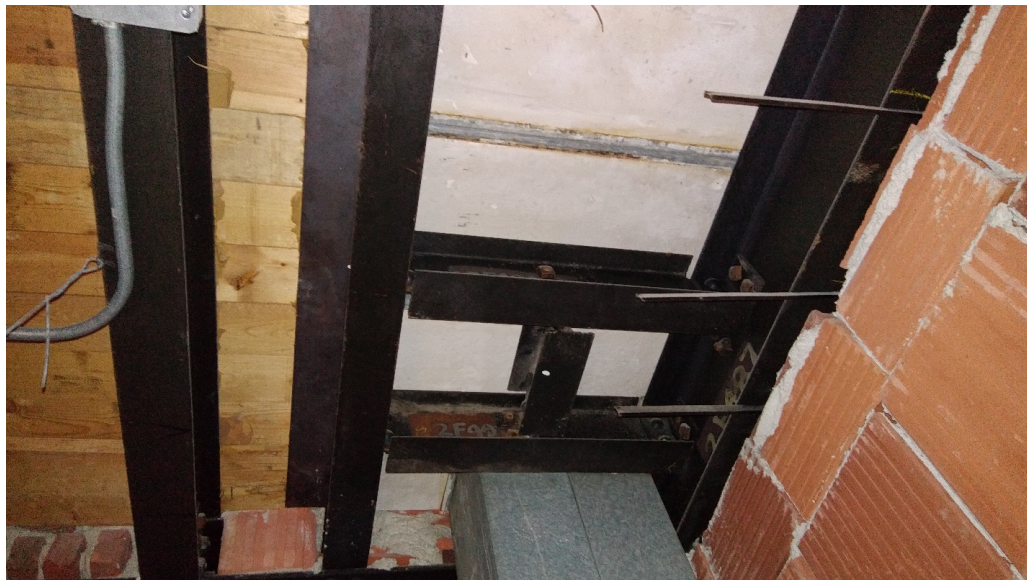
Figure 29 Example of Wood Plank Flooring and Gypsum Panel near Vent Shaft (2nd floor looking up)
