SECTION 2

FACILITY ANALYSIS

FACILITY ANALYSIS OVERVIEW

ELM STREET MIDDLE SCHOOL

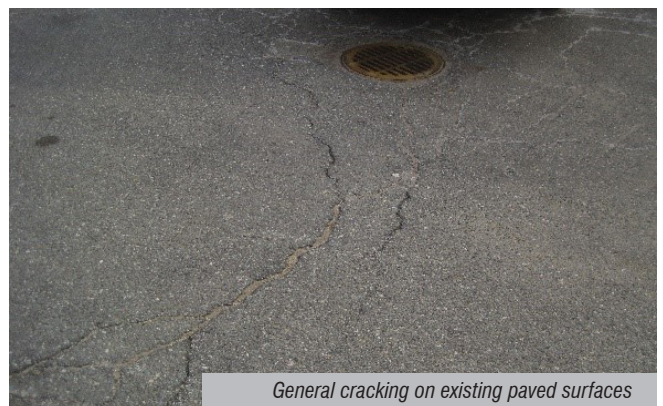
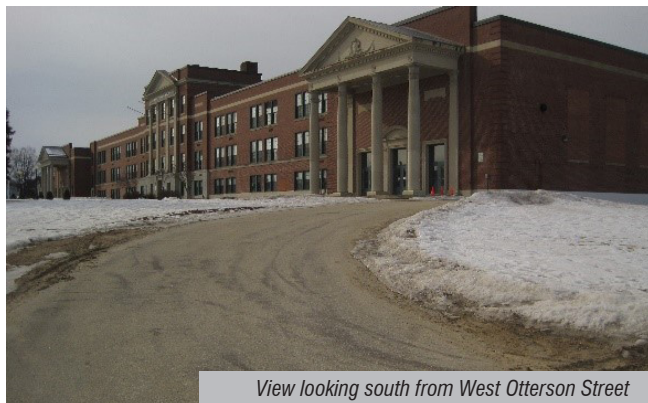
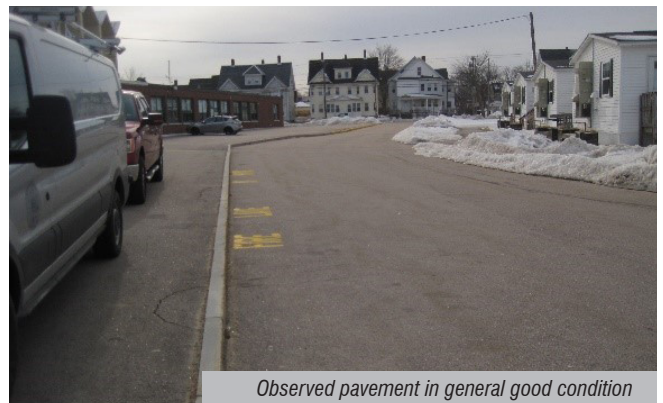
The pavement throughout the site generally appears to be in good condition. Observations of the pavement did not include many potholes, large cracks, or areas of substantial differential settlement. Instead, the pavement conditions appear to be consistent with expected exposure to the elements, in addition to general wear and tear.

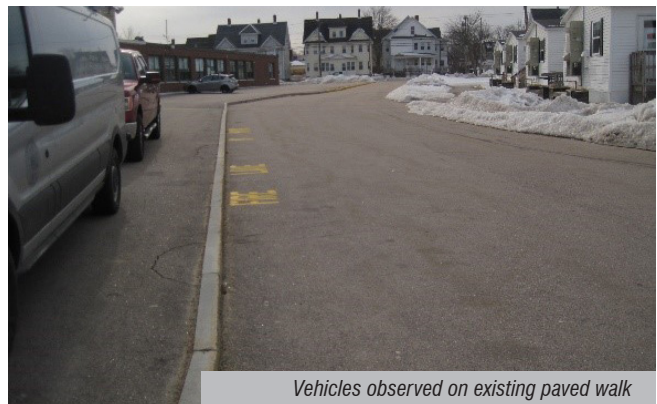
Vehicles observed on existing paved walk

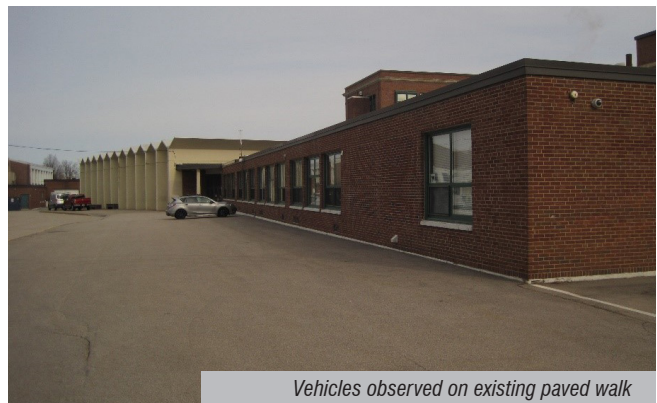
Vehicles observed on existing paved walk

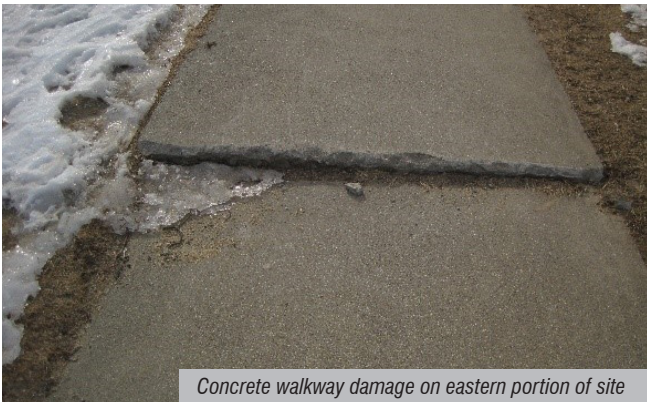
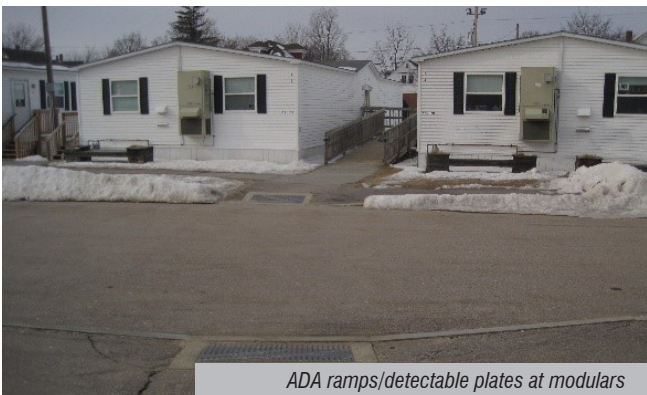
Due to the relatively flat topography throughout the site, ADA accessibility appears to be sufficient throughout the property. Most doorways observed have accessible routes to entrances, and all modular buildings observed have ramps for access. Handicap parking spaces were also observed in the parking areas to the north and south of the school. Some existing walkways, specifically within the eastern portion of the site, may require repairs, as some of the concrete joints have separated, cracked, and settled, causing a noticeable change in elevation over some portions of the walkway (see photo below).

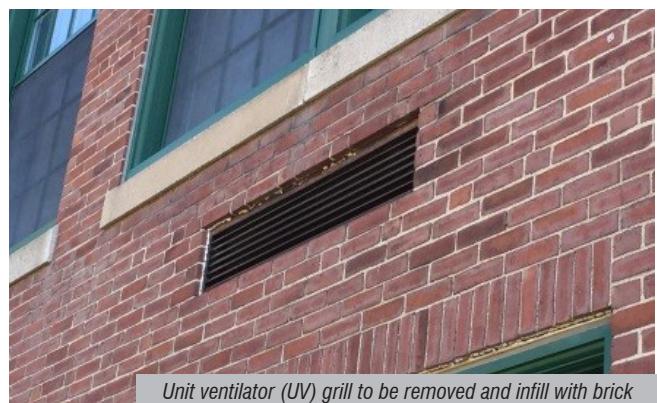
Unit ventilator (UV) grill to be removed and infill with brick

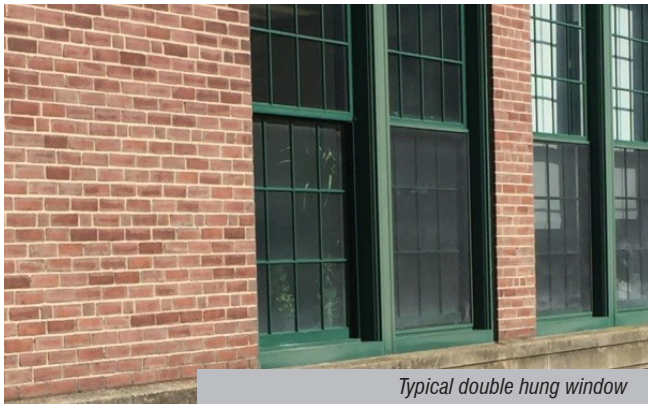
Observation of the large double hung windows: the sash is very heavy, and we understand the counterbalancing mechanism is constantly being replaced. The window system should be replaced. The operable sash size should be reduced to lessen weight of lifting sash, or different operation types should be explored.

Typical double hung window

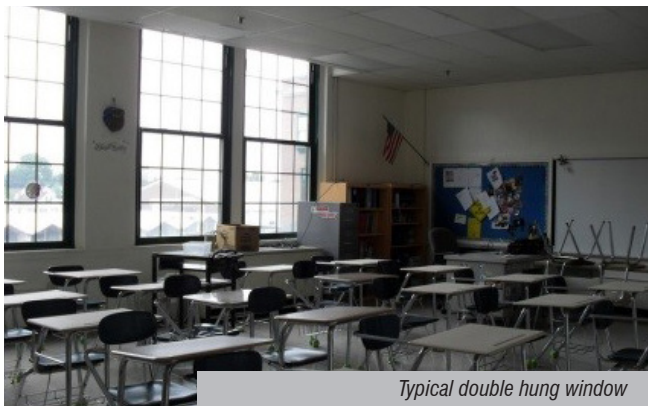
Typical double hung window

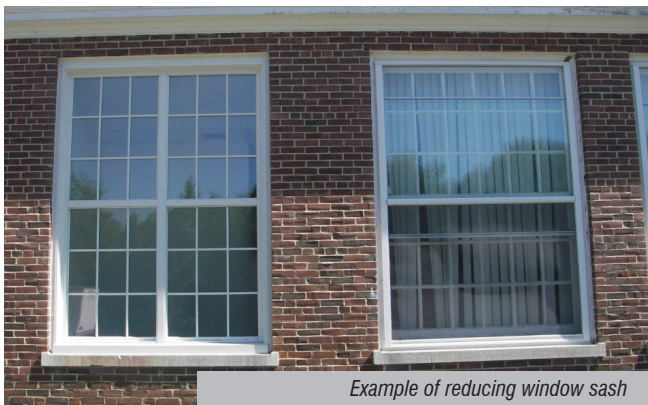
Example of reducing window sash

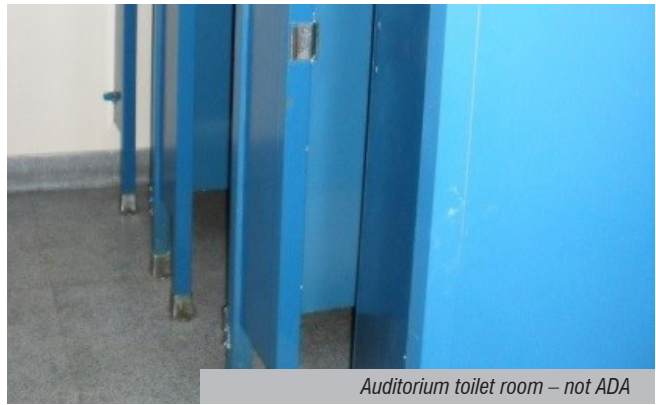
Auditorium toilet room – not ADA

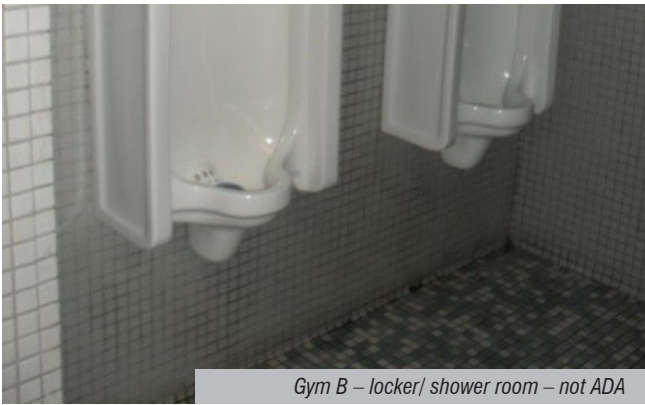
Gym B – locker/ shower room – not ADA

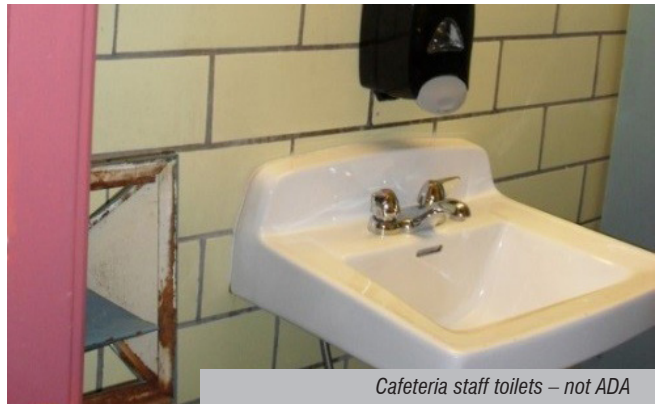
Cafeteria staff toilets – not ADA

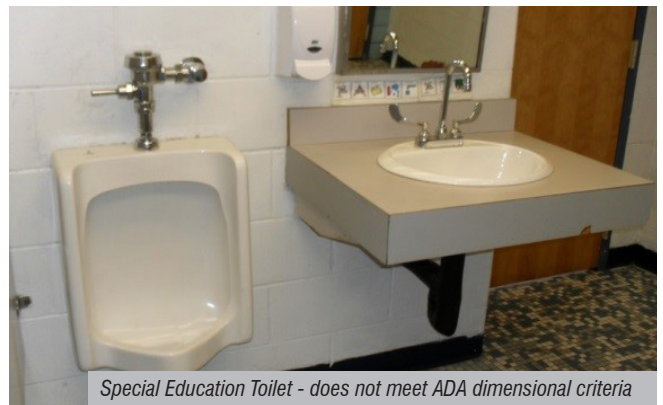
Special Education Toilet - does not meet ADA dimensional criteria

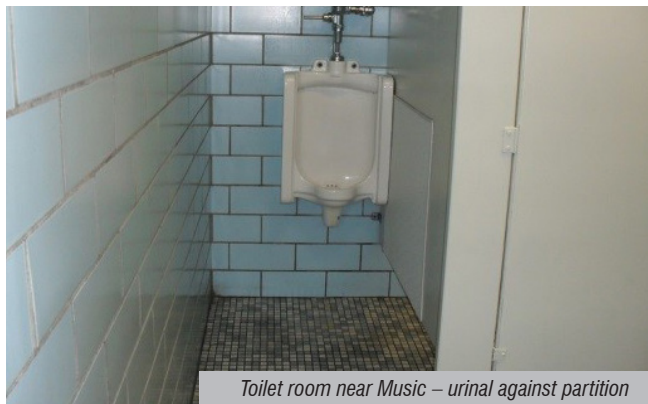
Toilet room near Music – urinal against partition

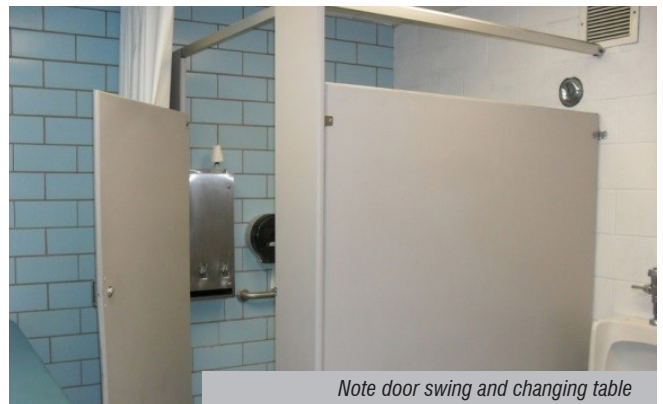
Note door swing and changing table

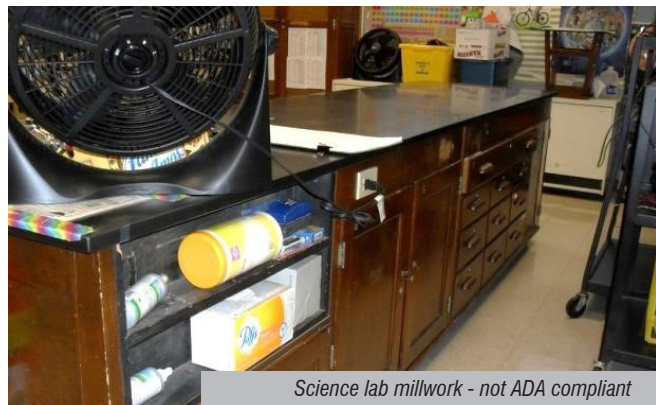
Science lab millwork - not ADA compliant

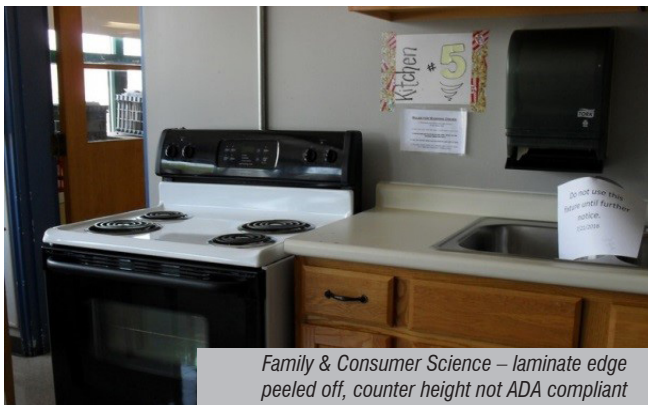
Family & Consumer Science – laminate edge peeled off, counter height not ADA compliant

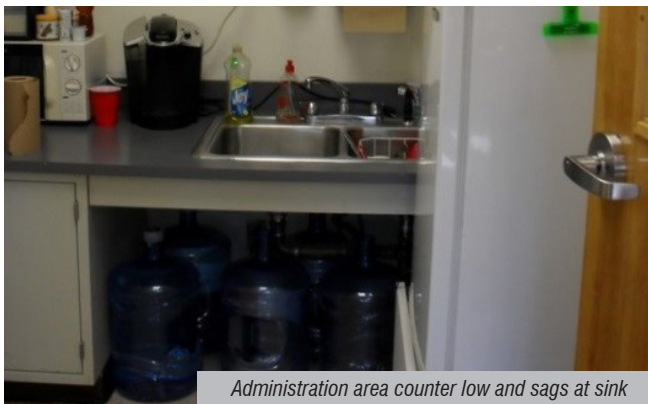
Administration area counter low and sags at sink

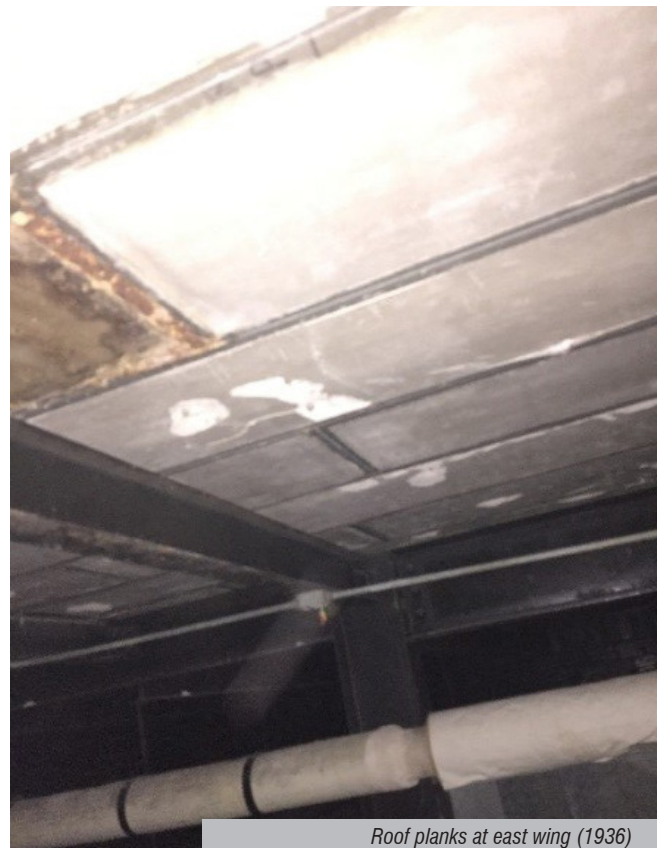
The gypsum-concrete roof system in the 1936 building exhibits signs of minor damage and possible small pieces of the gypsum plank were found to be missing at random areas on the planks. This condition was noted at all areas of the building that were visually inspected during the site visit.

Roof planks at east wing (1936)

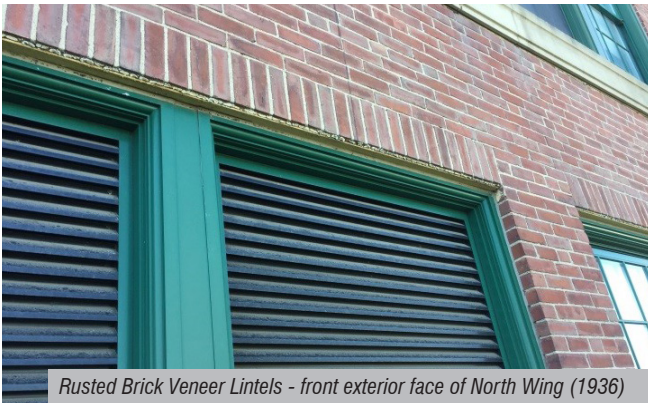
Rusted Brick Veneer Lintels - front exterior face of North Wing (1936)

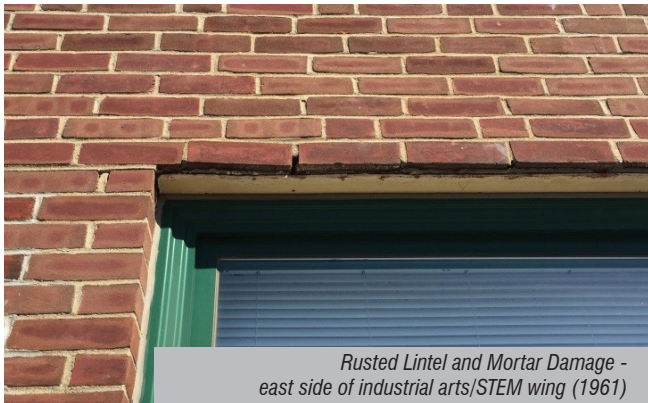
Rusted Lintel and Mortar Damage - east side of industrial arts/STEM wing (1961)

1. Rusted Lintels were noted in certain locations around the building and are recommended to be repaired or addressed to avoid further deterioration and potential brick cracking above.
2. The exterior construction joints at the roof level of the cafeteria exhibits significant signs of damage and deterioration. Rebar is exposed at certain joints of the affected area.

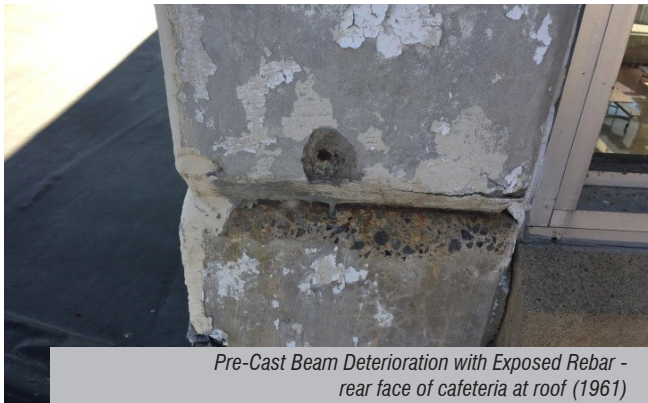
Pre-Cast Beam Deterioration with Exposed Rebar - rear face of cafeteria at roof (1961)

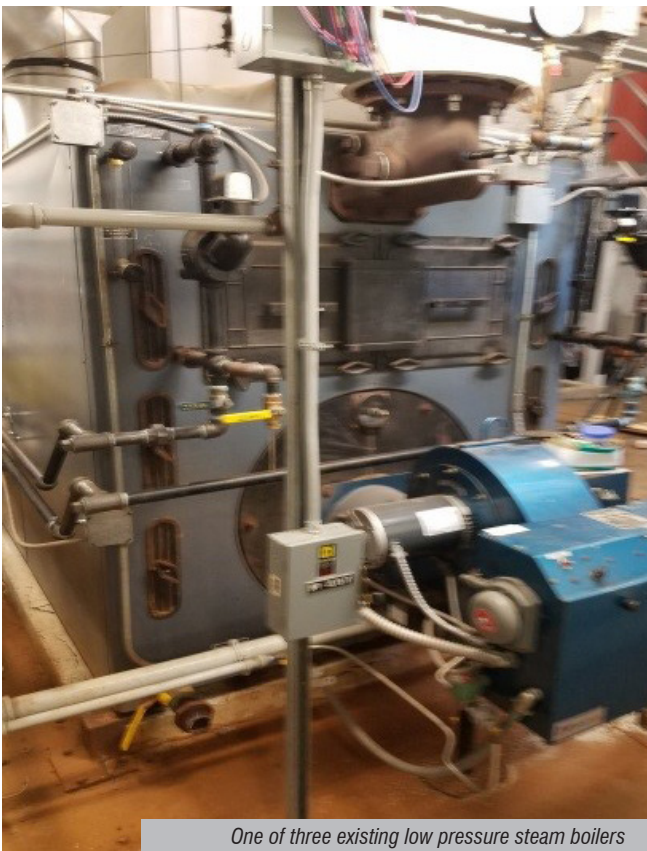
These boilers were installed since 1991. At 25 +/- years of age, they still have serviceable life. ASHRAE estimates the lifespan of a low pressure, cast iron, steam boiler at 35 years. The steam system has a history of modifications and repairs to keep it operating.

One of three existing low pressure steam boilers

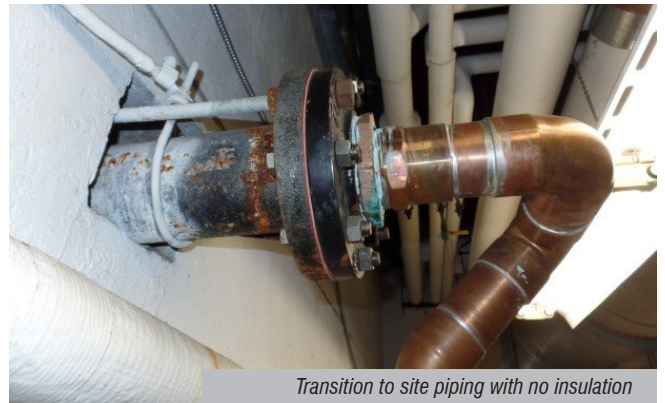
- / One entrance is in the basement under the gymnasium facing Chestnut Street with a 3" water feed from Chestnut Street. Some of the piping is uninsulated and condenses during times of elevated humidity. There is an open-ended valve for a bypass. The valve should be connected to the pipe downstream of the water to provide a workable bypass.

Transition to site piping with no insulation

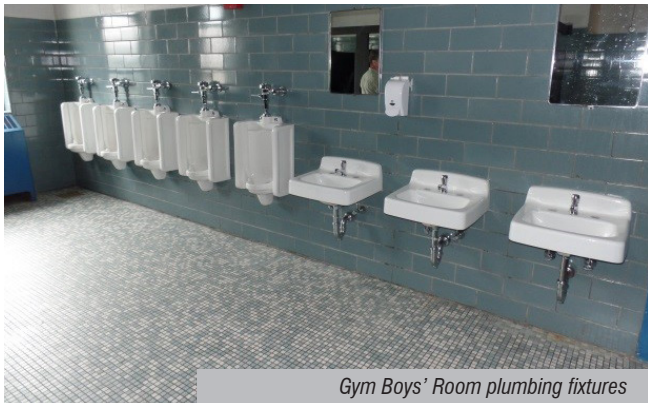
Gym Boys' Room plumbing fixtures

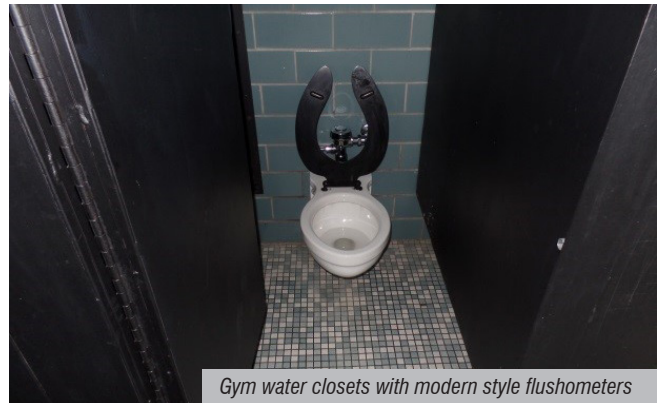
Gym water closets with modern style flushometers

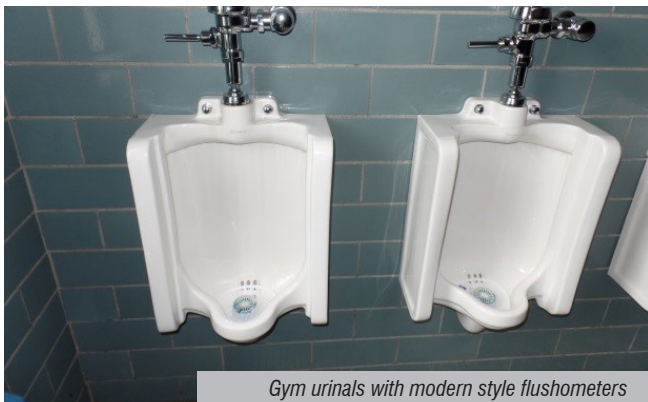
Gym urinals with modern style flushometers

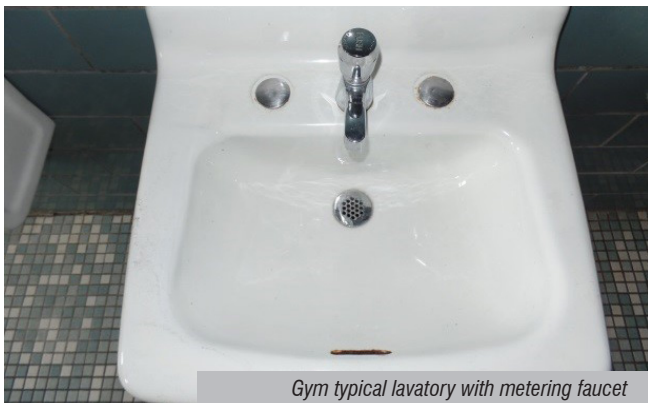
Gym typical lavatory with metering faucet

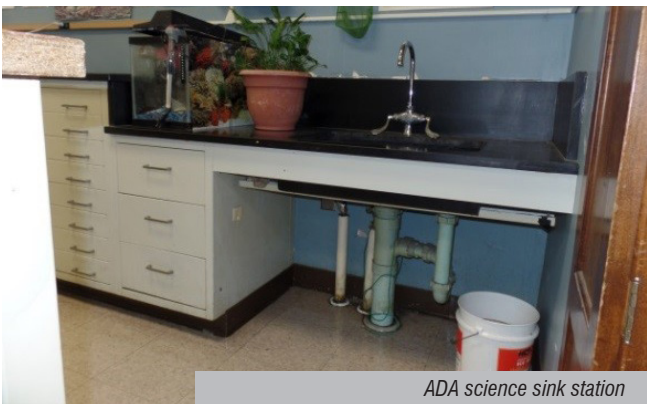
The science rooms have epoxy sinks integrated to the epoxy counter tops. The drainage is piped with acid-resistant polypropylene piping. The sinks have a swing goose-neck spout faucet. Most faucets have cross handles and a serrated hose tip. An attempt to create an ADA compliant station has a lower counter, wrist blade handle faucet and open knee space. The knee space clearance under the sink does not meet the ADA requirements.

ADA science sink station

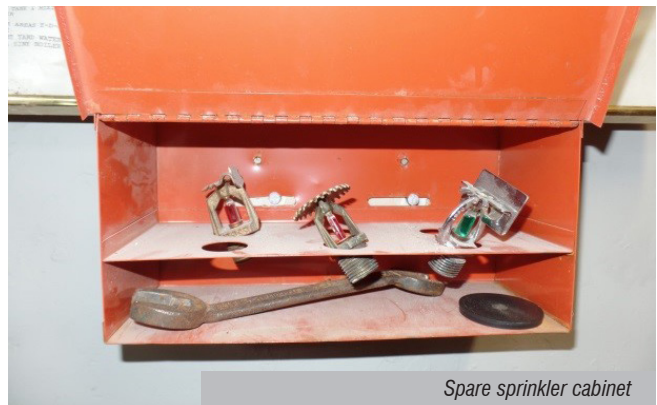
Spare sprinkler cabinet

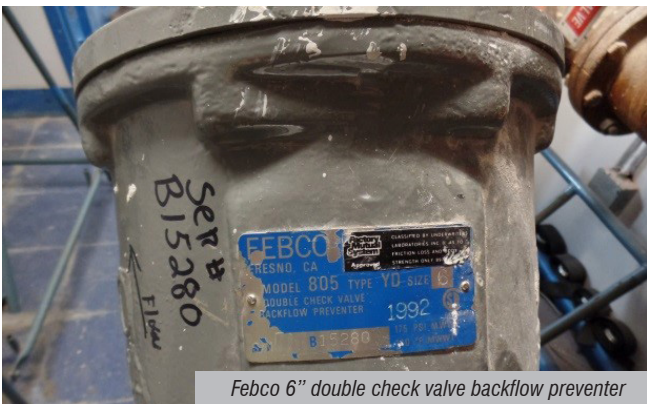
Febco 6" double check valve backflow preventer

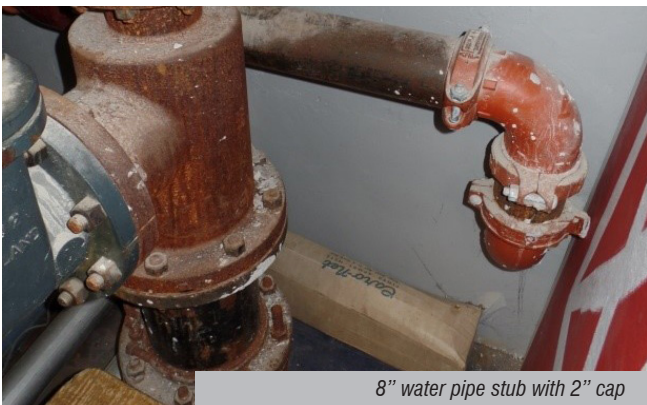
8" water pipe stub with 2" cap

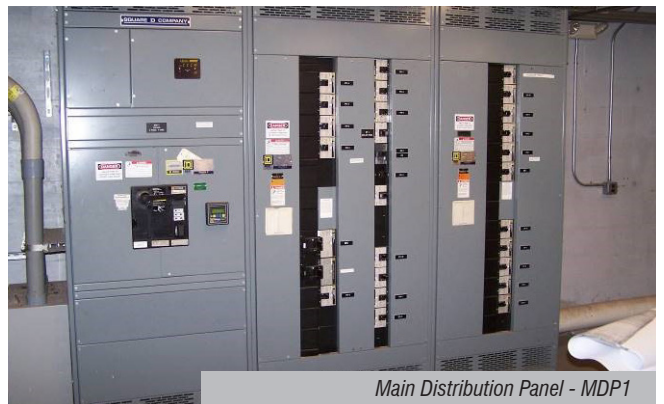
Records indicate the MDPs were installed in 2013 and they appear to be in good serviceable condition. The main distribution panels contain a variety of breakers which feed downstream panels and mechanical equipment, as well as spares and spaces for future loads.

Main Distribution Panel - MDP1

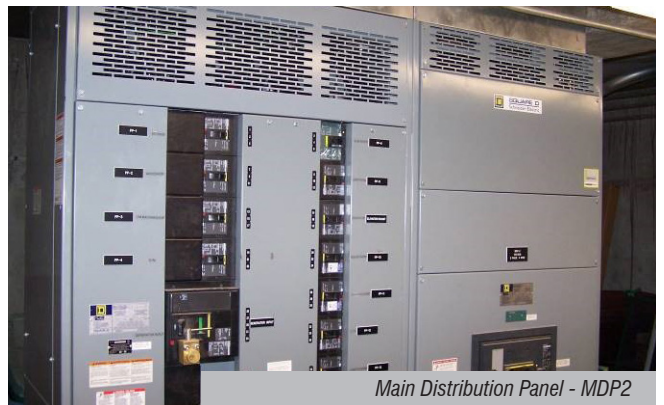
Main Distribution Panel - MDP2

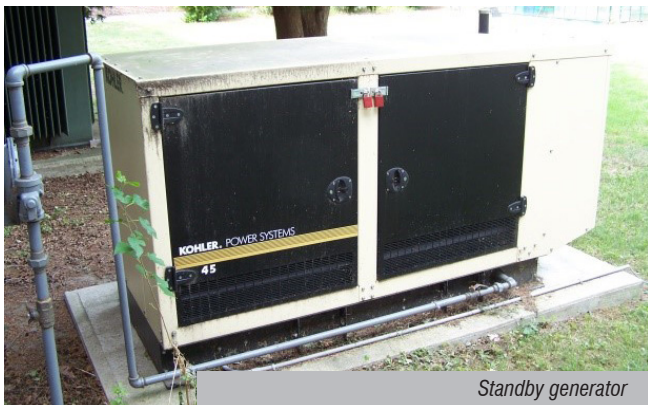
- / The generator provides emergency egress lighting in most of the building. Areas not covered by the generator, egress lighting is provided with emergency battery units.
- / The generator currently monitors “normal” power from MDP1 only (does not monitor “normal” power at MDP2). The generator needs to monitor each service so loss of power from either service will start the generator and provide emergency egress lighting.

Standby generator

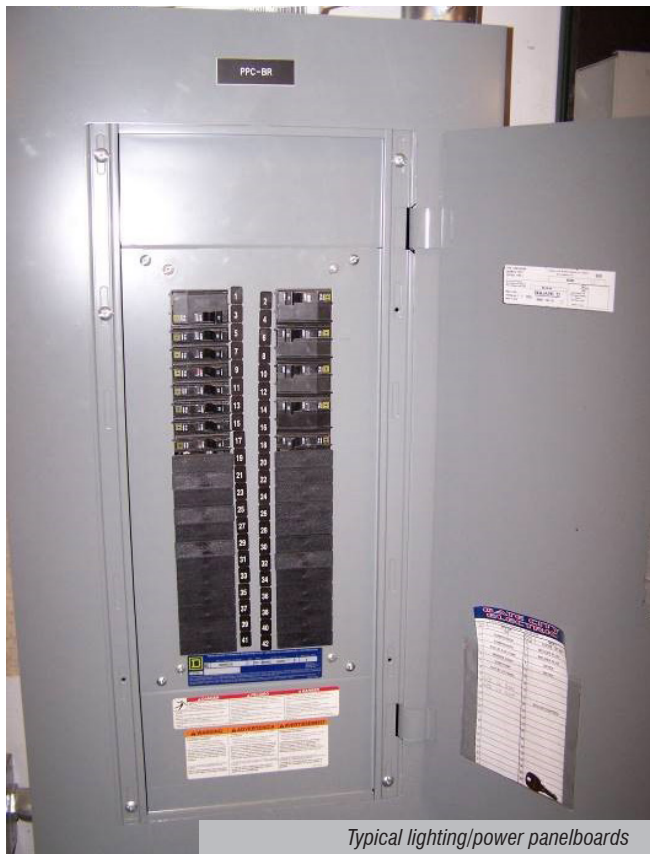
Lighting and power panelboards are located throughout the facility. Most panels are not filled to capacity, leaving space for future expansion. Panelboards were observed to be a combination of Square-D NQ and GE A series and, for the most part, in good serviceable condition. Some older model panels exist and are nearing the end of their service life. Several panels are located in the corridors and are accessible to the students.

Typical lighting/power panelboards

- / Panelboards should be provided with locks, preventing unauthorized access. Ideally the panelboards would be located in dedicated electrical rooms that would allow access by authorized persons and code-required working clearance.
- / Panelboard feeders require further investigation to determine the condition of each. It is believed that some feeders may be original to the original construction of each phase of construction the building has experienced.

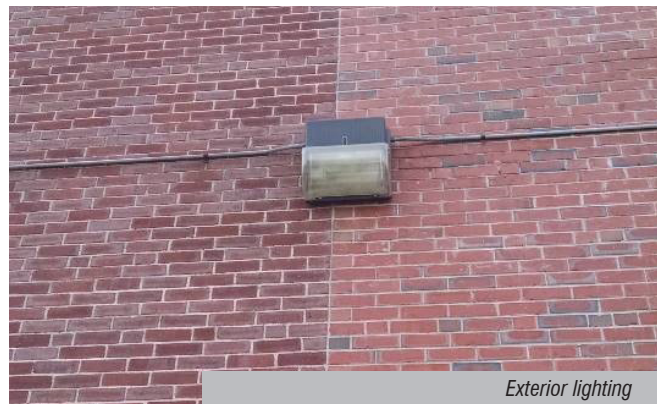
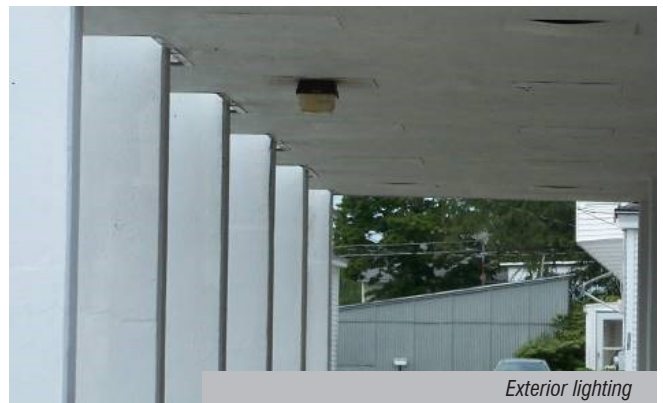
Exterior lighting

- / Lighting fixtures could be replaced with energy-efficient LED fixtures. There are often energy incentives available through the utility company to assist with the cost of energy-efficient upgrades.

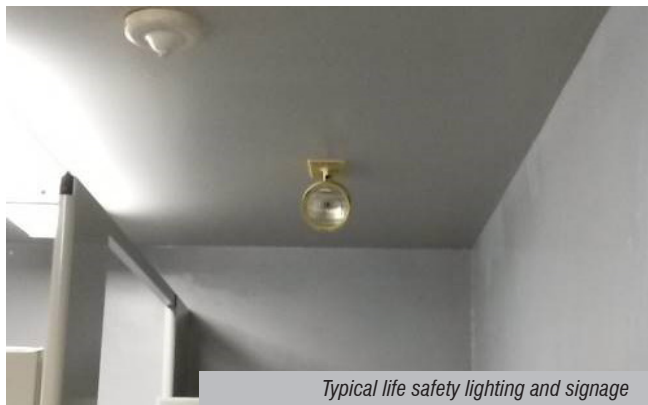
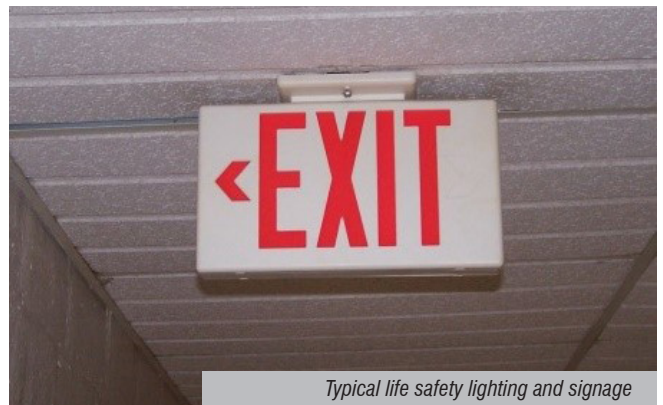
Lighting and signage observed appeared to be in good condition and appropriately spaced.

Typical life safety lighting and signage

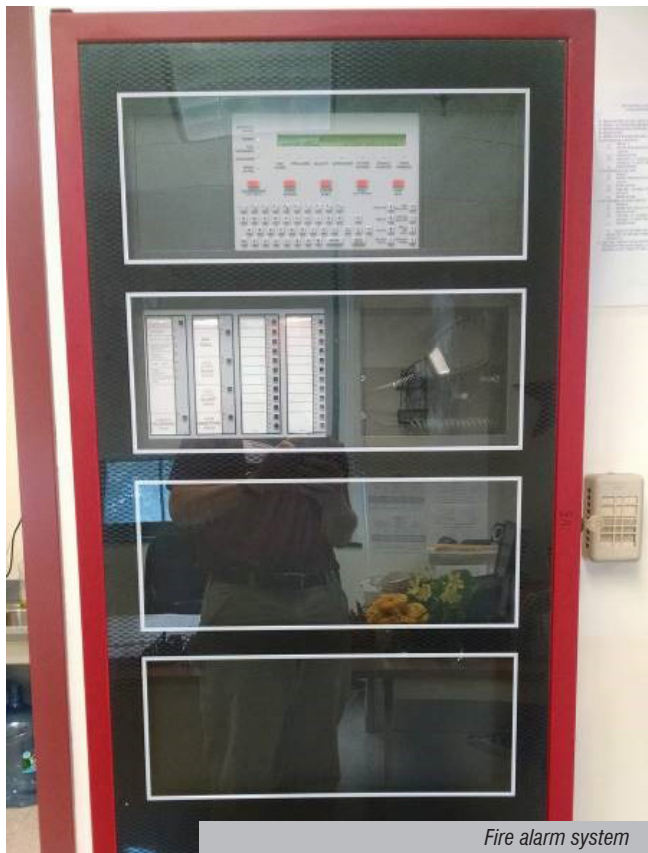
The fire alarm system is a Notifier NFS-640 with voice evacuation (voice evacuation is not provided throughout the building, only in areas of assembly), installed and maintained by BK Systems. Personnel report that there has been some trouble with the system. There are ongoing repairs and some possible installation flaws with respect to the speaker system. Smoke detectors, notification appliances, and pull stations are located throughout the building. Generally, coverage appeared adequate, though a thorough analysis would be required to verify. In the event of an alarm, the system reports directly to Nashua monitoring/dispatch facility via the city loop system.

Fire alarm system

- / Any work to the fire alarm system will require voice evacuation throughout the building. Recent changes in NFPA requires voice evacuation throughout educational facilities.

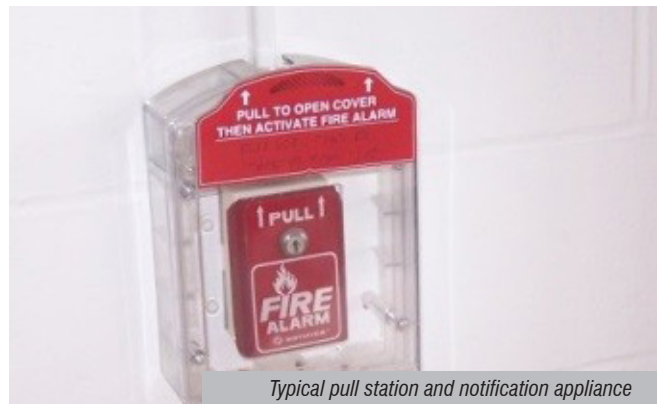
Typical pull station and notification appliance

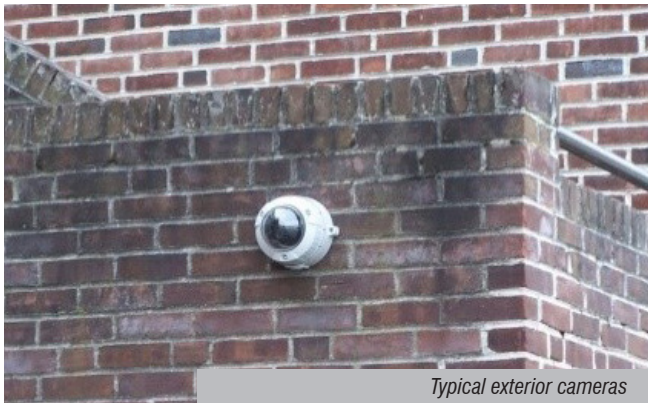
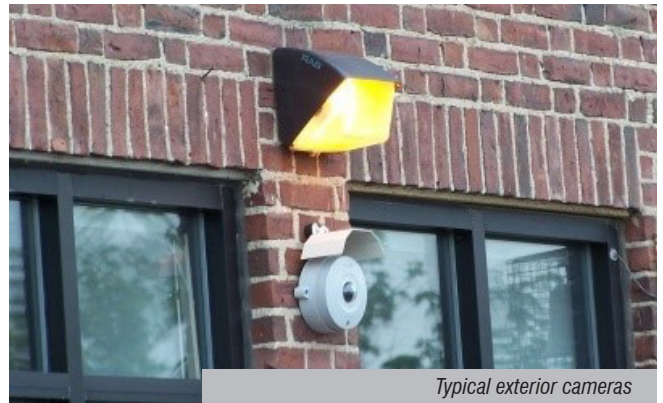
Typical exterior cameras

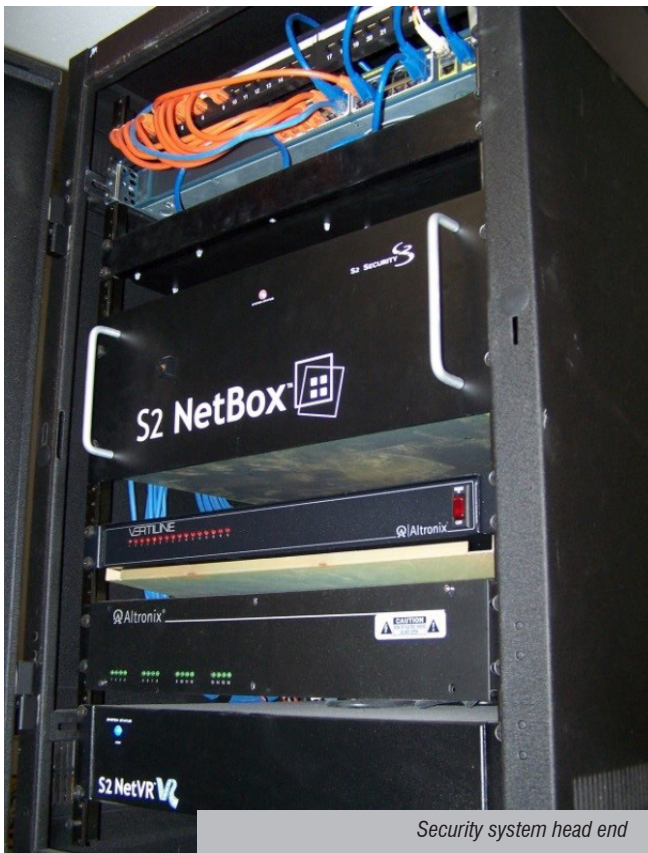
Security system head end

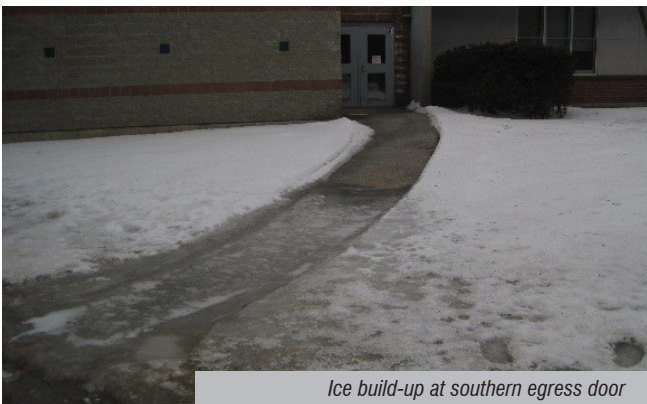
Ice build-up at southern egress door

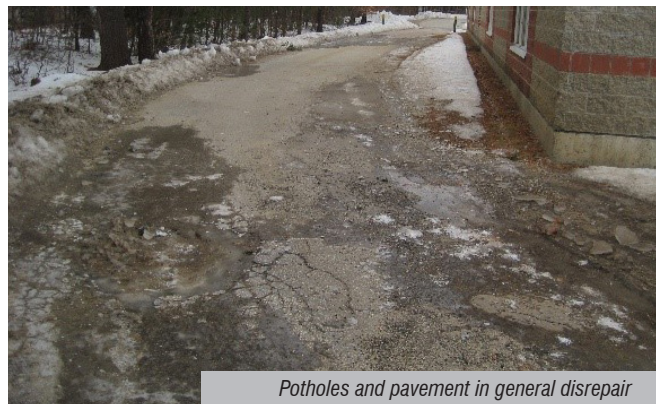
The pavement throughout the site appears to generally be in fair condition, with noted exceptions. Observations of the pavement included some potholes, large cracks, and areas of differential settlement. The pavement bus loop (nearest the main entrance) and fire lane, in particular, appeared to be in poor condition, and included numerous areas where ice had ponded, indicating that the road was not properly draining stormwater, and areas where pavement has eroded (see adjacent photos).

Potholes and pavement in general disrepair

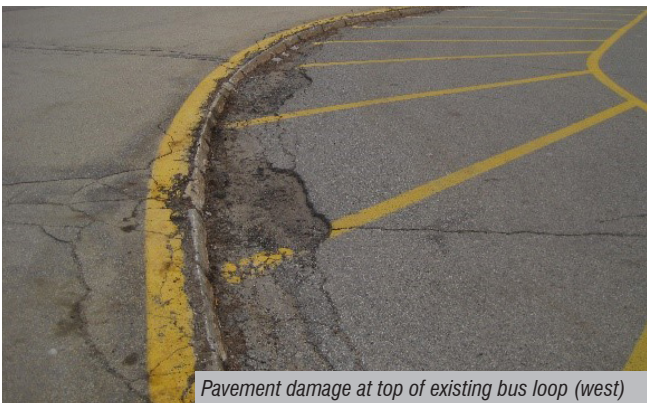
Pavement damage at top of existing bus loop (west)

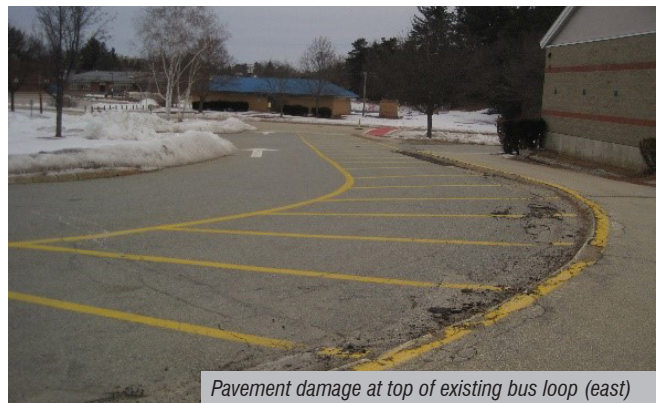
Pavement damage at top of existing bus loop (east)

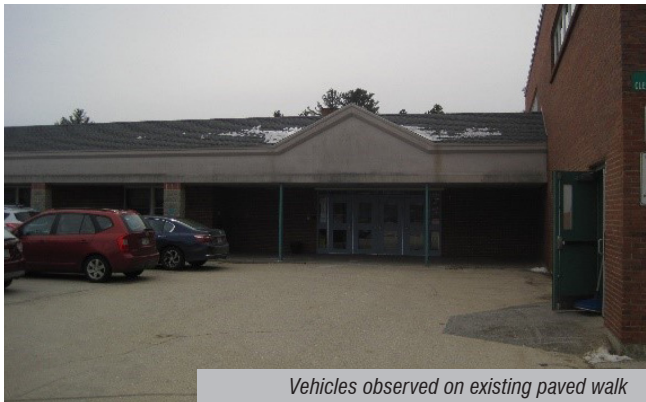
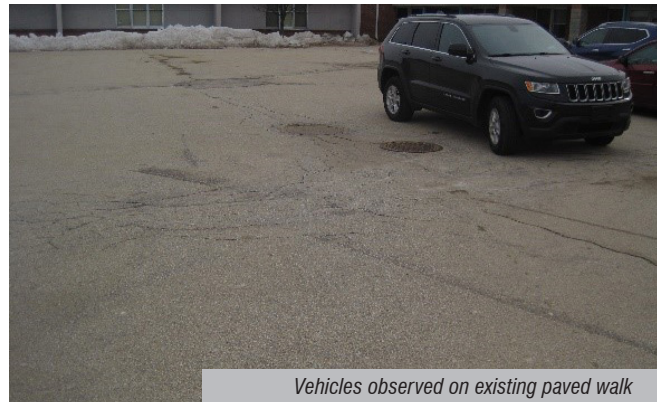
front (north-facing) of the building, adjacent to the bus loop. At the time of the site visit, several vehicles were observed to be parking on the paved walk area leading to what appeared to be the main entrance and various gym egress doors (see photos below). Harriman conducted the visit during school vacation hours, so it is unclear whether this is a regular occurrence.

Vehicles observed on existing paved walk

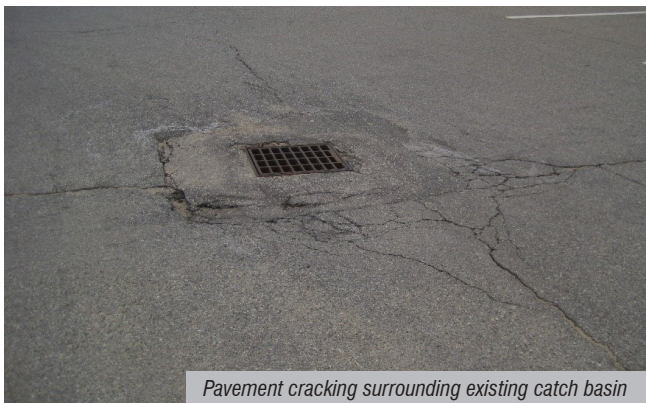
of erosion were observed adjacent to the existing fire lane. In general, the observed catch basins and drainage manholes appeared to be in fair condition. Differential settlement, pavement cracking, and some puddling appeared surrounding some of the structures. It should be noted that some of the puddling (ice/snow) may be a result of the cold weather conditions.

Pavement cracking surrounding existing catch basin

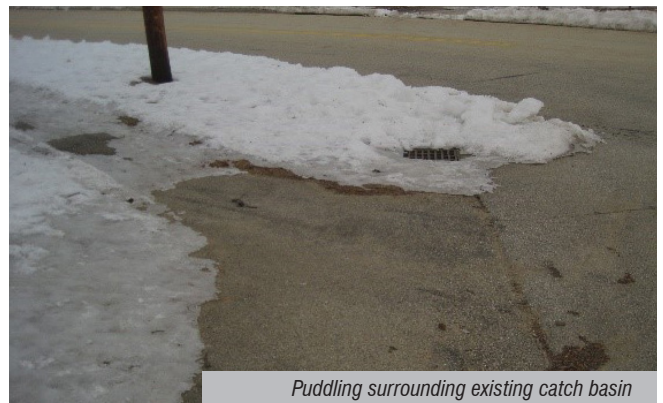
Puddling surrounding existing catch basin

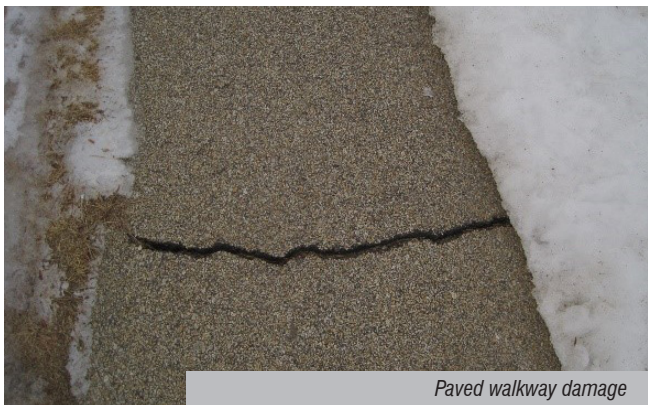
ADA accessibility appears to be sufficient throughout the property with appropriate ramps onto sidewalks from the ADA parking spaces. Most doorways observed have accessible routes to entrances. Some existing walkways may require repairs, as some of the paved walks have large cracks (see photo).

Paved walkway damage

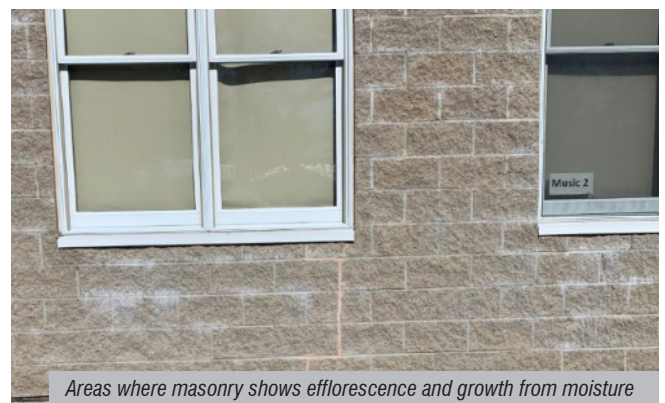
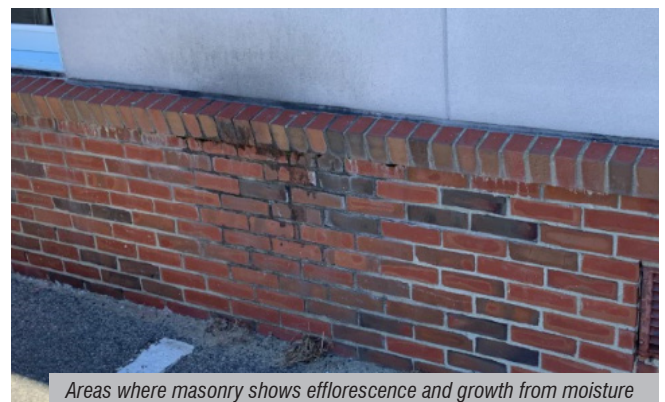
Most brick and mortar joints appear to be in good-to-fair condition overall; however, localized areas of joints in poor shape were noted and should be repaired. Brick weeps were not noted at the base of the brick around the original building, but were found in areas of the new addition CMU veneer. Although not prevalent everywhere around the building, there were some areas of efflorescence noted in a few locations on the masonry veneer. Efflorescence of masonry usually occurs when moisture occurs behind the brick and the moisture pushes the salts that are naturally in the brick and joints to the surface. A proper cleaning of these surfaces can typically alleviate any visual concerns. In instances where the building lacks an air vapor barrier or weather tends to breach the wall system, there is potential for reoccurrence. Regular inspection of sealants should be performed and resealed if the inspections warrant it. Any missing sealant at joints should be filled to prevent infiltration of weather.

Areas where masonry shows efflorescence and growth from moisture

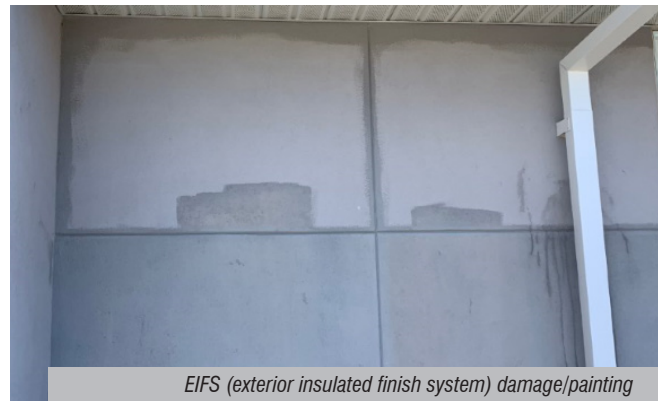
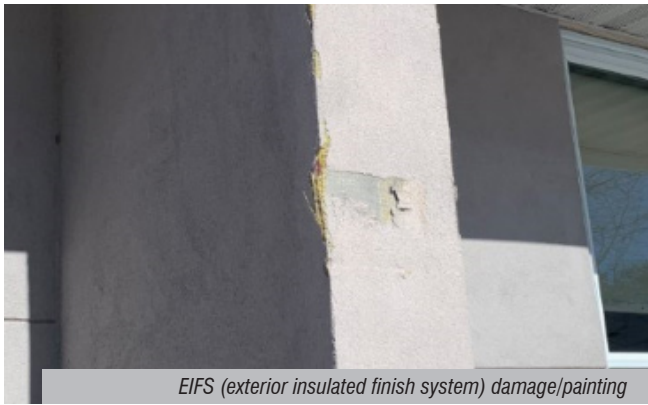
Locations with EIFS were generally in good shape. Some areas of damage or possible repairs were noted. At some locations it was noted that the paint did not match other locations. It is recommended to repair any damage and properly repaint EIFS. Continue a maintenance plan with inspections and periodic repainting as required.

EIFS (exterior insulated finish system) damage/painting

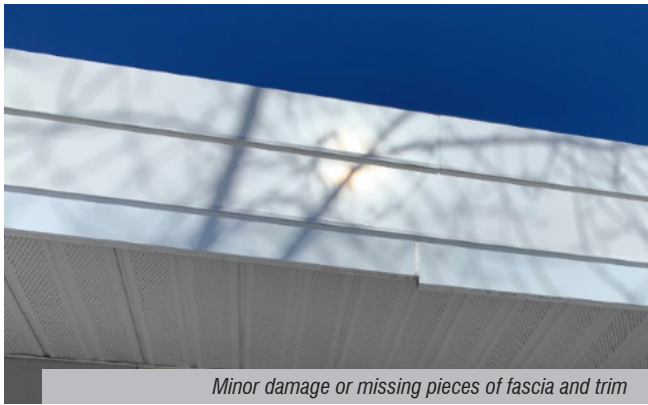
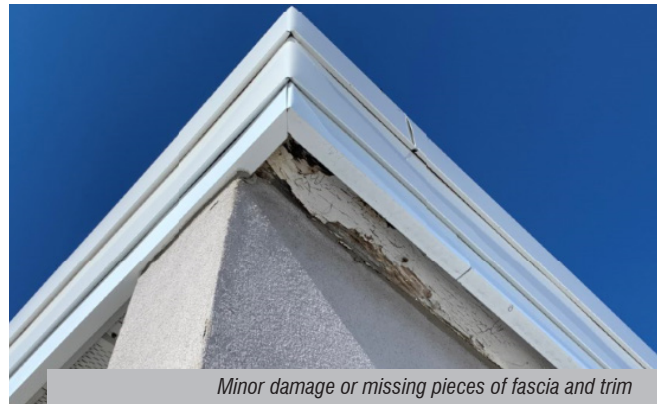
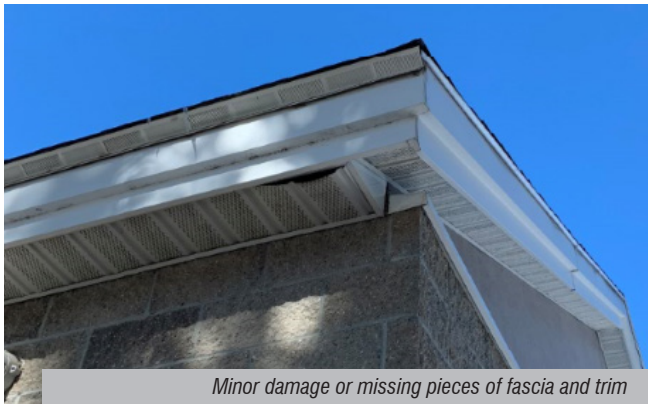
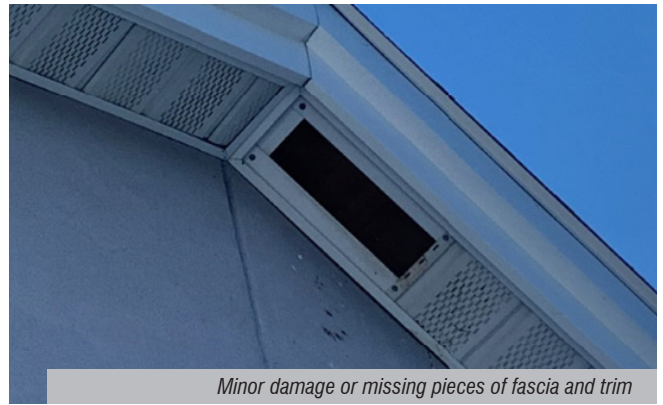
The roof fascia and soffits appear to be in good condition. A few locations of minor damage or missing pieces were noted. We recommend those minor items be repaired. Any open soffits should be closed up to prevent pests from entering and creating nests.

Minor damage or missing pieces of fascia and trim

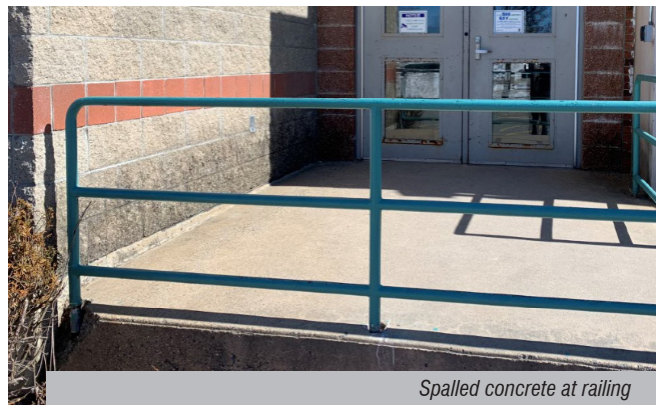
A ramp located near the library addition was noted as having rails embedded into spalling concrete. These should be repaired to prevent unintentional failure of the rail supporting persons leaning against it.

Spalled concrete at railing
