SECTION 2

FACILITY ANALYSIS

FACILITY ANALYSIS OVERVIEW

ELM STREET MIDDLE SCHOOL

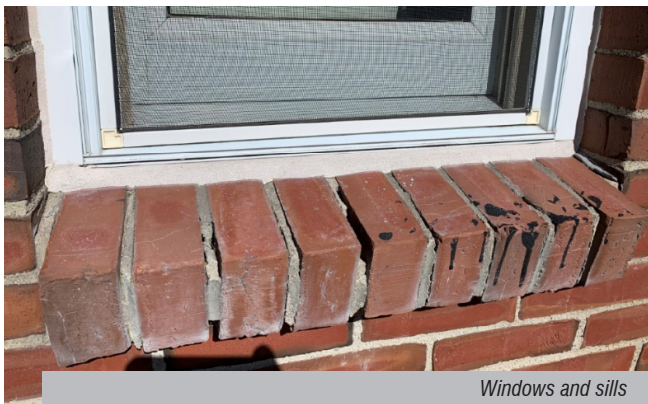
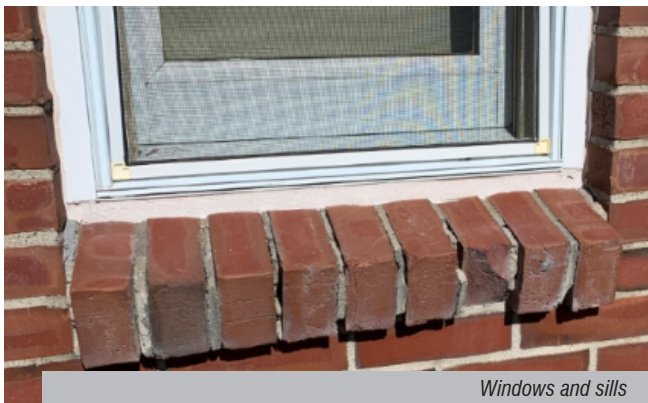
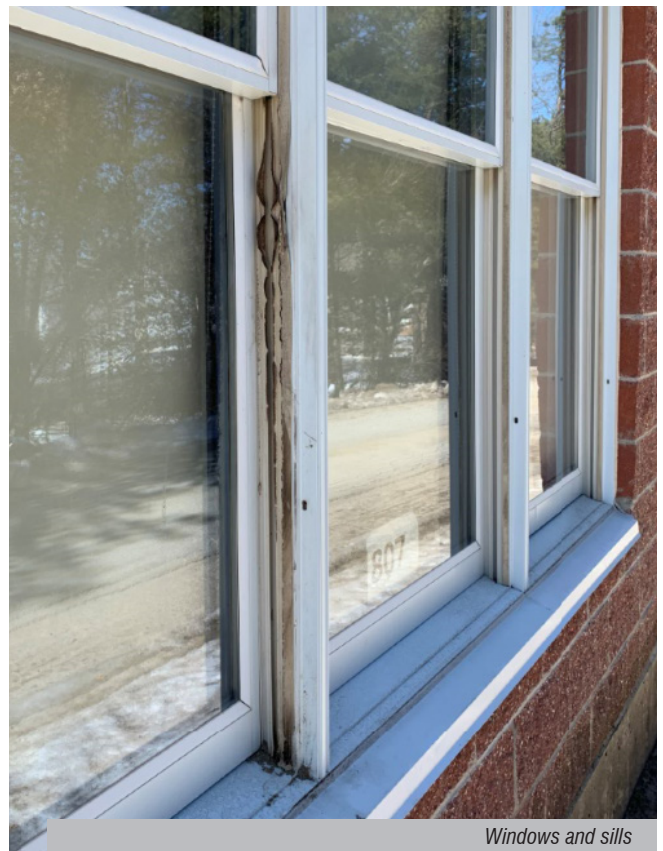
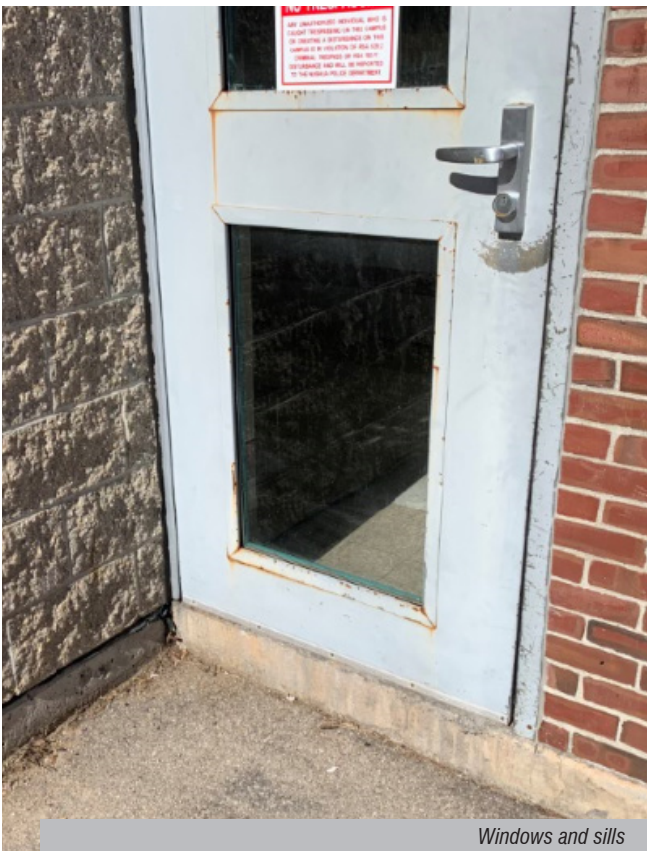
The windows appear to have been replaced during the 1996 renovation, with primarily aluminum-clad wood, double hung windows. Some windows were noted to be fixed type windows. They generally appear to be in good condition; however, some windows were found to be damaged. Damaged windows should be replaced. The glass was noted to be insulated panels and none were noted as failing at this time. A commercial window's life expectancy is based on average wear-and-tear of windows. Clad windows are expected to last around 25 years, and but can be extended with regular maintenance. In many cases the screen at the windows were missing. Replacement of any missing or damaged screens should be done to prevent pests from entering the building when windows are open.

The sills of the windows are made of prefinished metal at the 1996 additions. They are made from sloped rowlock brick at the original portions of the building. The locations with prefinished metal were noted as being in good shape. Several locations of brick window sills were noted as being in poor shape and may even allow weather into the wall cavity. At these locations, sealant may have been missing or disturbed, or in some locations the brick joints may have been disintegrating. Review of the locations should be done and repaired where needed. Resealing of windows should be done and continued maintenance should persist to ensure long life of wall components.

Windows and sills

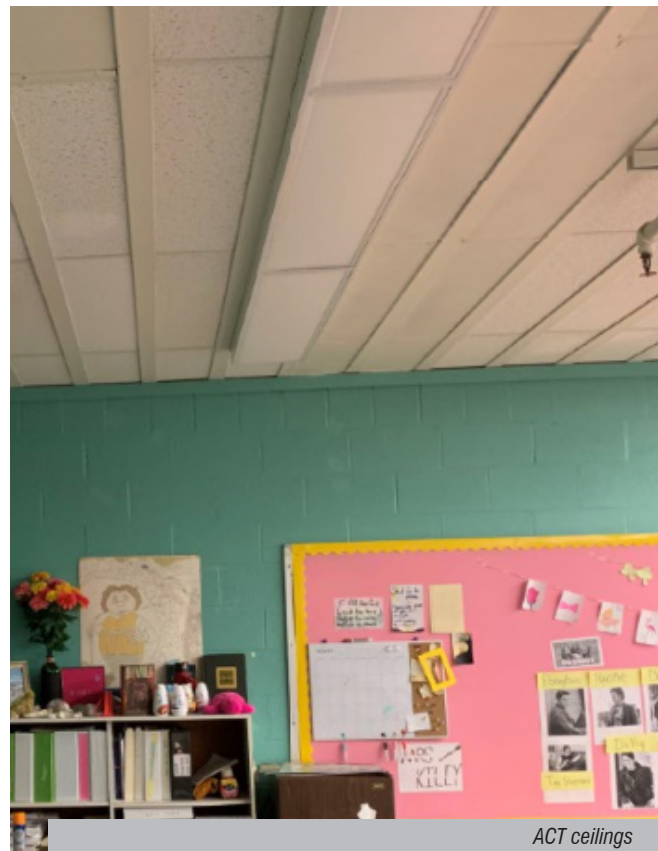
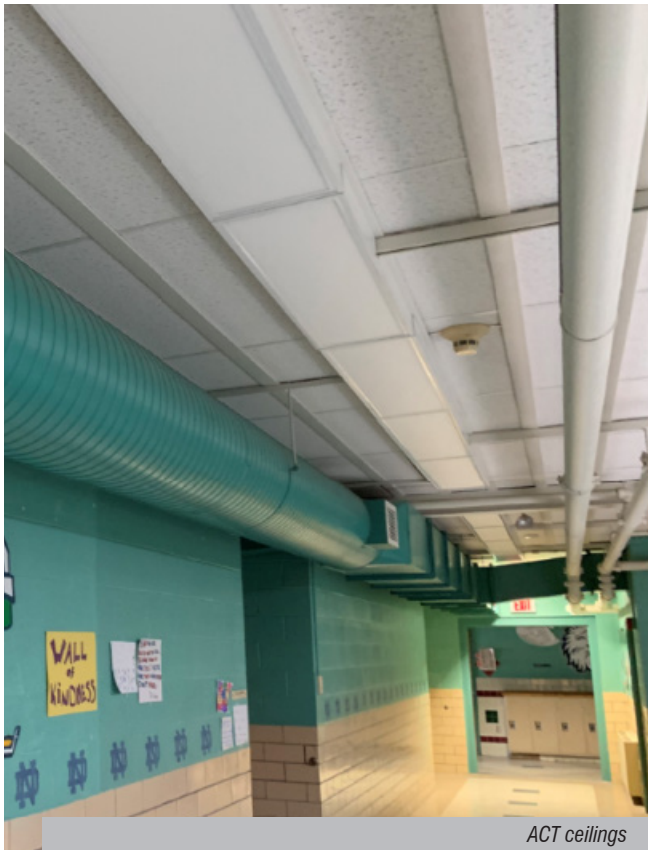
The ceiling tiles throughout this building are installed in a peculiar way in a majority of the original building. They have been installed between the bottoms of the structural members. The ceiling appears to be in good condition in these spaces and due to the nature of the smaller tiles, do not show any signs of sagging. This installation does create some difficulties when trying to run wiring and such. Any infrastructure needs to be installed below the ceiling as the structure blocks most pathways. Lowering the ceilings is not a viable option as the ceilings are generally fairly low as they stand. Any damaged or stained tiles should be replaced to match existing tiles.

ACT ceilings

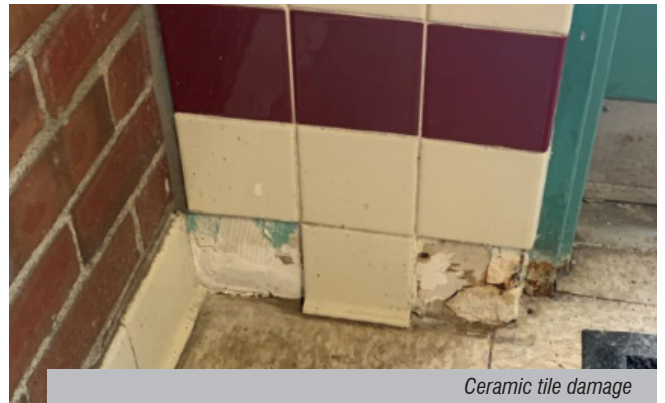
Ceramic tile wainscoting was used in the newer addition corridors and is generally in poor shape in many of the areas, with chipped and broken tiles. Replacement by patching or wholesale is recommended.

Ceramic tile damage

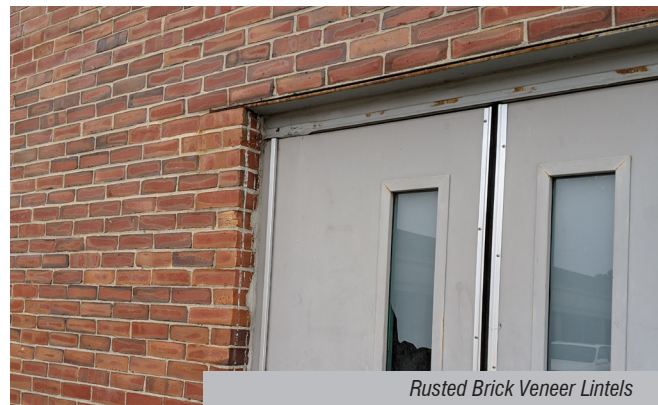
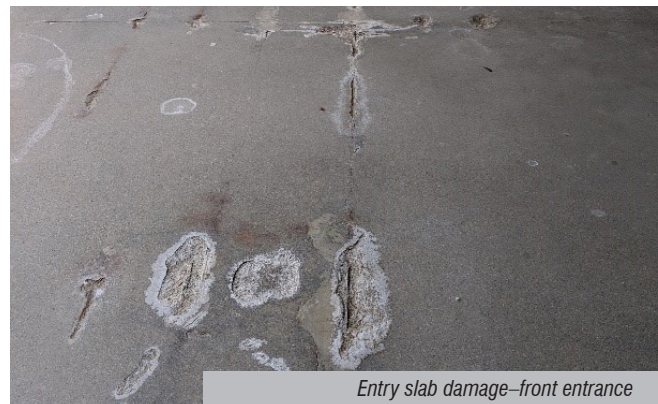
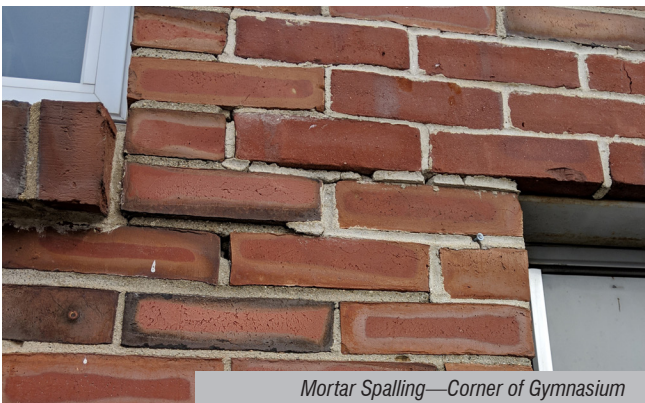
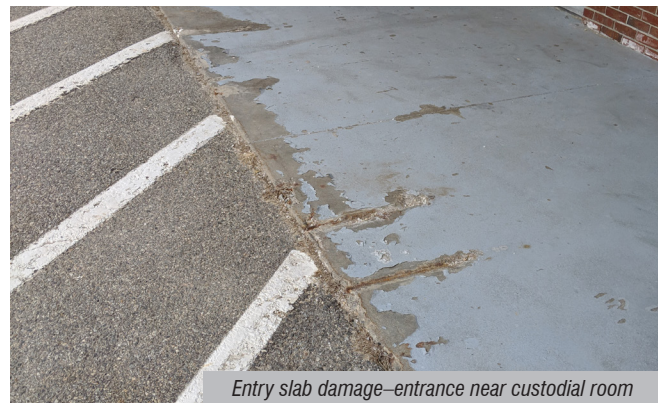
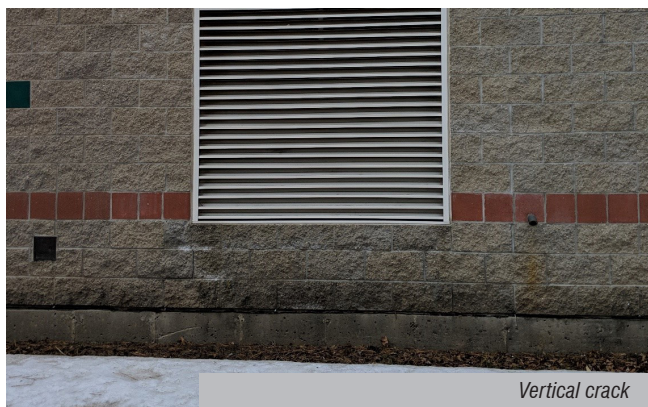
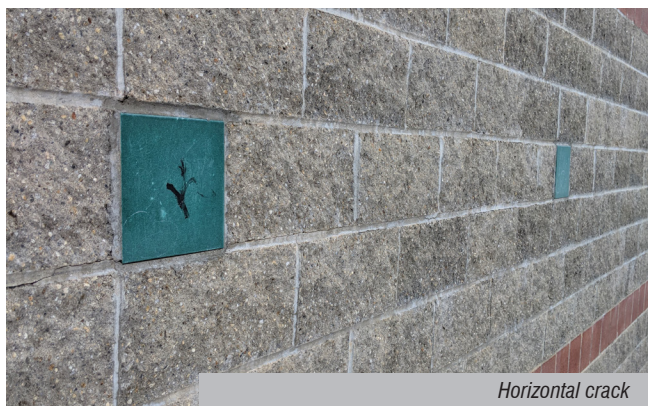
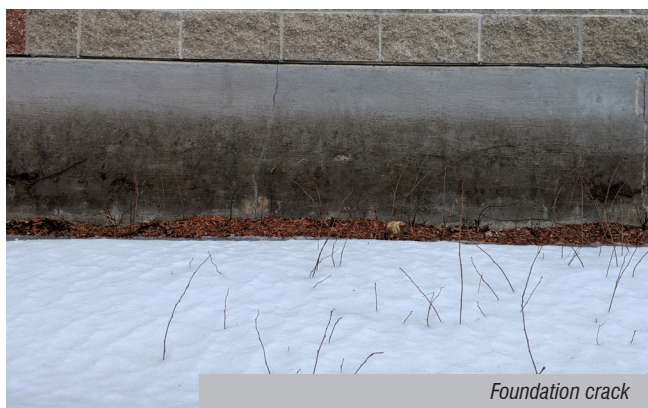
1. Areas were observed where there was damage to the mortar around bricks.
2. Rusted Lintels were noted in certain locations around the building and are recommended to be repaired or addressed to avoid further deterioration and potential brick cracking above.
3. Concrete entry slab detail damage and exposed rebar caused by exposure and salt.
4. Cracking in existing mortar both horizontal and vertical
5. Minor to moderate cracks were noted in localized areas at the foundation.

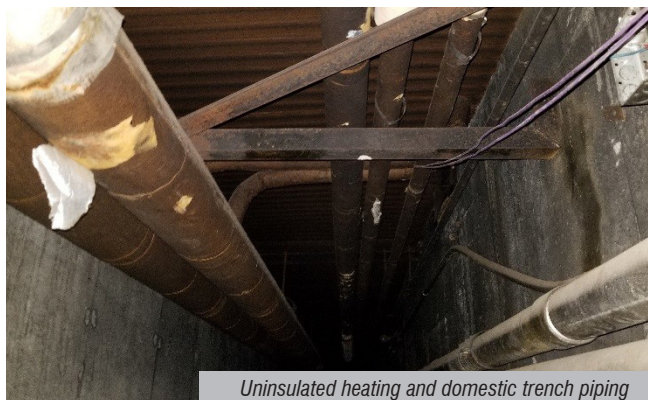
Uninsulated heating and domestic trench piping

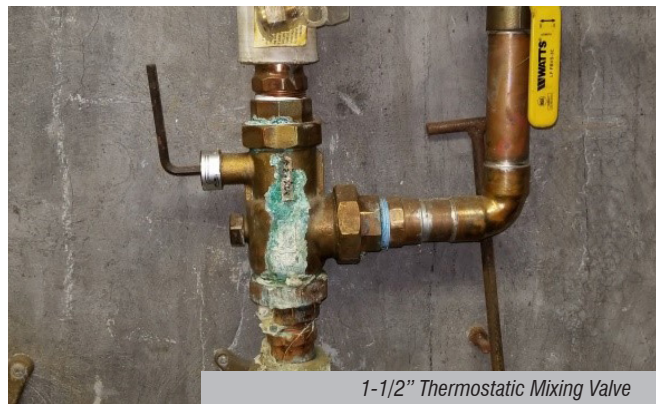
1-1/2" Thermostatic Mixing Valve

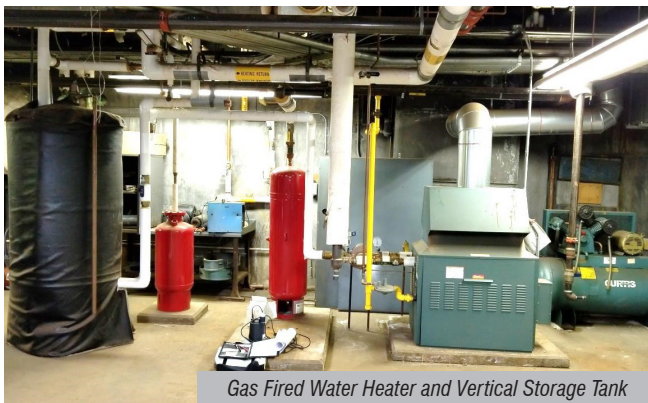
The mixing valve is a 1-1/2" Honeywell model MX129C. The unit has some surface corrosion from a past leak at the union, at the top of the valve. The mixing valve is not a lead-free model. The mixing valve should be replaced with a lead-free model of the same size.

Gas Fired Water Heater and Vertical Storage Tank

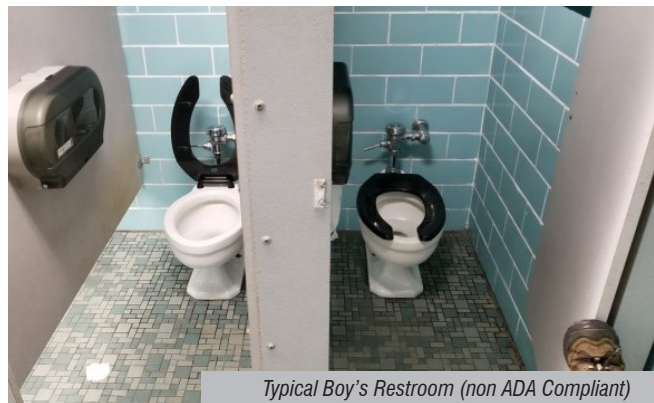
Typical Boy's Restroom (non ADA Compliant)

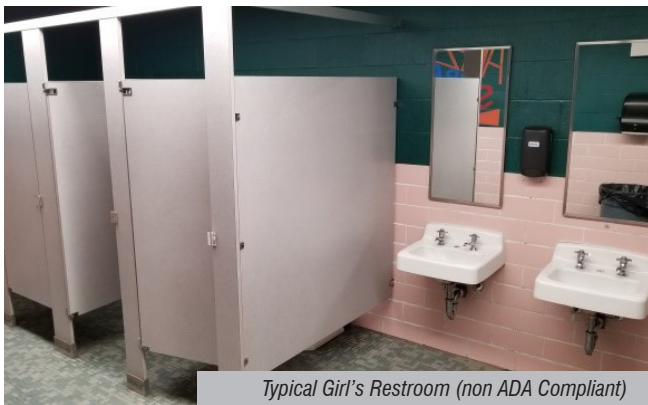
Typical Girl's Restroom (non ADA Compliant)

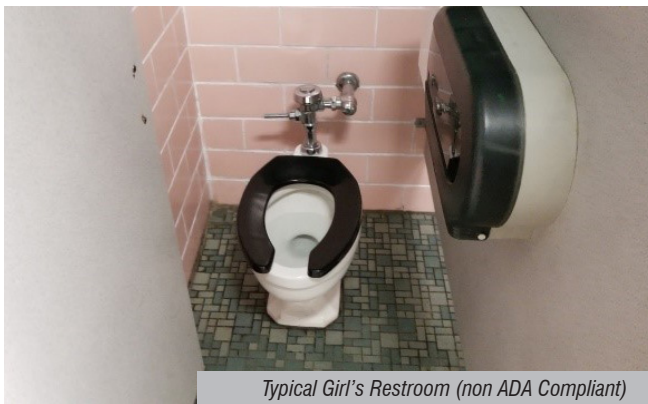
Typical Girl's Restroom (non ADA Compliant)

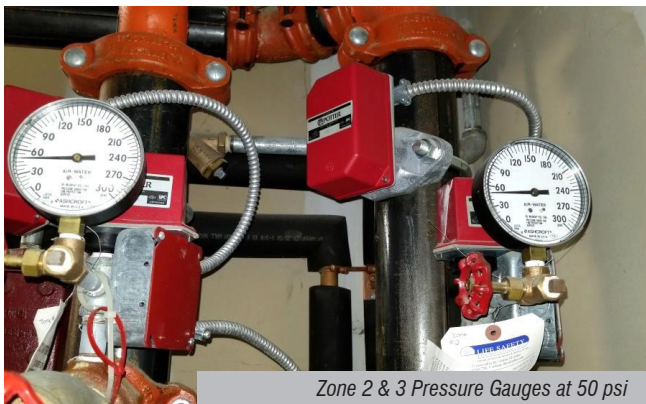
The sprinkler system was installed in the mid-1990s. Three wet pipe riser valves serve all areas of the building. The static pressure at the base of the risers on the day of the survey was 50 psi. The test cards indicate a static pressure of 60 psi. It appears the sprinkler piping and calculations were produced with 60 psi incoming static pressure or higher. The design calculation labels on the piping indicate a required pressure for each protected zone between 48 and 53 psi flowing pressure. At a static pressure of 50 psi, the system will not flow water to the design areas at the calculated rate.

Zone 2 & 3 Pressure Gauges at 50 psi

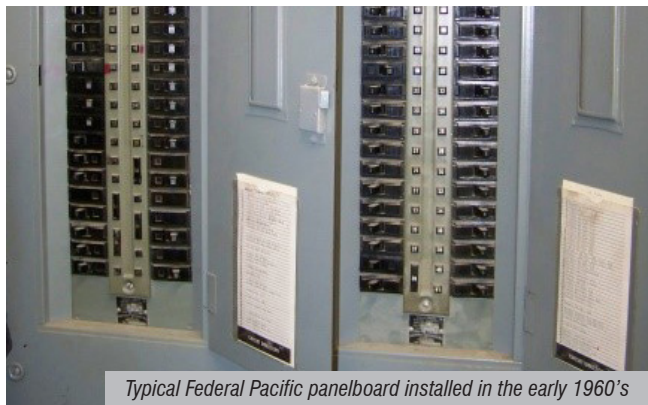
Most panelboards observed were either Federal Pacific or Square-D. Federal Pacific panelboards appear to have been in place since the original building was constructed in the early 1960’s, the Square-D panelboards were installed as part of the 1990’s renovation and additions. The original Federal Pacific panelboards have been in service beyond their serviceable life, some have labeling indicating that breakers are failing.

Typical Federal Pacific panelboard installed in the early 1960's

- / Add additional panelboards and/or replace panelboards with tubs containing larger quantities of circuit breakers to allow additional circuits as needed.
- / All Federal Pacific panelboards need to be replaced. Feeders serving each of these panelboards should be considered for replacement as the feeders are almost 60 years old.
- / Any panelboards located in student accessible locations should be relocated to areas of no student access.

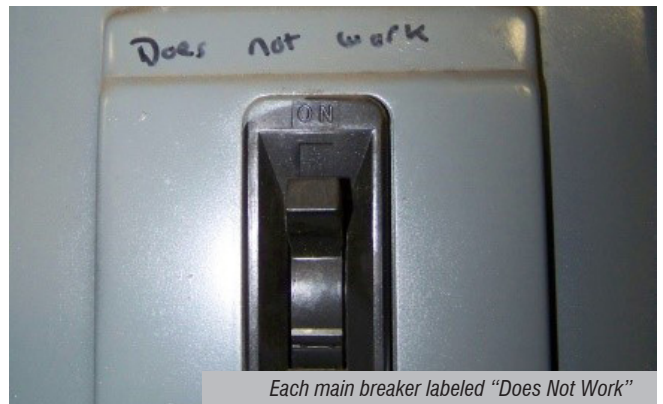
Each main breaker labeled "Does Not Work"

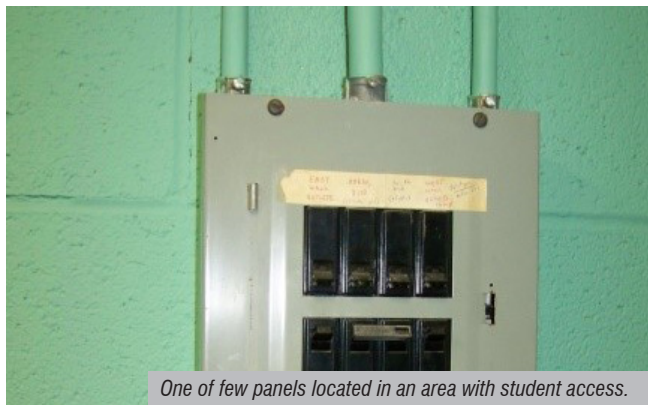
One of few panels located in an area with student access.

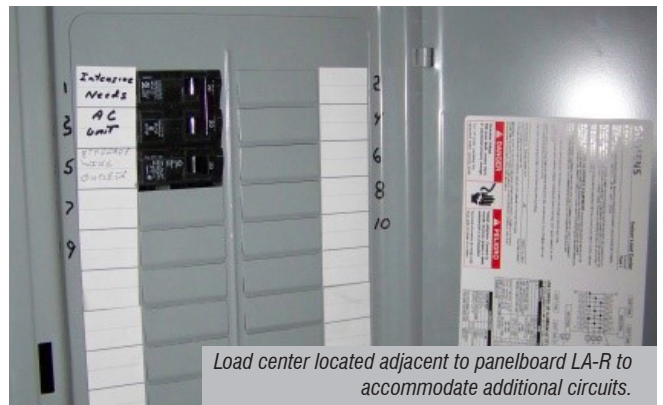
Lighting and power panelboards are located throughout the facility. Panelboards observed were either full or nearly full (no room to feed additional circuits). Load centers have been placed adjacent to existing panelboards in some locations to accommodate additional circuits. Most all panelboards are located outside areas of student access, mostly located in janitor’s closets or mechanical spaces.

Load center located adjacent to panelboard LA-R to accommodate additional circuits.

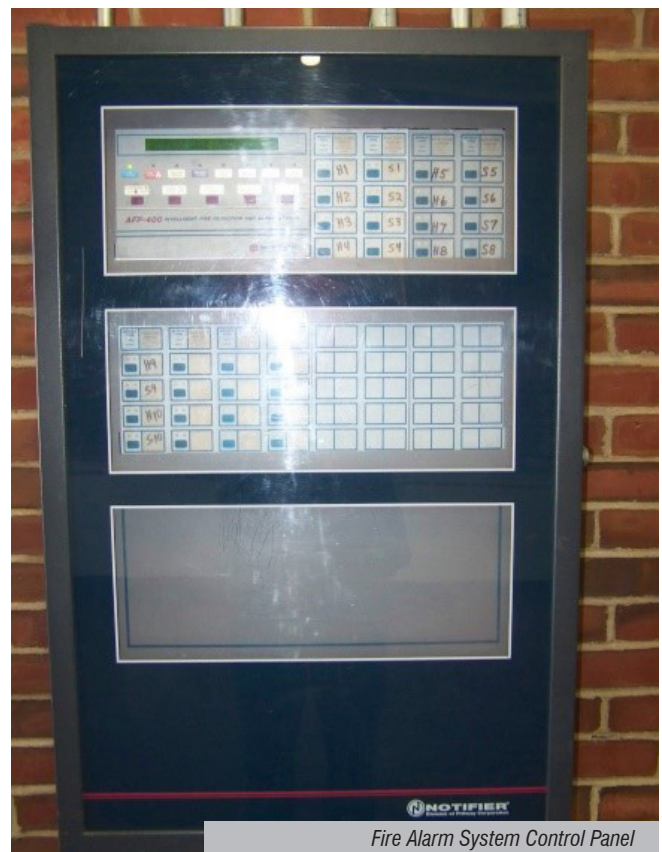
The fire alarm system is a Notifier AFP-400. Smoke detectors, notification appliances and pull stations are located throughout the building. Generally, coverage of notification appliances is inadequate. Typical classrooms area missing notification. In the event of an alarm, the system reports directly to Nashua monitoring / dispatch facility via the city loop system.

Fire Alarm System Control Panel

- / Replace the existing Fire Alarm System with new throughout with a full voice evacuation system.
- / Recent changes in NFPA requires voice evacuation throughout educational facilities.

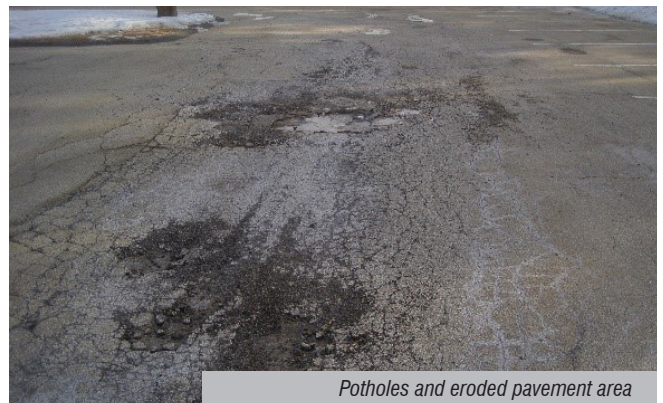
Potholes and eroded pavement area

The pavement throughout the site appears to generally be in fair condition, with noted exceptions. Observations of the pavement included numerous potholes, large cracks, and various areas of differential settlement. The pavement surrounding existing manholes and drainage infrastructure in particular appeared to be in poor condition.

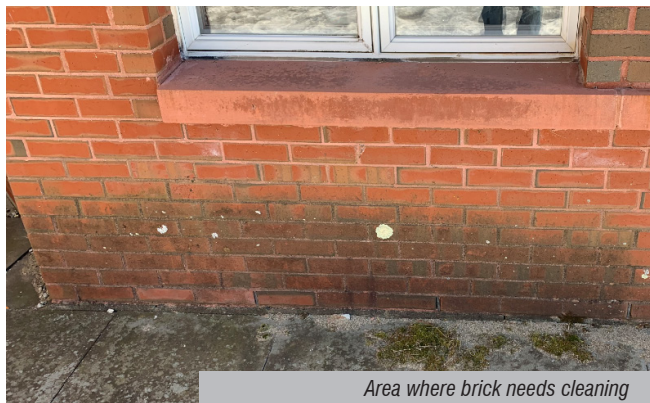
Most brick and mortar joints appear to be in good condition overall. Brick weeps were noted at the base of the brick and above windows around the building. The majority of brick and CMU veneer located at ground level under pitched roofs were noted as heavily soiled. A proper thorough cleaning could alleviate any visual impurities and aesthetics. Although not prevalent everywhere around the building, some efflorescence was noted in a few areas of the building on the brick. It was most notably seen on the northeast side of the building. Efflorescence of brick usually occurs when moisture exists behind the brick and the moisture pushes the salts that are naturally in the brick and joints to the surface. A proper cleaning of these surfaces can typically alleviate any current visual concerns. In instances where the building lacks an air vapor barrier or weather tends to breach the wall system, reoccurrence can potentially happen. There was some evidence of missing sealant at brick expansion joints. Regular inspections of sealants should be done and upkeep, should the inspections warrant it. Any missing sealant at joints should be filled to prevent infiltration of weather.

Area where brick needs cleaning

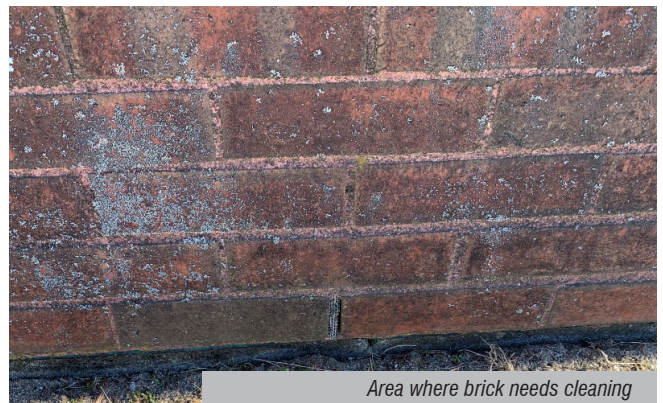
Area where brick needs cleaning

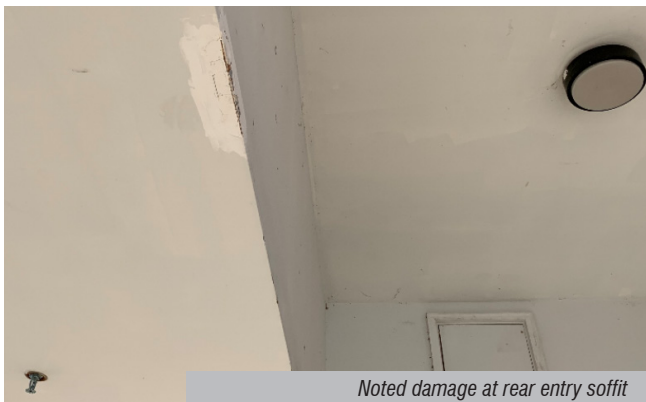
The undersides of the main and rear, secondary main entry were painted drywall. According to the original drawings, there were two layers of fire-rated drywall. The majority of the ceilings were in fair shape. Some damage was noted at the rear entry soffit. Repair utilizing the appropriate drywall should be made. Occasional painting of the soffit should be done to prevent peeling of the surface long term.

Noted damage at rear entry soffit

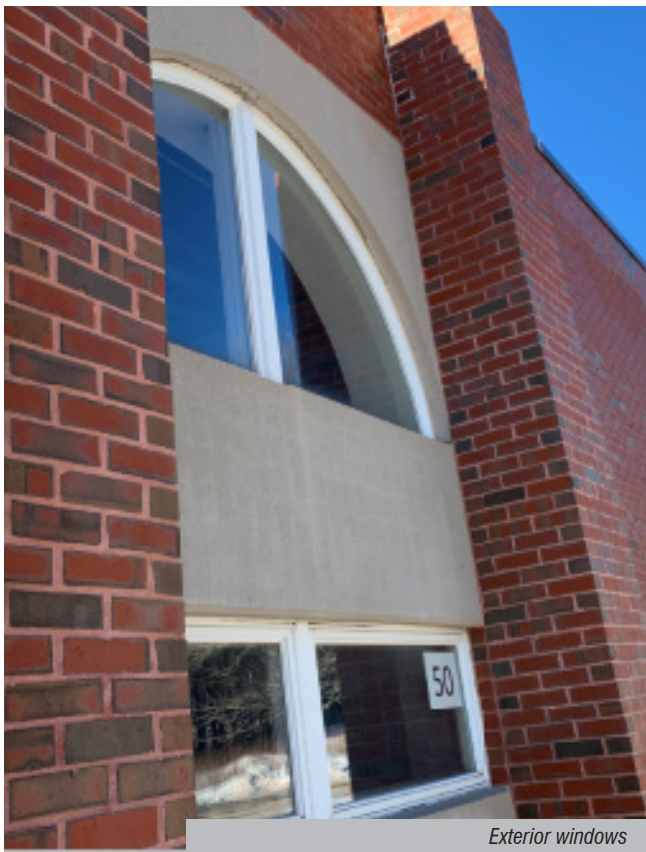
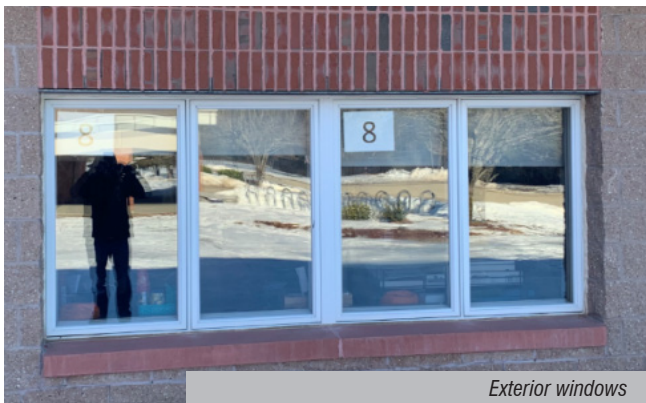
Exterior windows

The windows appear to be original to the building, built in the late 1980s. The windows are a clad wood window in several configurations of functions. The majority of them are crank out clad, with several awning and fixed windows throughout the building. They appear to be in good condition. The glass was noted to be insulated panels and none were noted as failing at this time. A commercial window's life expectancy is based on average wear-and-tear of windows. Clad windows are expected to last around 25 years, and can be extended with regular maintenance.

The sills of the windows are made of precast. Generally the precast is in good condition. Resealing the joints is an important part of maintaining walls at windows and should be part of a regular maintenance program. It is recommended that any joints missing sealant be resealed.

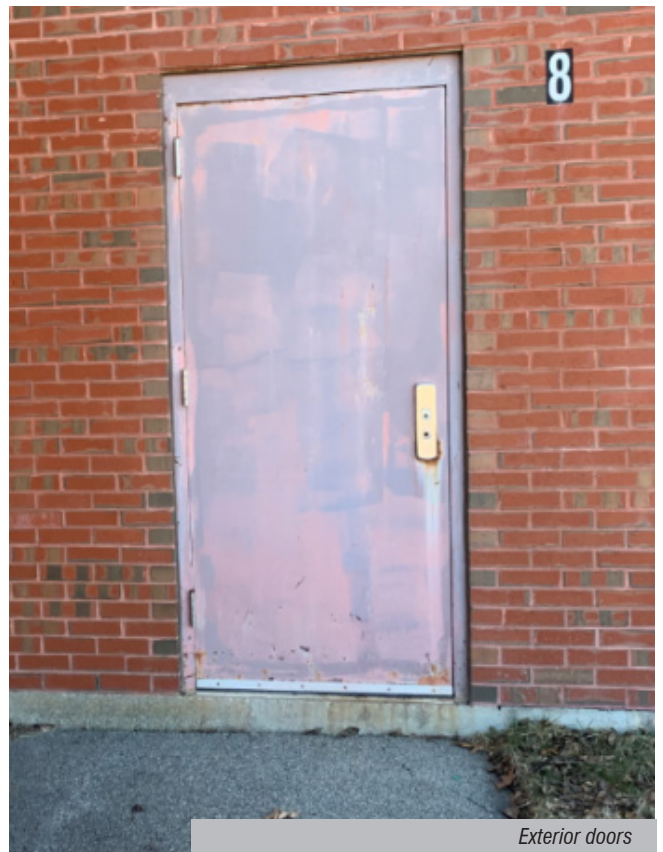
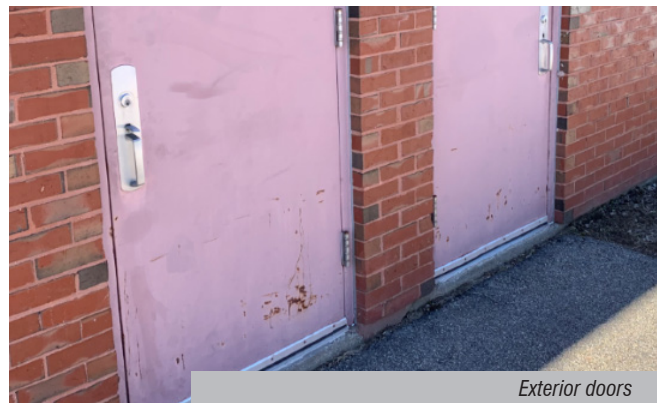
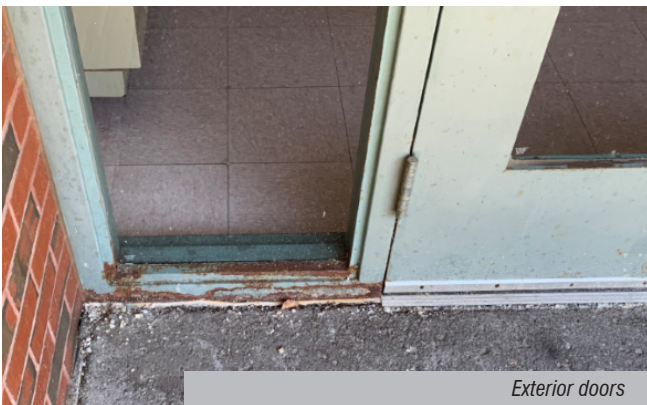
Exterior doors

The exterior hollow metal doors and frames were noted as being in very poor condition in a majority of locations. They have succumbed to years of moisture and salting and have severe

rust damage. It is recommended that the doors and frames be replaced with new galvanized doors and frames.

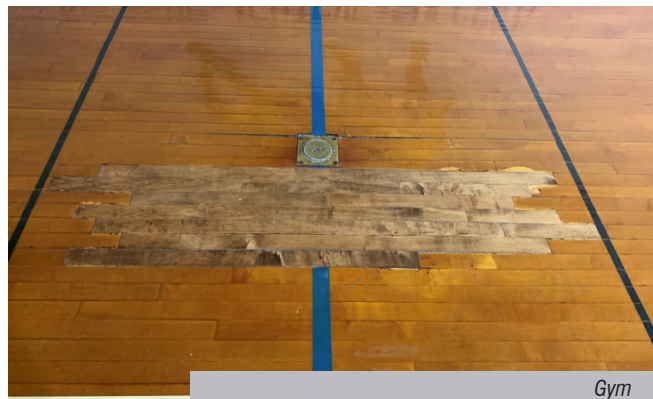
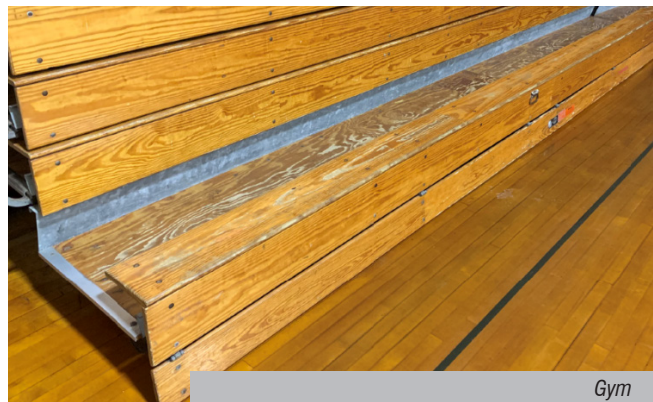
Gym

- / The wood gym floor has areas that have been patched and do not match. At the location of the volleyball net, the floor has a slight distortion. Replacement should be considered.
- / The bleachers not only need refinishing, but are not accessible to meet today's codes. Replacement should be considered.
- / The acoustic properties of the space were poor. It was very loud with students present. The space could benefit from the addition of sound panels around the walls to absorb some of the noise in the space.

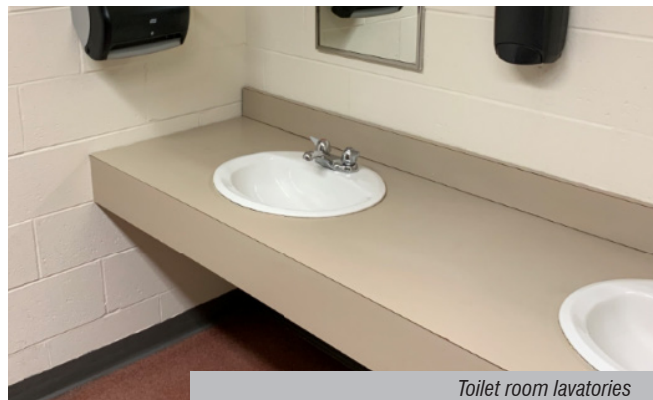
Toilet room lavatories

- / The lavatories were installed in plastic laminate counters. At this time, the condition of the laminate that was reviewed appeared in good shape. At the time of replacement, alternate products should be considered for the counter surface where sinks are present, as laminate can be subject to moisture issues. Moisture getting under the laminate can lead to lifting of the finish. Other products like solid surfacing can have a higher initial cost, but tend to have less maintenance costs long term.

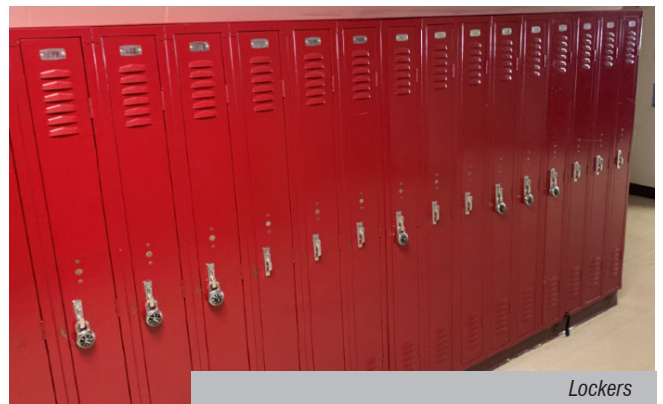
Lockers

/ The lockers were located in the classroom wing corridors. Overall the lockers were in fair shape. It was noted that the lockers are single-stacked and narrow. The width is about 6" wide, making it a tight fit for backpacks or coats. Modern locker widths are usually 12" wide for acceptable use. Handicap-accessible lockers should be appropriately located throughout the field of lockers to accommodate those with accessibility concerns. Numerous padlocks were installed on the lockers, which may indicate that the lockers are used by the students.

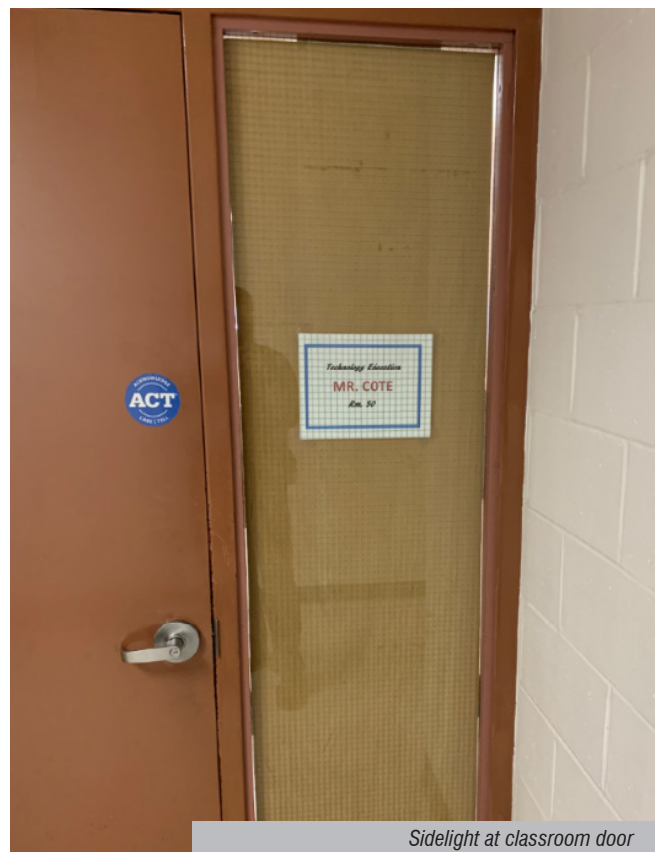
Sidelight at classroom door

Interior doors are generally painted hollow metal doors with painted hollow metal frames. According to the existing drawings, any glass in the doors is a tempered glass. Door hardware appears to meet modern day accessibility requirements. The handles to classrooms appear to have been installed in relatively recent years as they have a classroom security function. One area of concern that was brought up by staff was that classrooms often have tall glass sidelights adjacent to the door that was of concern for safety and security. Most teachers cover the glass with paper or by some other method. Replacement of these frames should be considered.

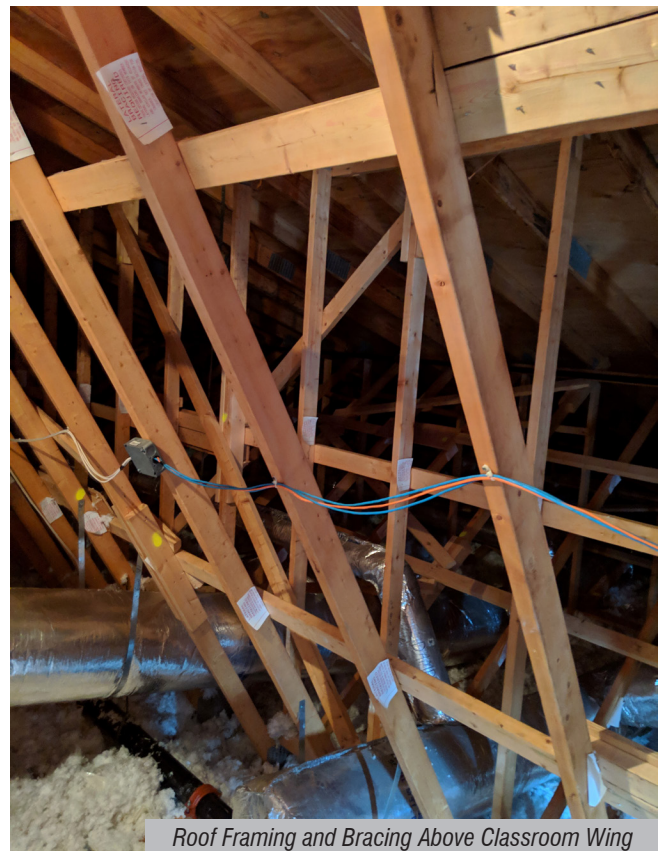
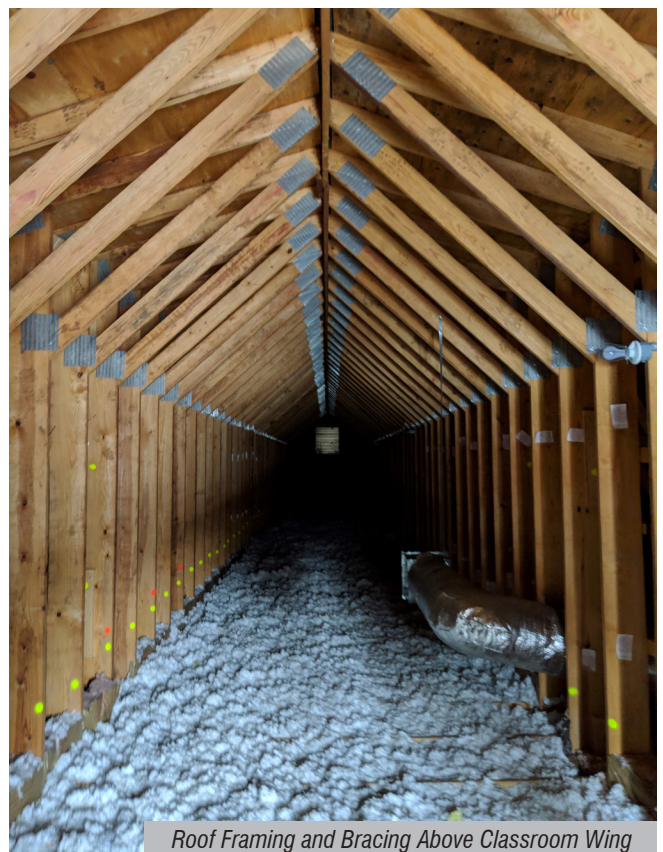
Roof Framing and Bracing Above Classroom Wing

All of the sloped roofs were constructed of pre-engineered wood-framed trusses. Due to the nature of wood framed truss design, where the wood truss manufacturer utilizes stress-grade lumber and proprietary connections, the capacity of these trusses cannot be evaluated with typical processes. As such the trusses were not evaluated as part of this study. From our observations, the wood framed trusses appear to be in overall good condition, and lateral bracing was present.

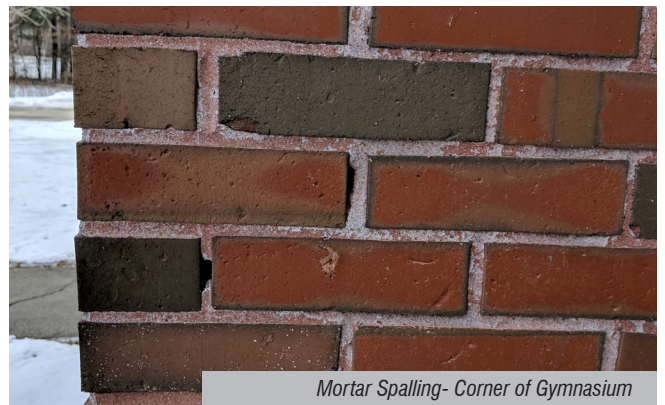
1. Areas were observed where there was damage and spalling to the mortar between the bricks and precast concrete sills.
2. Rusted Lintels were noted in certain locations around the building and are recommended to be repaired or addressed to avoid further deterioration and potential brick cracking above.

Mortar Spalling- Corner of Gymnasium

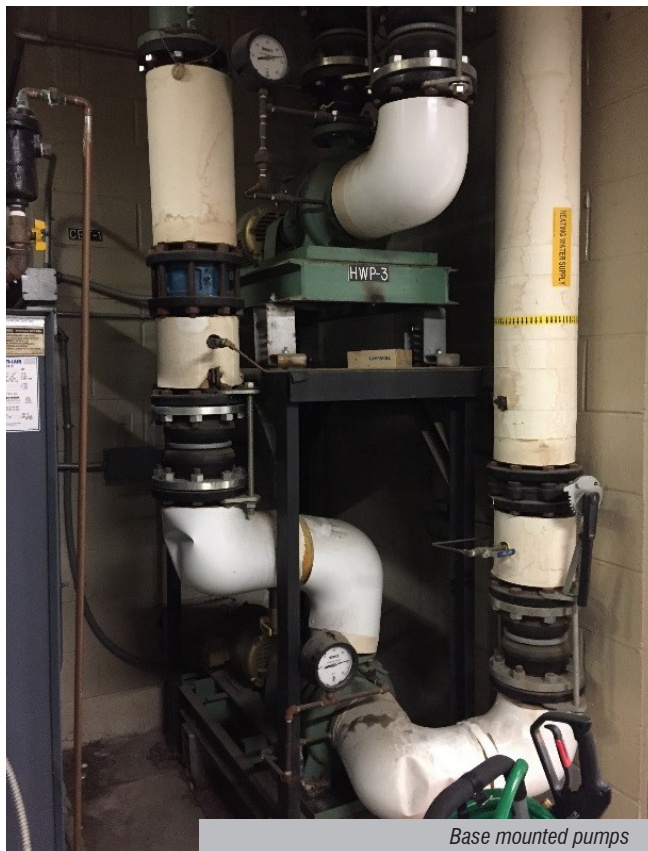
Base mounted pumps

Two base mounted pumps (HWP-3 & 4) circulate water in a lead/standby arrangement throughout the building. The pumps are stacked vertically on a custom made rack. Each boiler is served with a separate inline pump (HWP-1 & 2) which are decoupled from the base mounted pumps with closed spaced tees. The exact selection requirements for any of the pumps are unknown as nameplate data was illegible or did not provide ample information. The pumps are not original so information from existing construction documents could not be used. What nameplate data that could be used indicate that the base mount-

ed pumps were installed in 2000 and have an 8.4" impeller with a 7.5 HP motor. The design flow and pressure drop are unknown. None of the pumps are connected to a VFD.

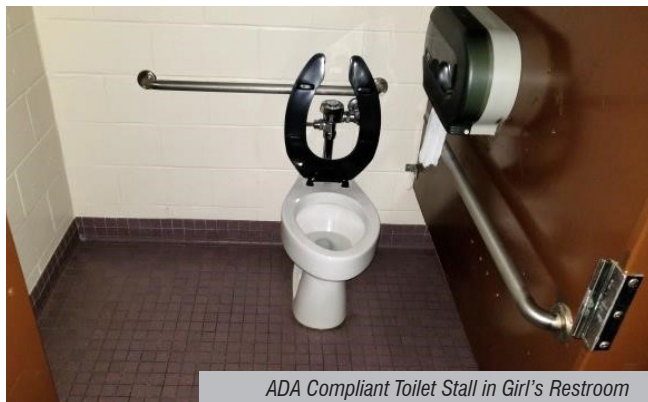
ADA Compliant Toilet Stall in Girl's Restroom

The main restrooms have floor-mounted toilets with manual flush valves. The girl's restroom has an ADA compliant toilet stall and ADA compliant wall-hung lavatory. The women's restroom has an ADA compliant lavatory with a goose-neck spout with wristblade lever handles. The boy's restroom has floor-mounted toilets, wall-hung urinals with manual flush and counter-mounted lavatories. Lavatories are vitreous china oval drop-in sinks with manual two-handle faucets. Lavatory faucets have a flow rate of 2.2 gpm. All lavatory faucets look new within two years except the ADA compliant lavatory and kitchen restroom lavatory. Floor drains are located within the restrooms.

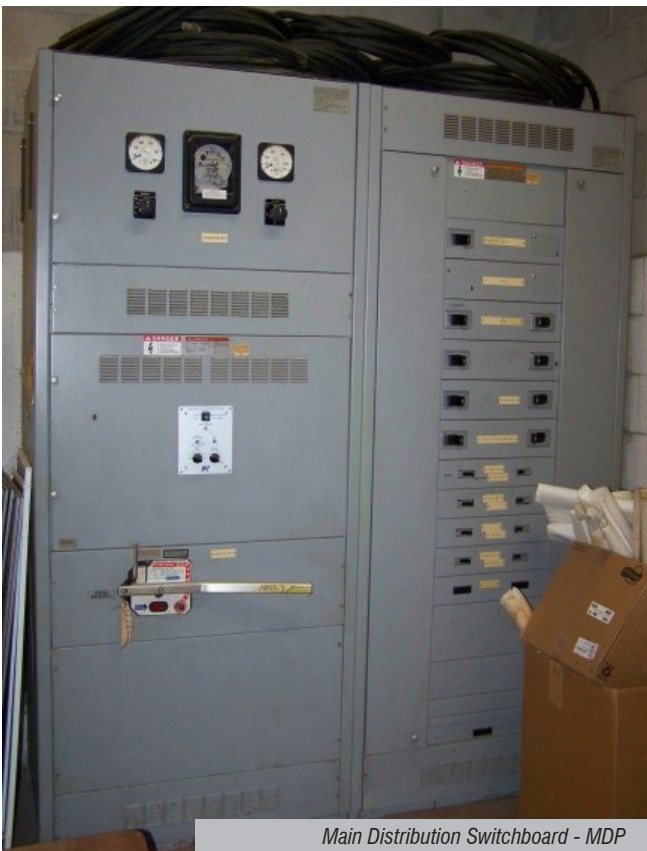
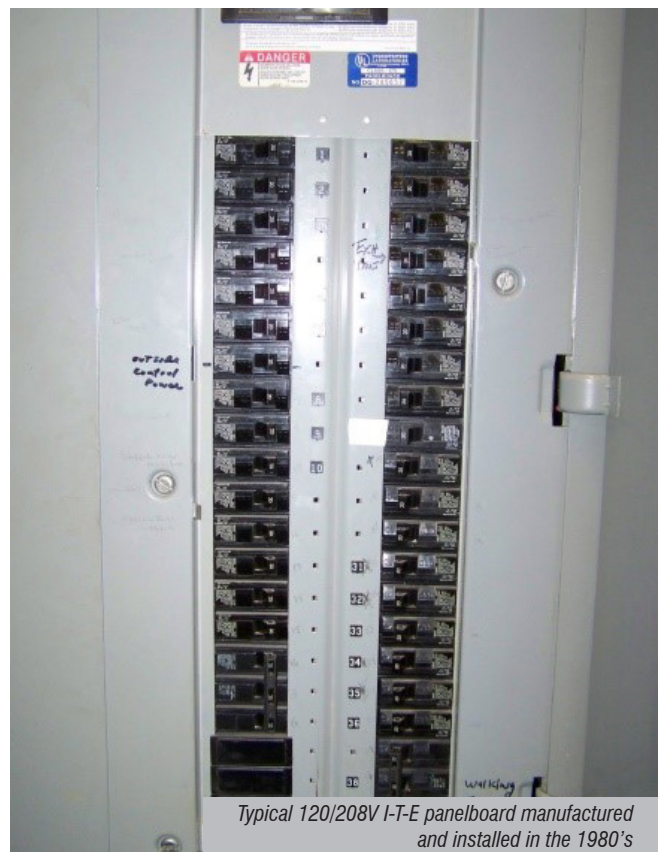
All of the electrical equipment has been in service since the 1980's putting the equipment just beyond the 30 year life expectancy. Some of the panelboards look dirty but all appears to be in good condition.

- / Add additional panelboards and / or replace panelboards with tubs containing larger quantities of circuit breakers to allow additional circuits as needed.
- / Open and clean all panelboards. Visually check condition panelboard interiors.
- / Open, clean and test all dry-type transformers.

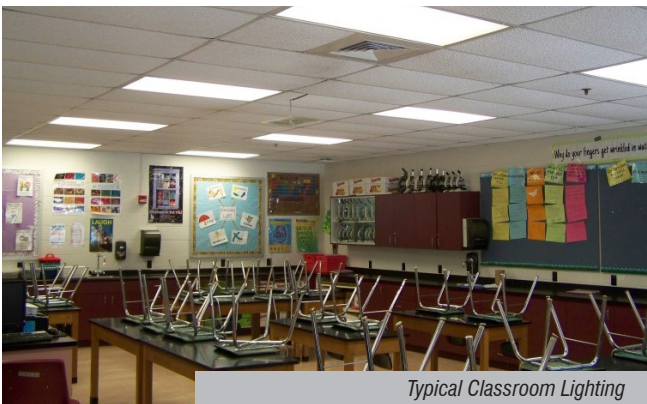
Typical Classroom Lighting

In general, lighting is in fair to good condition. Lighting fixtures exist using both fluorescent and LED technologies. Lighting levels throughout the building are adequate.

- / Lighting fixtures could be replaced with energy efficient LED fixtures.
- / There are often energy incentives available through the utility company to assist with the cost of energy efficient upgrades.

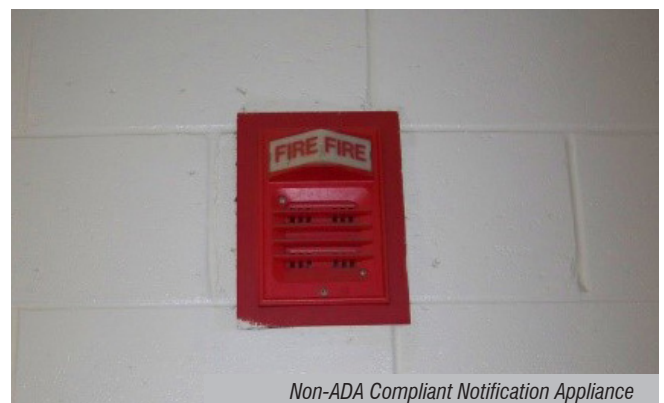
Non-ADA Compliant Notification Appliance

- / Replace the existing Fire Alarm System with new throughout with a full voice evacuation system.
- / Recent changes in NFPA requires voice evacuation throughout educational facilities.

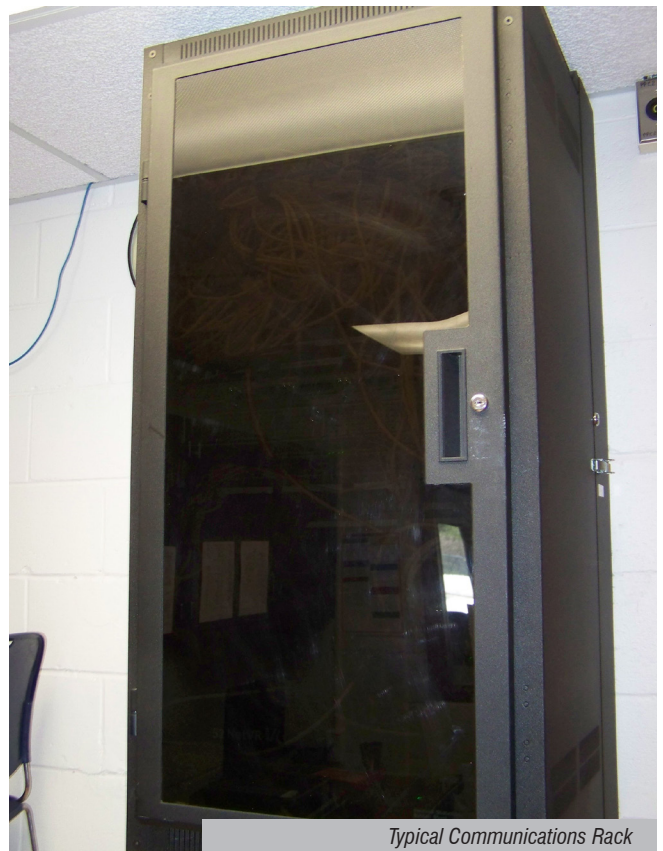
Typical Communications Rack

Communications racks observed are wall mounted, had little to no space to accommodate additional patch panels or switches and are not in rooms dedicated to IT.

- / To accommodate future needs floor mounted communications racks should be provided in rooms dedicated to IT.
- / Replace and upgrade cabling, jacks, patch panels and switches to current standards.
- / Provide additional drops as required to accommodate the requirements of today and the near future.

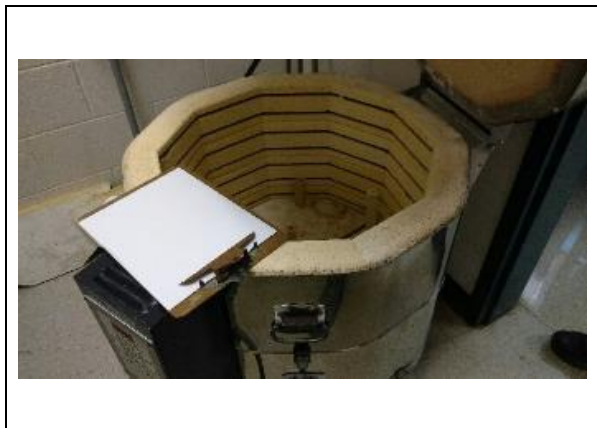
12. Assumed Kiln at New Searles School.

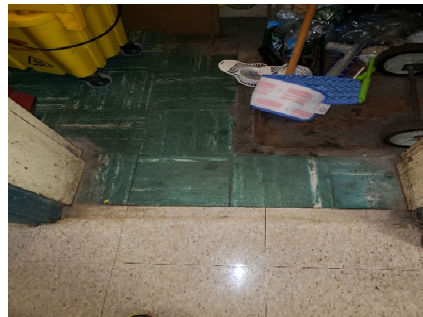
**Asbestos Floor Tile & Mastic
Asbestos Mastic on 12X12**

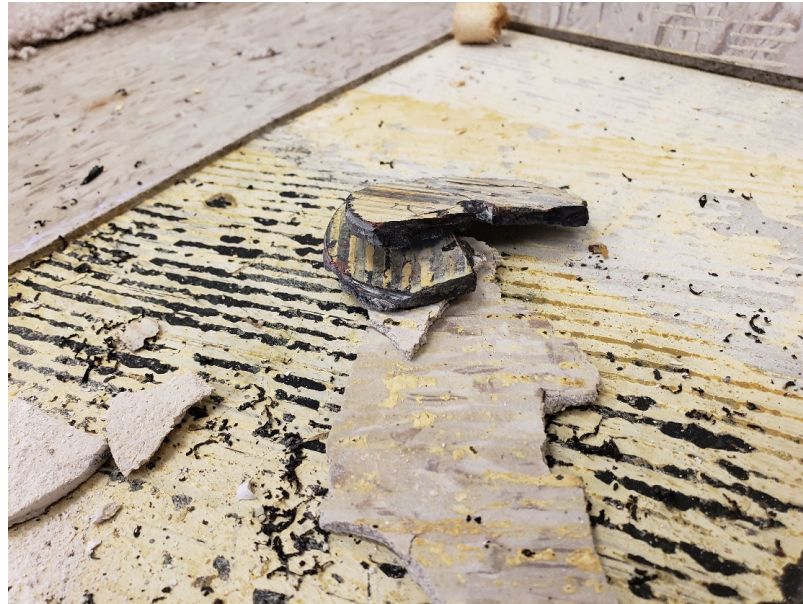
Figure 1 ACT Top Layer Present in Classroom
