SECTION 2

FACILITY ANALYSIS

FACILITY ANALYSIS OVERVIEW

ELM STREET MIDDLE SCHOOL

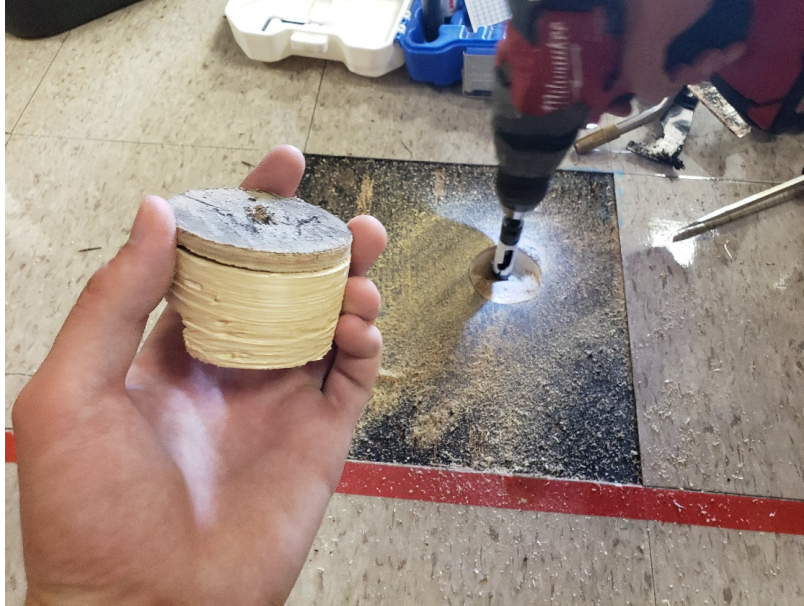
Figure 3 Hallway Wood Core with Luan top layer

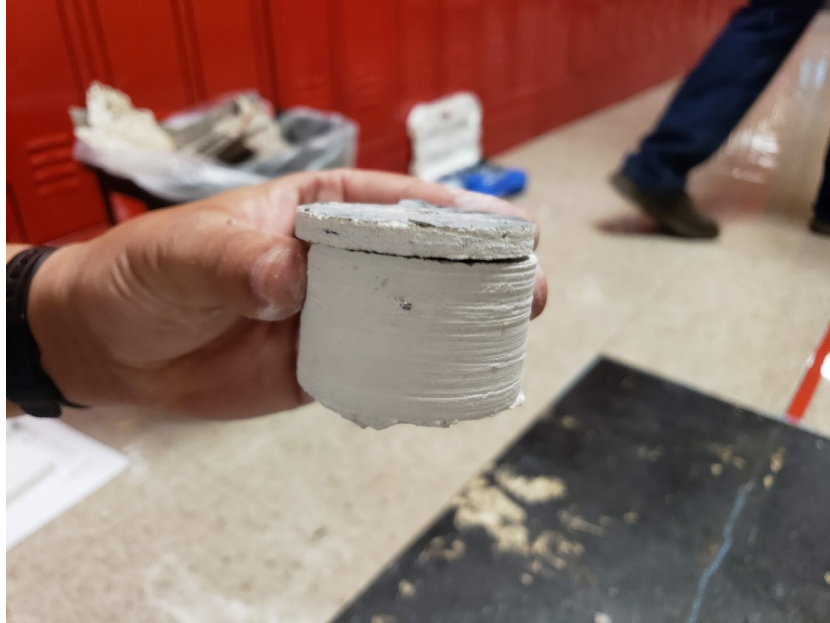
Figure 5 Gypsum Core with Gypsum Top Layer

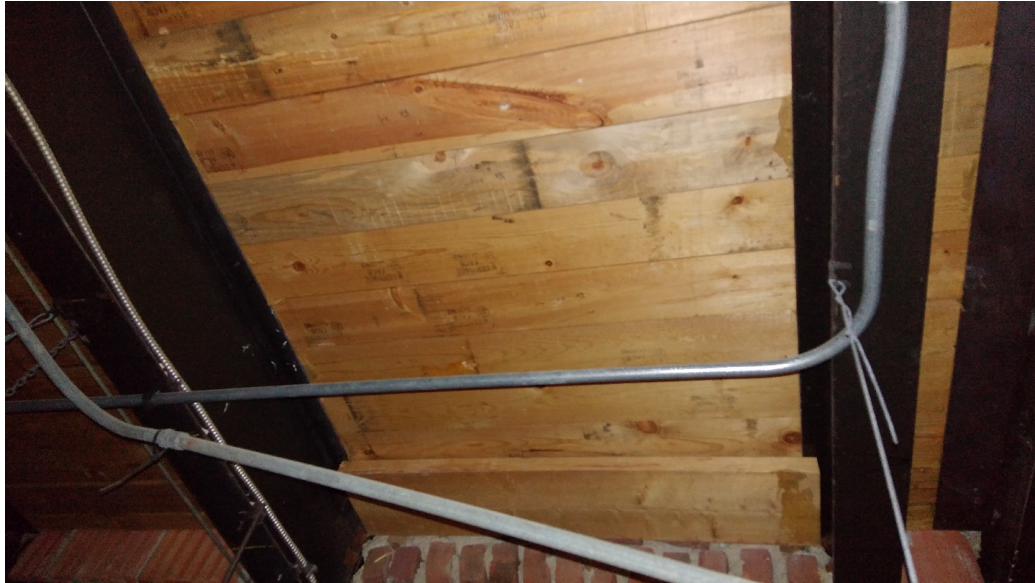
Figure 28 Example of Wood Plank Flooring
